A REPORT ON RECLAMATION OF COAL EXPLORATION ON THE DUKE MOUNTAIN BLOCK OF THE MONKMAN COAL PROJECT IN 1978

PACIFIC PETROLEUMS LTD P.O. #6666 CALGARY ALBERTA T2P 6T6

7 December, 1978

PROJECT NO: 3054.2

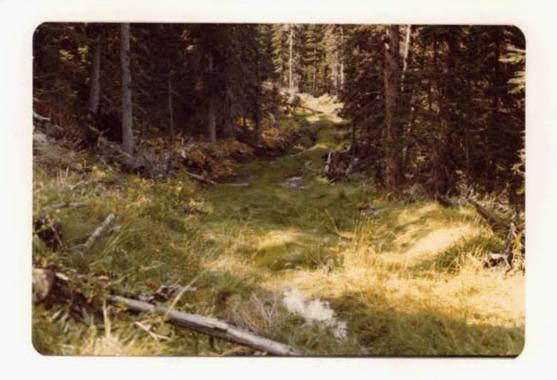
Exploration has been conducted on the licences during 1970 and 1973 by McIntyre Mines Ltd.; in 1975 by Canadian Superior Exploration Ltd.; and in 1976 and 1977 by Pacific Petroleums Ltd. The exploration programme conducted by Canadian Superior in 1975 was an extension of work carried out by McIntyre in 1970 and 1973. Early records of reclamation activities by McIntyre, Canadian Superior and Pacific Petroleums describe general features of their reclamation programme – although it is evident from the well established vegetation cover on the roads that their reclamation procedures were effective (Fig. 1).

FIG. 1 PREVIOUSLY SEEDED SECTION OF ROAD ON DUKE MOUNTAIN

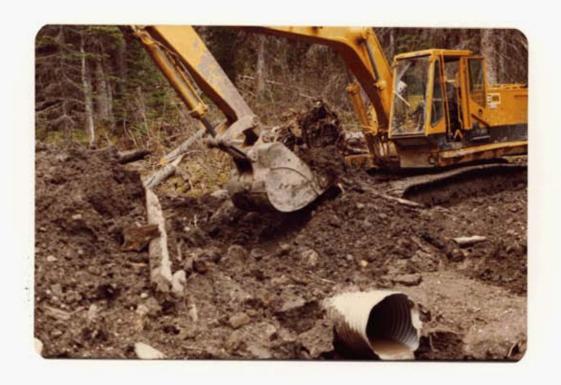
Culverts were removed from an abandoned section of road (Map 1). In all cases, the streams were restored to their natural water course. The culverts were removed from these streams with a Cat 225 backhoe. The backhoe worked well for this job; with the large bucket it was possible to pull out the culvert with a minimal disturbance of surrounding ground and stream. With the use of the bucket it was possible to build a narrow stream channel with high banks so they will not be breached during high water (Fig. 2).

FIG. 2 CAT 225 BACKHOE REMOVING CULVERT FROM AN ABANDONED SECTION OF ROAD

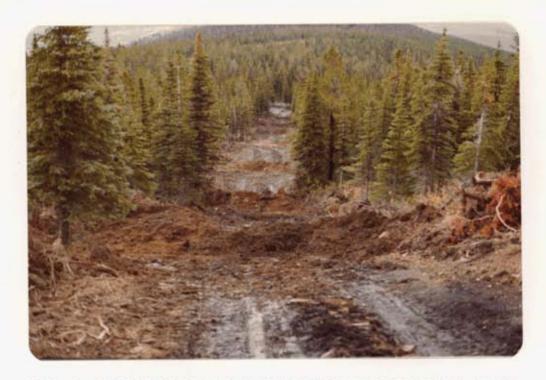
Erosion bars were placed on all roads where the slope was great enough to require some drainage control. Frequency of erosion bars depended on the slope of the road and soil type, and skewed to ensure effective drainage (Fig. 3). Erosion bars were built with a wide pad Cat D-4 with a backhoe attachment, which was found to be superior to a D-6 for this type of work. A D-6 was initially used but it was found to be impractical. The D-4 could build better erosion bars and work in areas too soft to support the heavier D-6 and the backhoe attachment was also found to be useful. When installing erosion bars on a downhill slope it is unavoidable for the Cat to run over the bars after they have been built; with the backhoe it was

FIG. 3 EROSION BARS ON A NEWLY SEEDED SECTION OF THE ALPINE SPUR, DUKE MOUNTAIN

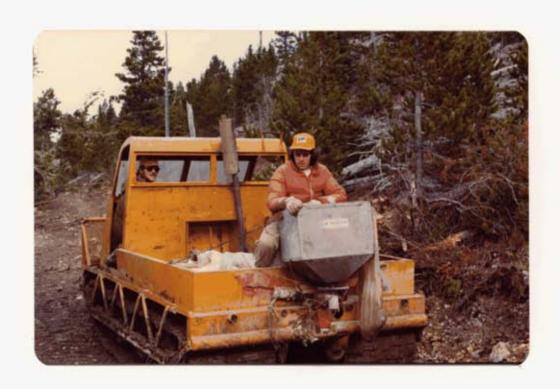
Fertilizer was spread by a Cyclone seeder, powered by a 12-volt electric motor, mounted on the back of a bombardier (Fig. 4). The powered Cyclone seeder could easily spread the fertilizer the width of the road in one pass. Deflectors were built on the sides of the seeders to help regulate the distance the fertilizer was spread. To save time, the seed and

FIG. 4 BOMBARDIER MOUNTED WITH A 12-VOLT CYCLONE SEEDER USED TO SPREAD FERTILIZER
