STRUCTURAL GEOLOGY OF MINE NO. 1
AND ADJOINING AREAS
SUKUNKA COAL PROJECT

PREPARED FOR : COALITION MINING LIMITED

BY : CLIFFORD McELROY & ASSOCIATES PTY LIMITED

REPORT NO. 1/4/24

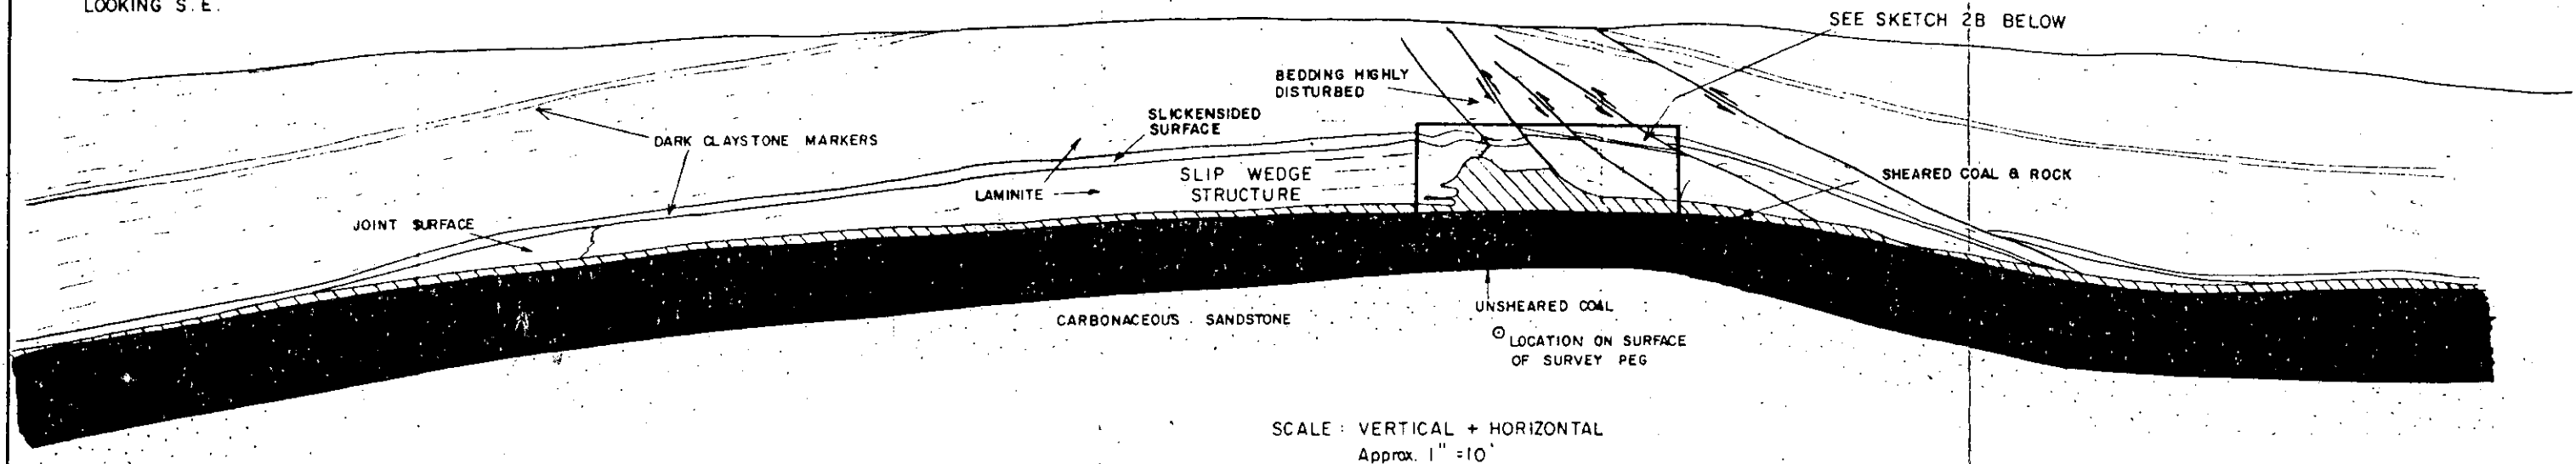
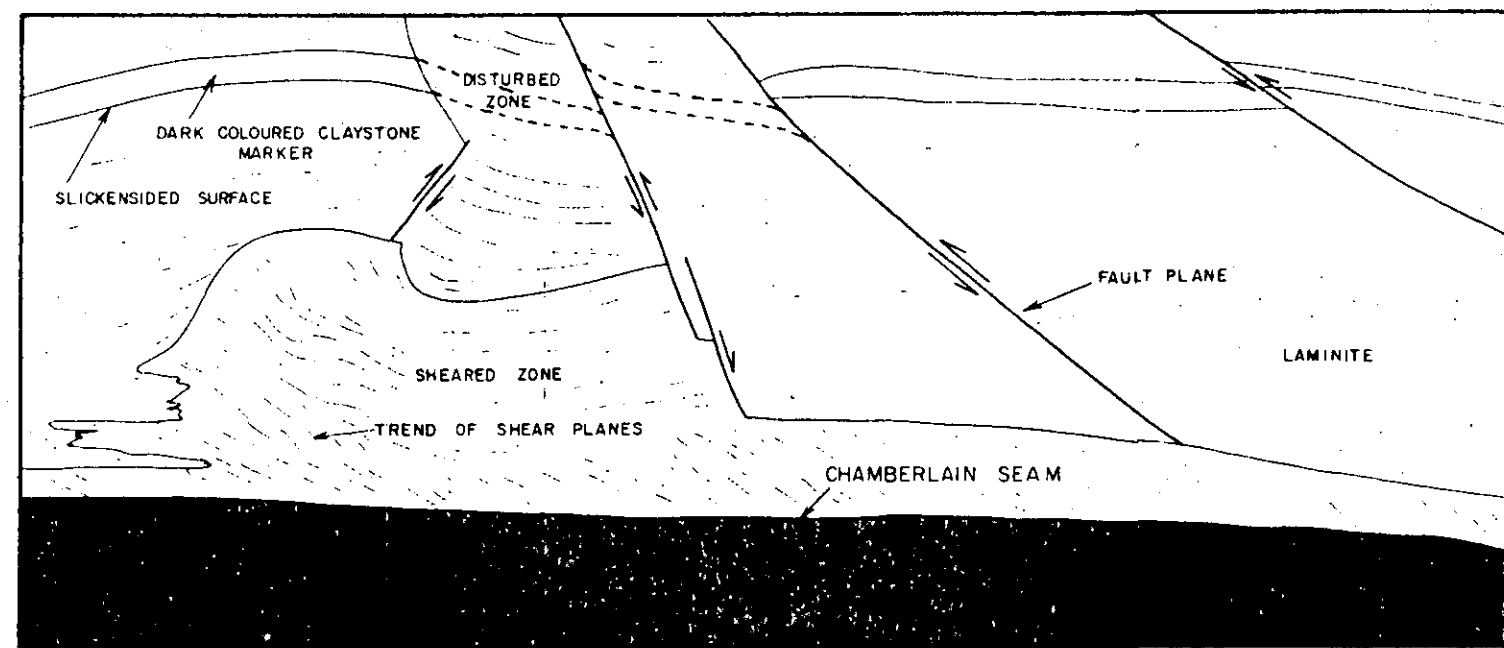
FIGURE 2

The upper part of the Chamberlain Seam is sheared in this area, with up to 0.8 feet of sheared coal and laminite lying immediately below unsheared roof strata. Sheared and iron-stained laminite occurs as a distinct unit above the sheared coal. The thickness of sheared coal is usually greater than the thickness of sheared laminite, although minor amounts of sheared laminite or mudstone occur within the sheared coal.

SKETCH No. 2A
LOOKING S. E.

SKETCH No. 2B
SHOWING DETAIL OF SKETCH 2A
& TRENDS OF SHEAR PLANES IN SHEARED ZONE

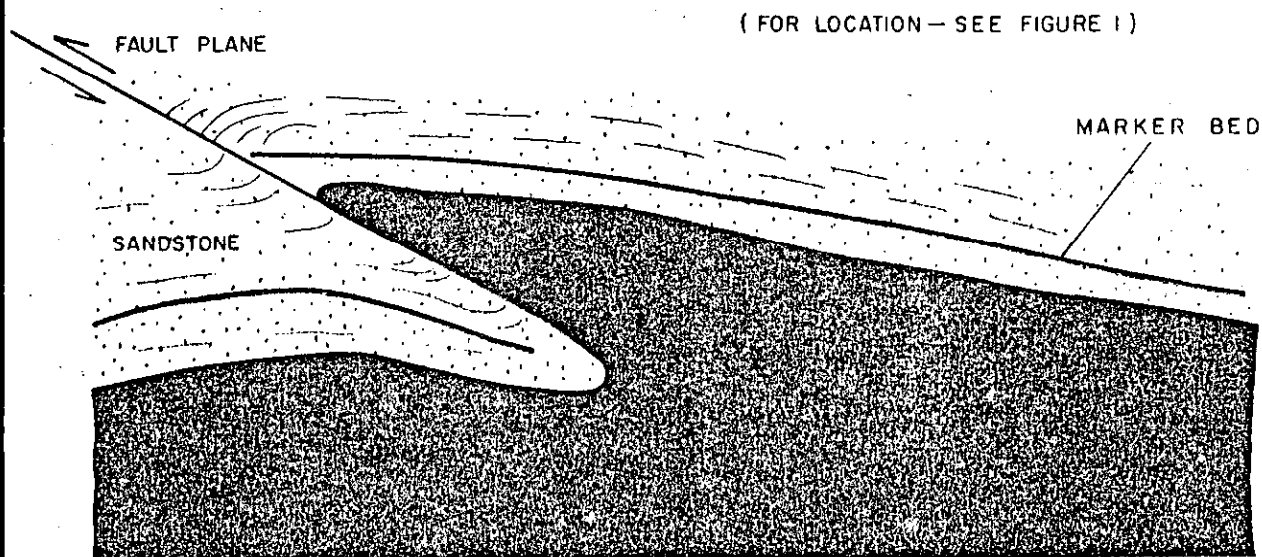
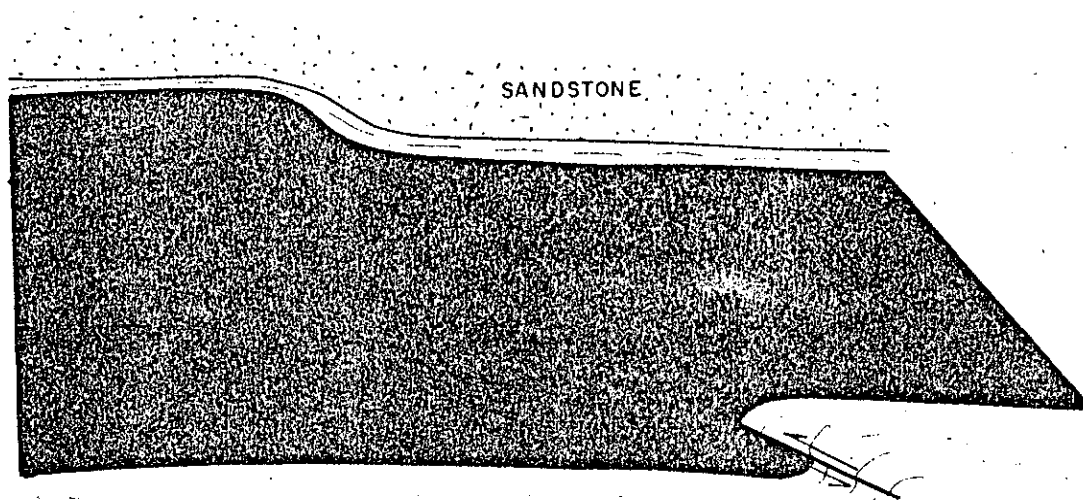
SKETCH SECTION - SKEETER SEAM EXPOSURE MINE No. 1

(i) SHOWING ROOF STRUCTURES - 'THRUST FAULTS'
ABOVE SKEETER SEAM

(ii) THRUST FAULT - FLOOR OF SKEETER SEAM

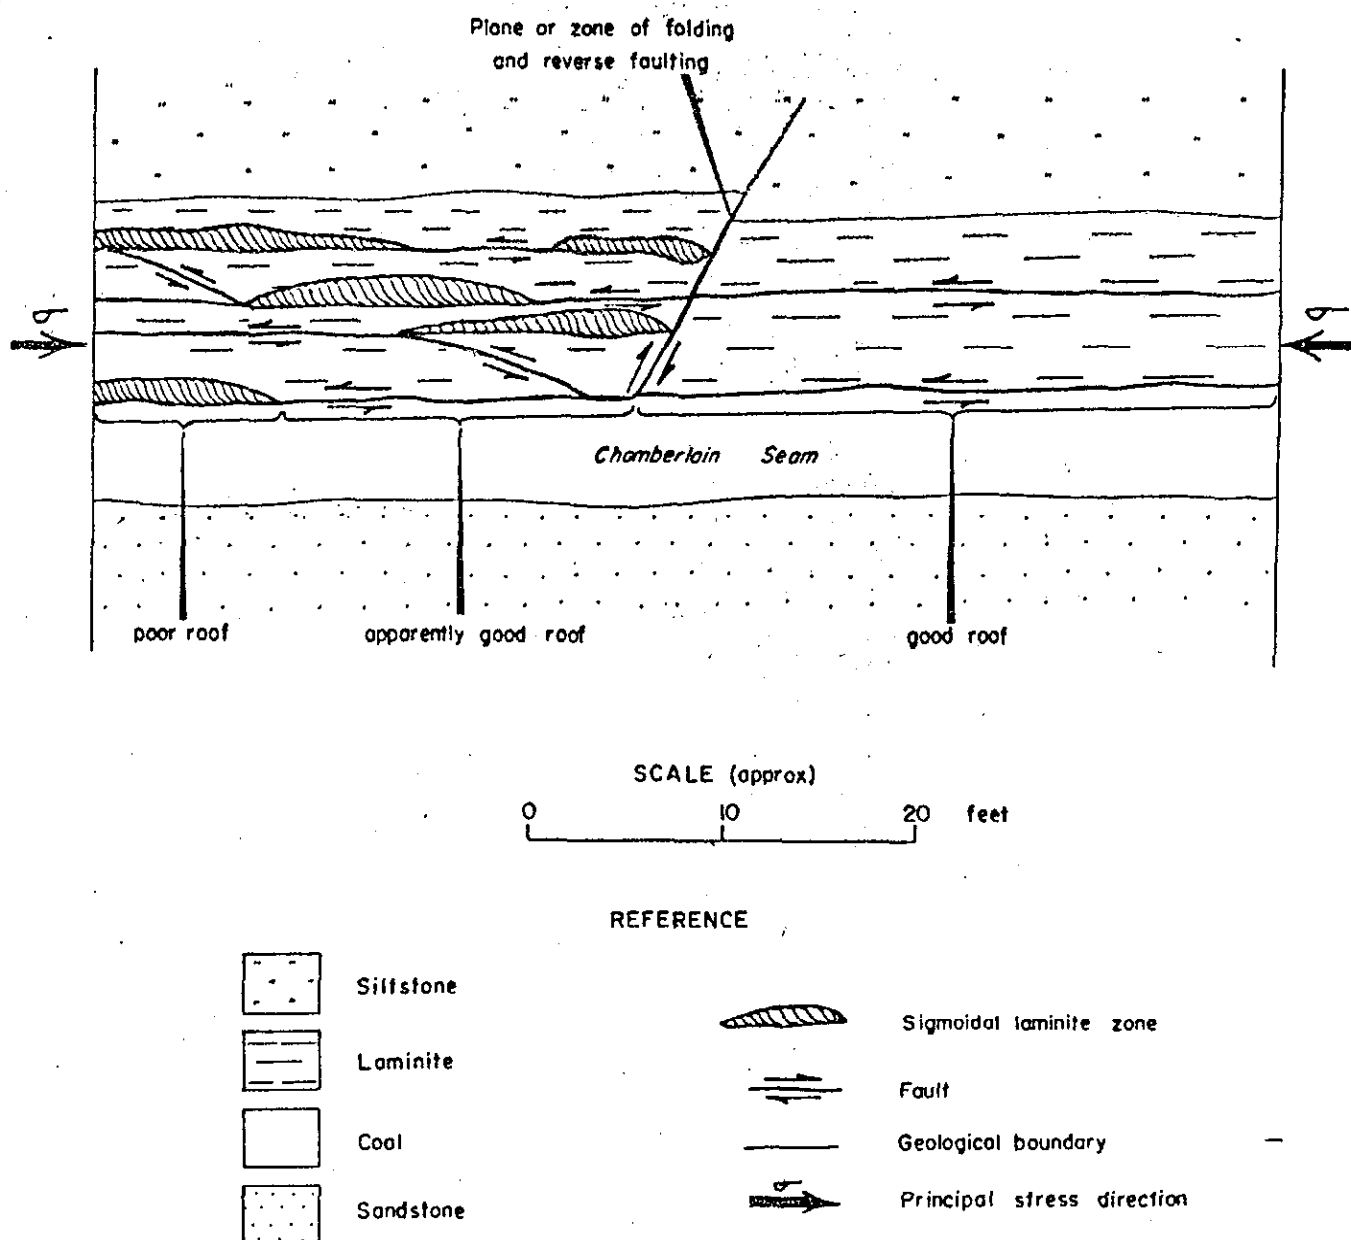
DIAGRAMMATIC RELATIONSHIP BETWEEN ZONES WITH SIGMOIDAL LAMINITE STRUCTURES and RELATIVELY UNDEFORMED ADJOINING STRATA

Figure 5 shows diagrammatically the relationship between these domains. The transition zone between domains of different amounts of shortening and thickening is not as distinct as the sketch indicates. In addition, it is generally observed that the thickness of the sigmoidal laminite zone increases towards the axis of the anticlines and thins on the limbs. Figure 6 shows the relationships that exist near the margins of the sigmoidal laminite structures.

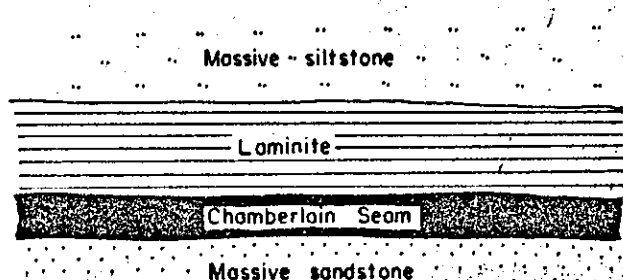
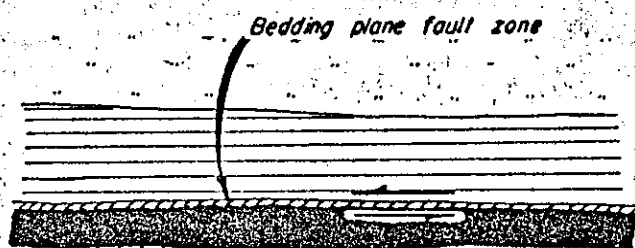
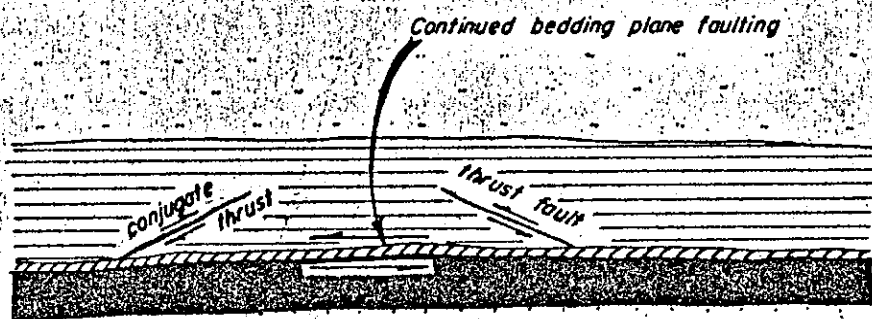
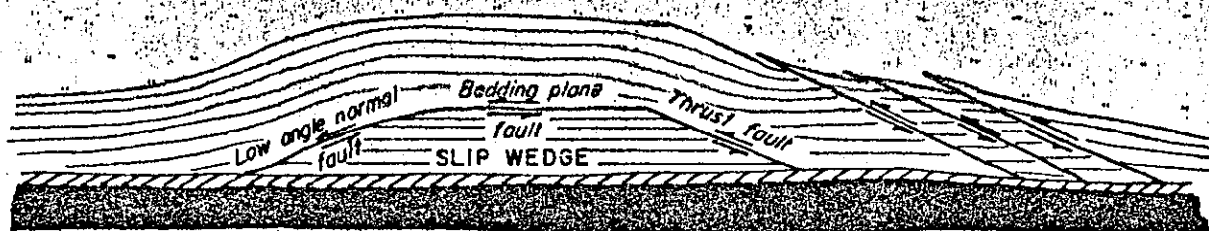
DEVELOPMENT OF A SLIP WEDGE

- (1) Failure of the laminite takes place with the formation of a thrust and a conjugate to this thrust in a favourable location in the laminite strata.
- (2) Movement of the surrounding and overlying strata takes place along the thrust, its conjugate and a bedding plane. This leaves the slip wedge as an isolated block of strata. This sequence is shown diagrammatically in Figure 7.

STEP 1: PRE BEDDING PLANE FAULTING

STEP 2: BEDDING PLANE FAULTING

STEP 3: LAMINITE FAILURE

STEP 4: SLIP WEDGE FORMATION

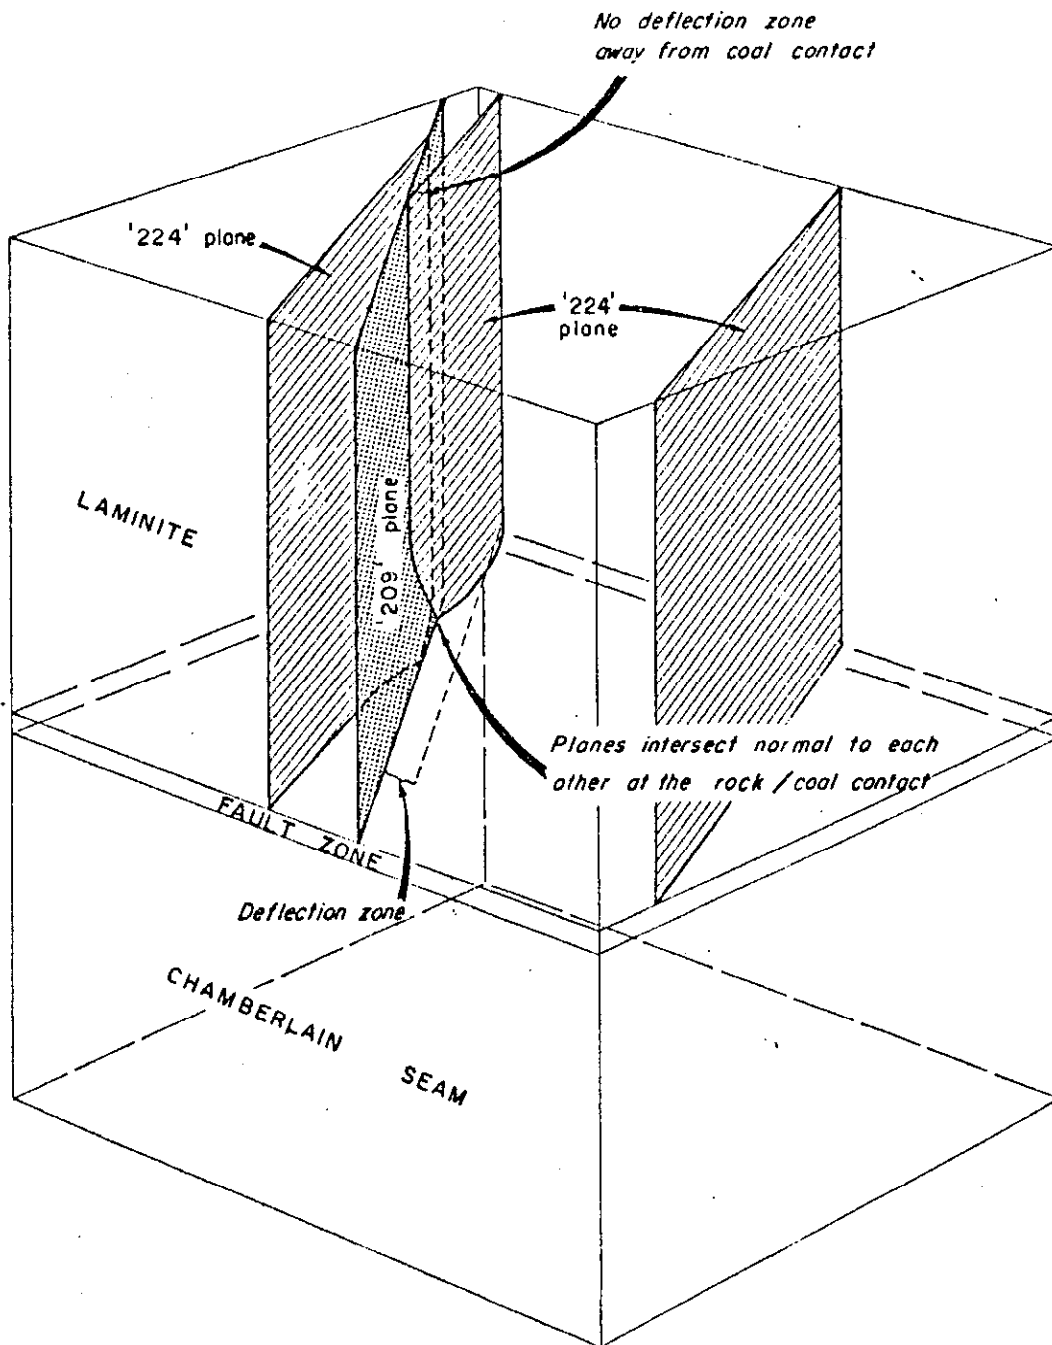
In Mine No. 1 an area of well developed '042' joints can be observed. Here, two principal planes of this set exist: the 209 and 224 planes. The 209 plane is most strongly developed with joints continuing across the heading. However, the density of these planes is lower than those of the 224 group. The planes of the 224 group trend parallel outside a 6 inch zone along either side of each of the 209 planes. As each of the 224 planes approaches the 209 plane within this zone, the 224 plane is deflected, in most cases, into the 209 plane.

Additionally, the junction of these planes at the contact between rock and coal is almost perpendicular and the dip of the 224 planes becomes shallow within the zone of deflection into the 209 planes. These relationships are shown in Figure 9.

Block diagram showing relationship between '209'
joint plane and '224' joint plane.

At the coal/rock contact, the joint planes tend to be deflected, whereas as little as 2 feet away from the contact, deflection does not occur. A time sequence for the generation of these planes can be inferred. No displacement along these joints can be observed, but the lack of 224 planes cutting across 209 planes, and the deflection of the 224 planes as they approach the 209 planes, indicates that the 209 planes were present at the time of formation of the 224 planes.

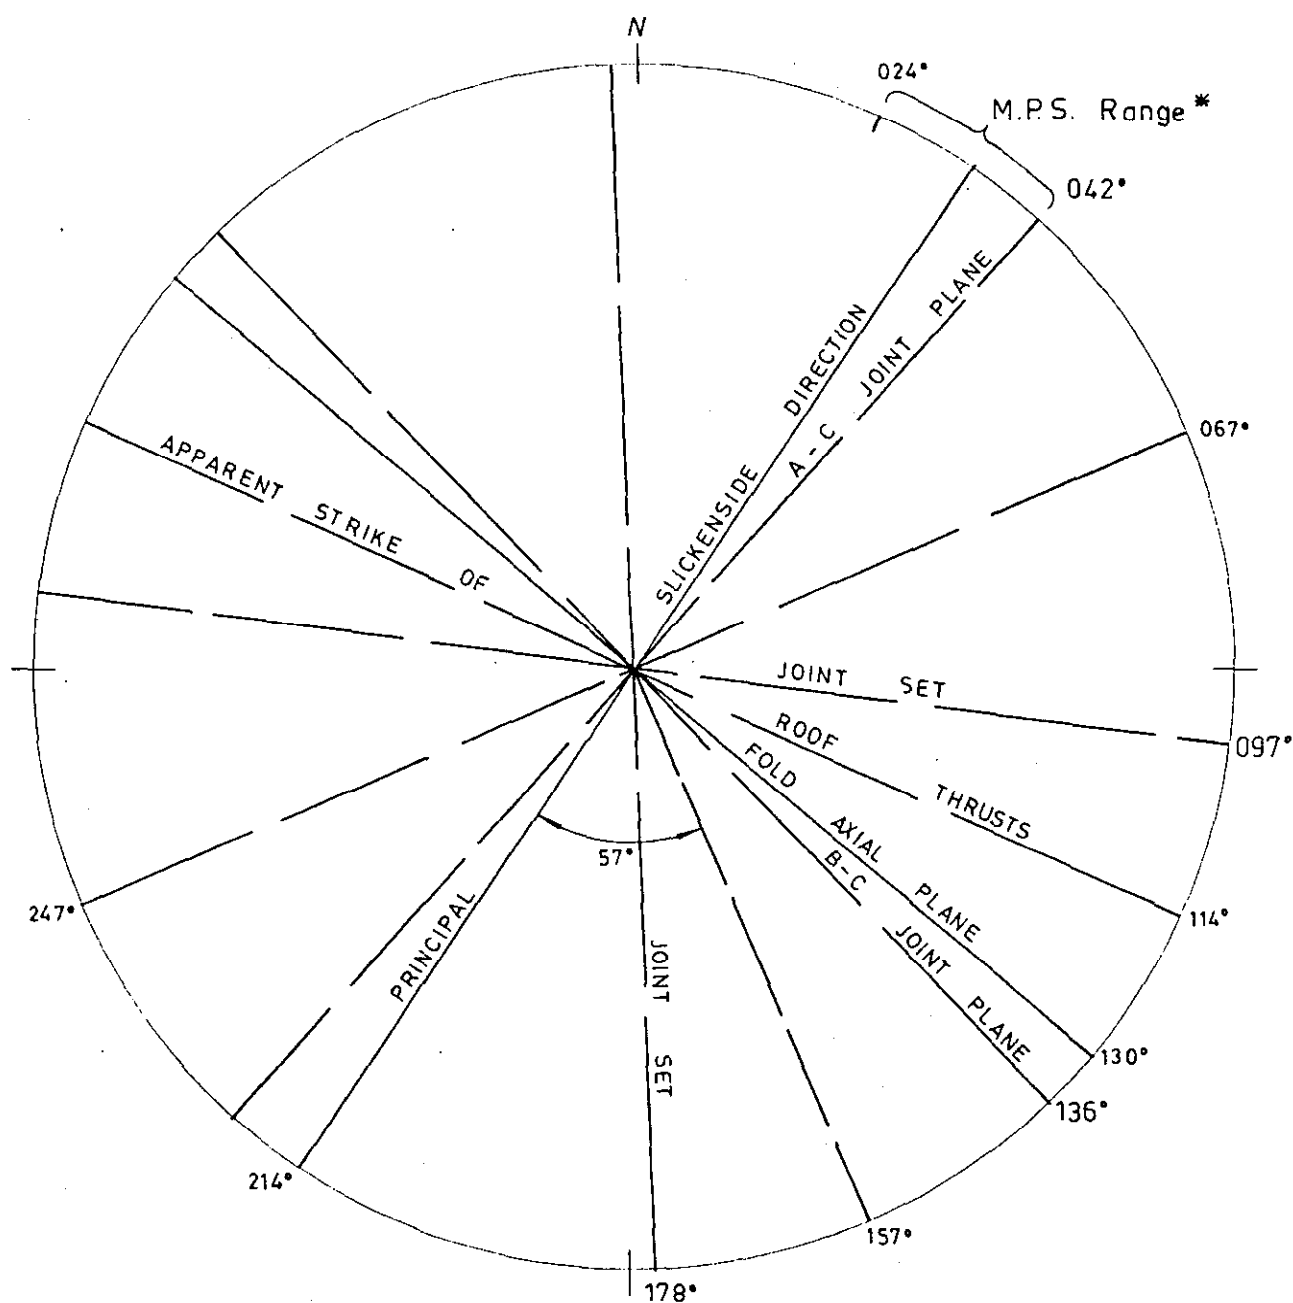
GENERALISED DIAGRAM OF STRUCTURAL ELEMENT DIRECTIONS

* Range of azimuths for
MAXIMUM PRINCIPAL STRESS = PREFERRED DIRECTION OF CROSS CUTS

PRESENT HEADING DIRECTION 157°

It is recommended that driving parallel to the M.P.S., that is 214° , be tested in order to minimise the effects of the thrust structures. While the main headings are controlled by the intra-plate faults, a modification of the cross-cut directions should be possible, within the normal constraints of mine layout and machine manoeuvrability.
