GEOLOGICAL INVESTIGATION OF THE
UNDERGROUND WORKINGS:
SUKUNKA COLLIERY

PREPARED FOR: B P EXPLORATION CANADA LIMITED

BY: G R JORDAN CONSULTING SERVICES LTD.

DECEMBER 1977

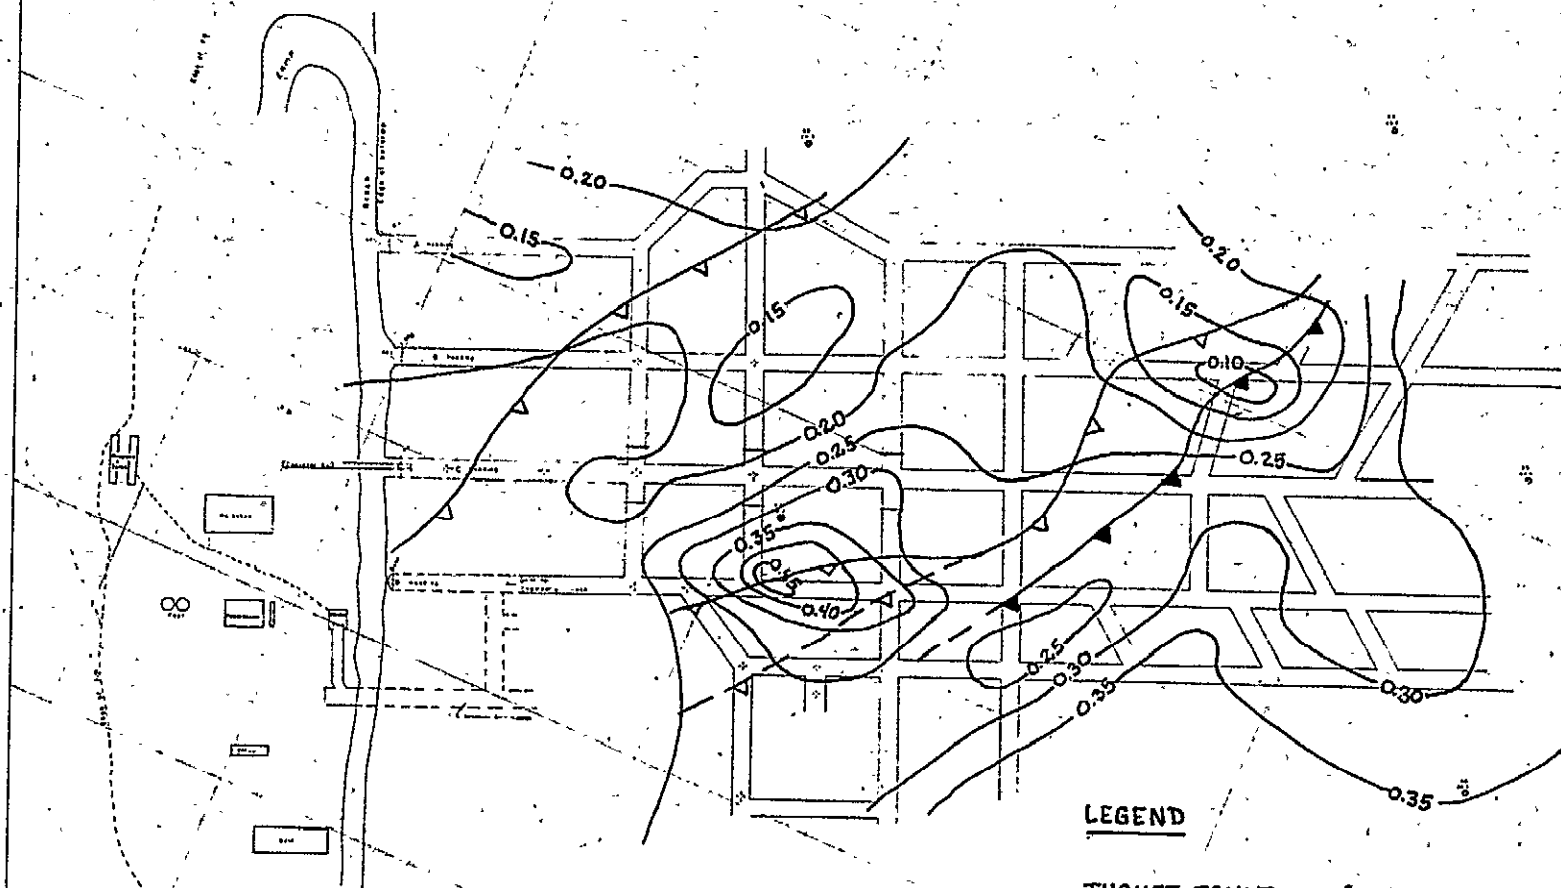
MINE NO.1 - SKEETER SEAM - ROCK BAND ISOPACH MAP

The rock band is composed of a hard, very poorly bedded carbonaceous mudstone and is found to be continuous throughout the mine workings. Map No. 2 is an isopach map showing the thickness variation of the rock band. The map shows that there is an increase in thickness at the face to 0.30 metres, especially towards the western side of the mine workings.

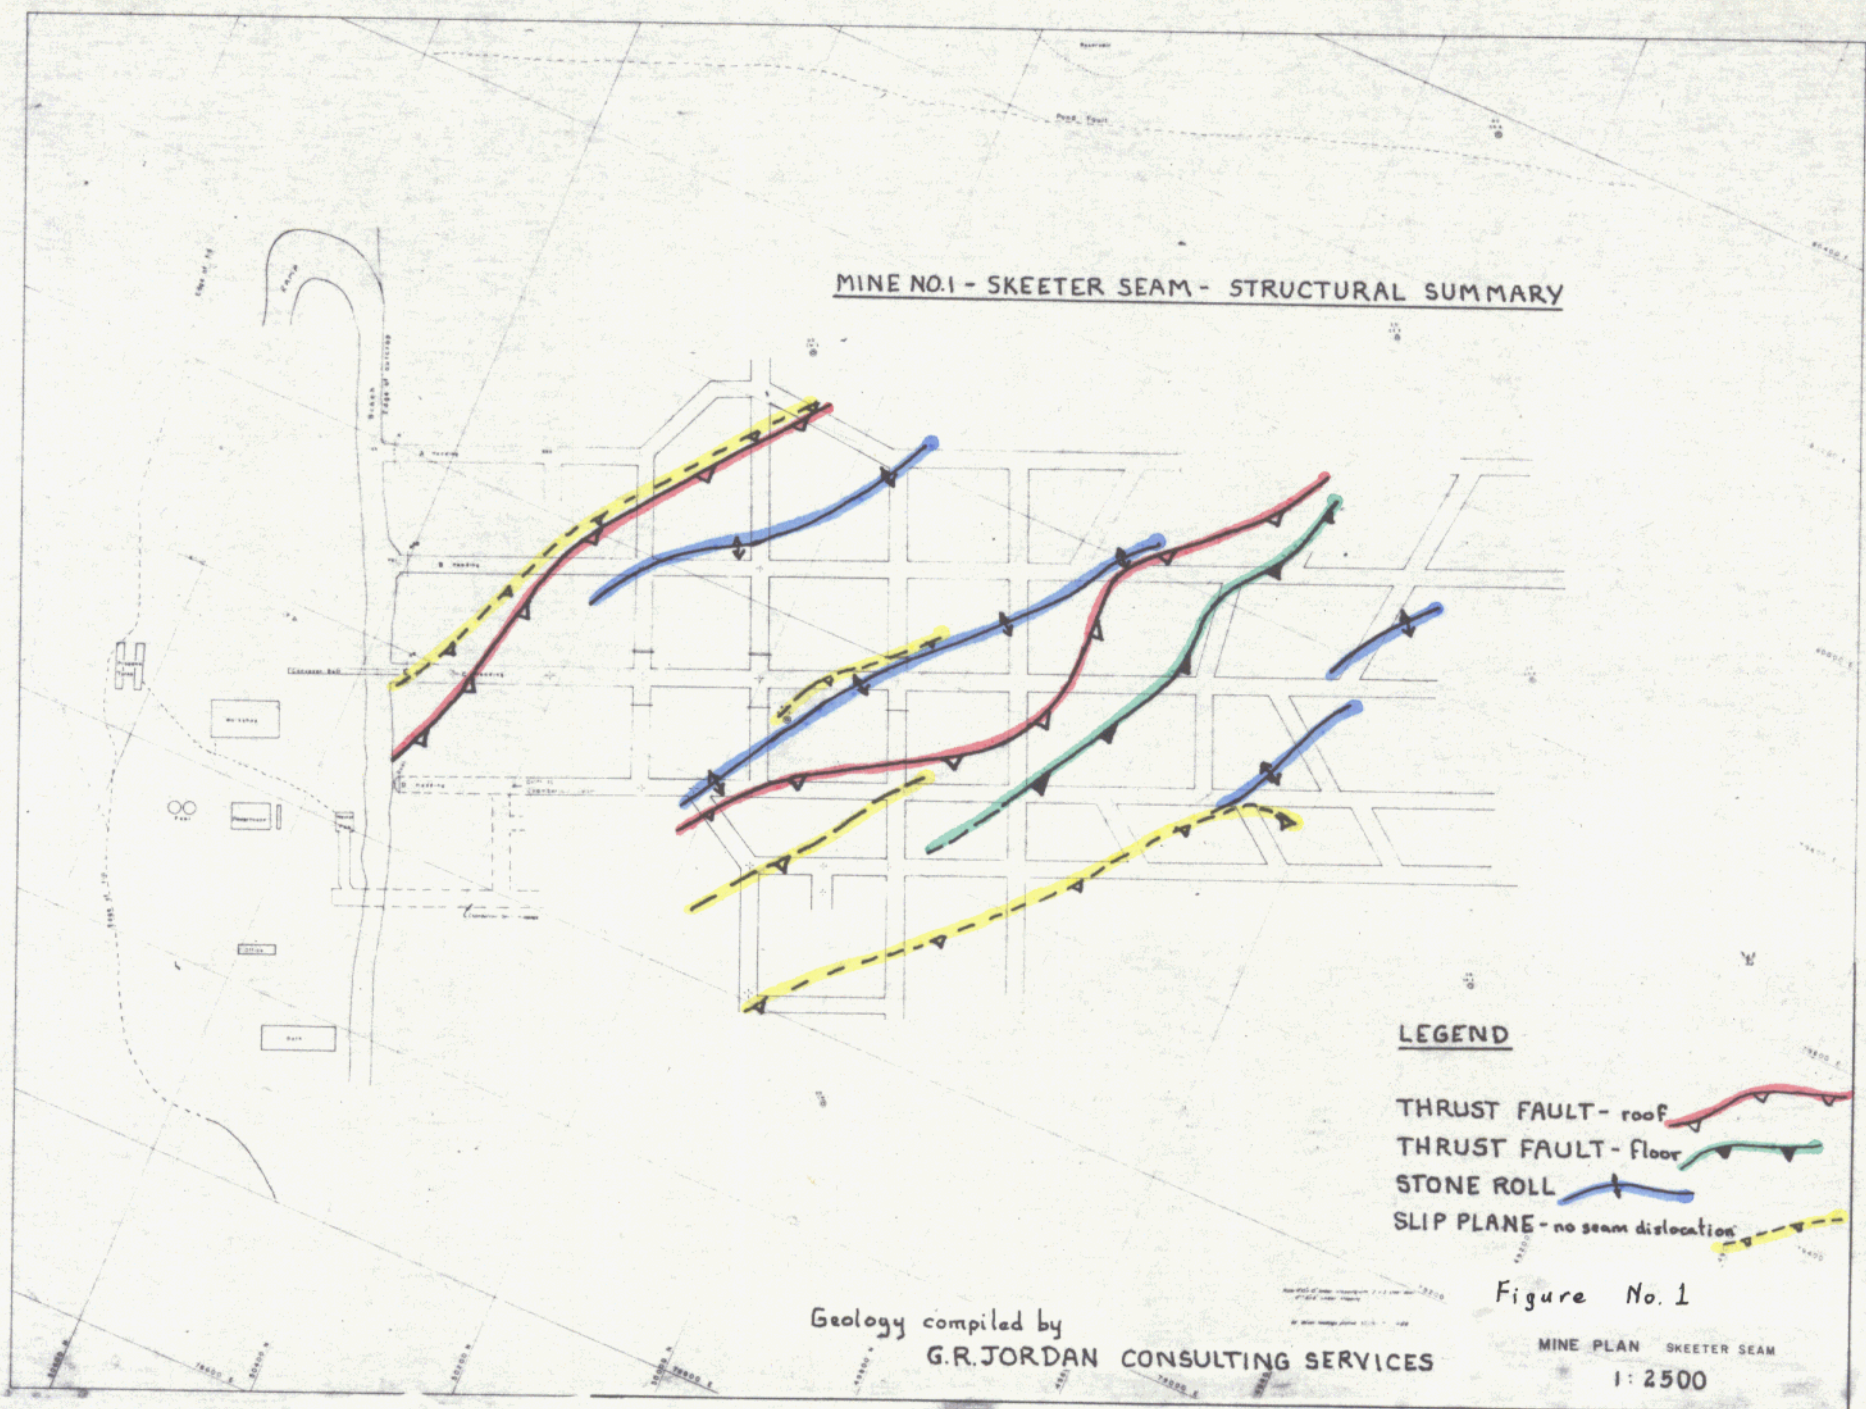
MINE NO.1 - SKEETER SEAM - STRUCTURAL SUMMARY

Small scale thrust faulting is frequently observed in the Skeeter seam roof and occasionally in the seam floor. Most of the roof thrusts are small scale slip planes involving no displacement of the coal seam.

With very minor exceptions, all the thrust fault structures trend in a north west - south east direction diagonally across the mine workings and the fault planes dip towards the south west. Figure No. 1 shows the trend of the principal roof and floor thrust faults and slip planes, and Map No. 5 shows all the structures in detail.

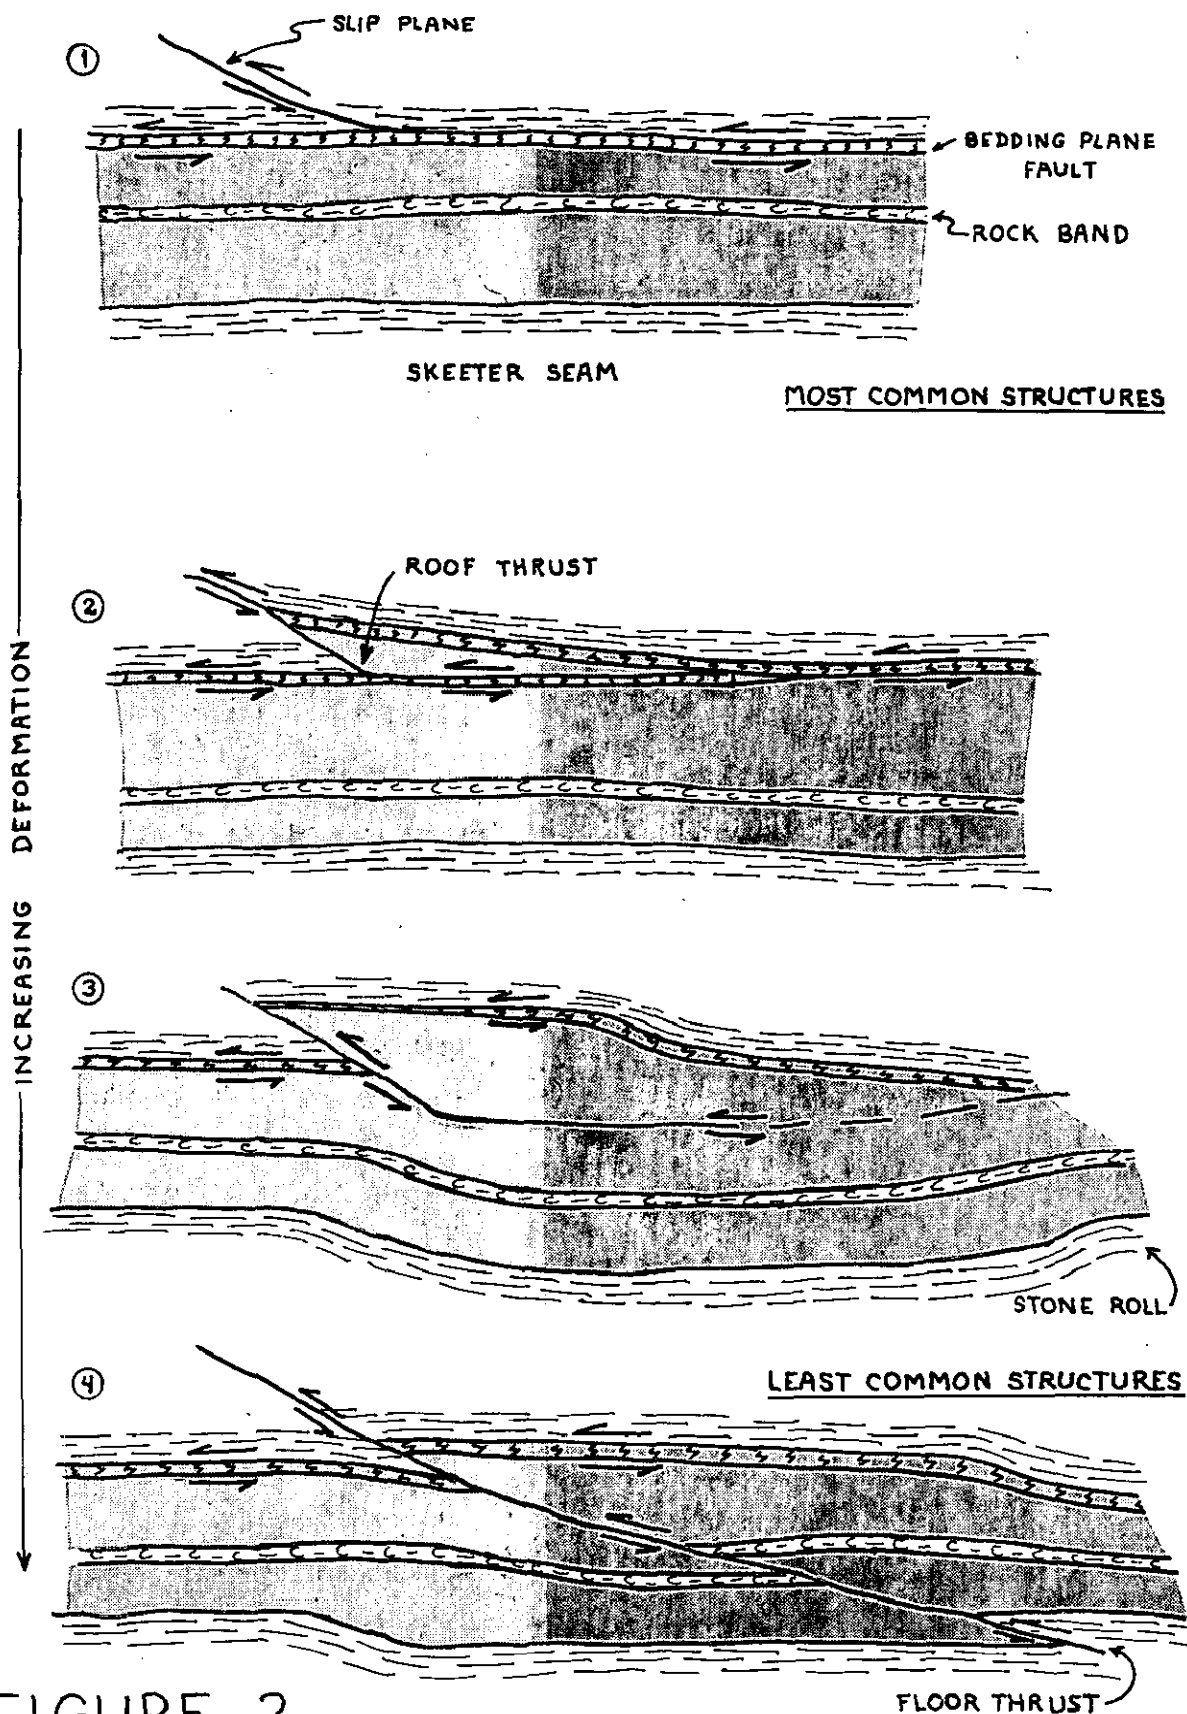
FIGURE 2

The McElroy report No. 1/4/24 documented a bedding plane fault located at the top of the Chamberlain seam in Mine No. 1. A similar structure appears to be present at the top of the Skeeter seam in Mine No. 1 and most of the thrust faults located in the Skeeter seam roof have developed from this fault in a "ski jump" fashion. Consequently no displacement of the coal is observed. Only two thrust faults in the roof and one in the floor displace the coal, and in some instances it can be observed that these structures have developed in a similar manner to the "ski jump" style of structure. It therefore appears that the nature of thrust faulting is related to the degree of deformation. Figure No. 2 illustrates such a mechanism with increasing intensity of deformation. This mechanism suggests that small scale slip structures will be the most common thrust fault related structures encountered underground, displacement of the seam roof the next most common, and failure of the roof and floor being the least common situation. Roof and floor thrust faulting apparently required the greatest amount of deformation and the least conservation of energy.

The floor thrust and its roof thrust, which is located immediately to the north, are clearly the same thrust fault. Projection of the "Zone A" structures of the Chamberlain seam shows that this is also the same structure.

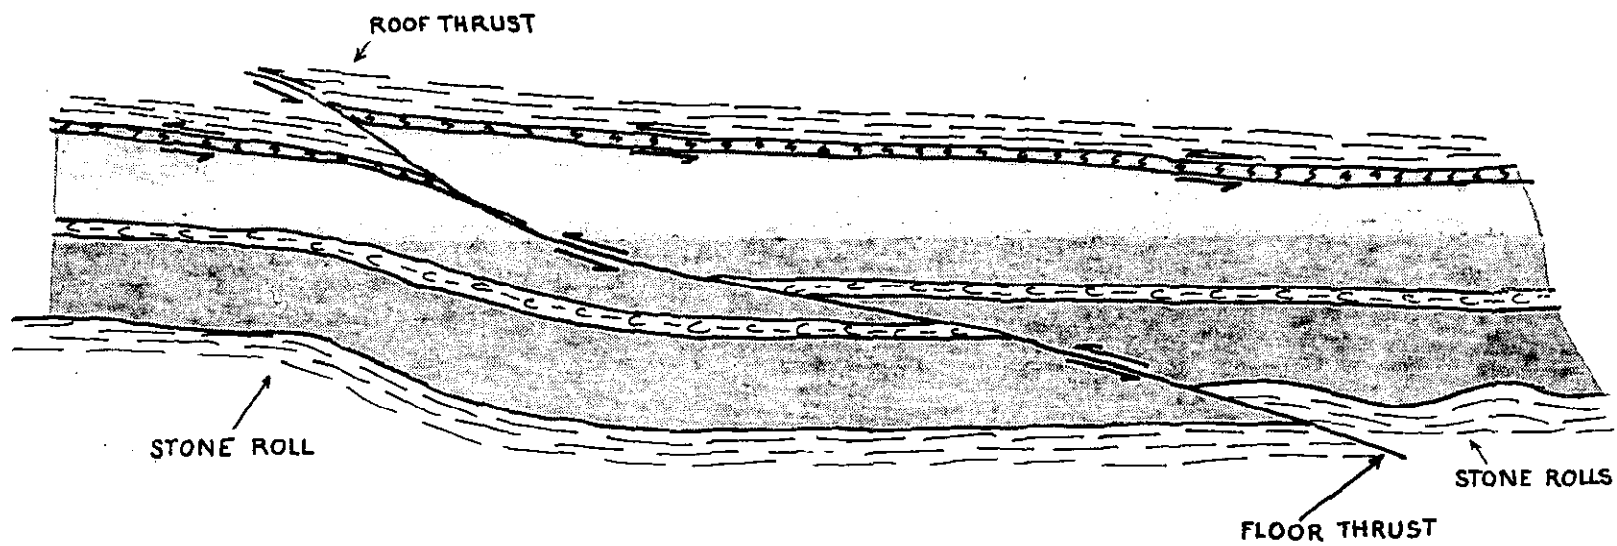
FIGURE 3

The rolls are broad and regular and follow the trend of the roof structures. They are distinctly different from stone rolls of the Chamberlain seam floor which are abrupt, often asymmetrical, discontinuous

and trend in a random manner with respect to the tectonic structures.

During mining and mapping of the subsequent worked area it was observed that the rolls often occurred immediately below or preceeding the "lip" of a thrust fault displacing the seam at the roof or floor. Hence the presence of stone rolls can be a useful indicator of roof support difficulties to follow.

All Skeeter seam roof falls occur at the unsupported lip of a slip plane or roof thrust and terminate upwards at the slickensided coal parting located 0.20 metres to 0.25 metres above the immediate seam roof. In most cases the roof was "caught" within 3 metres of the slip plane joining the polished coal parting. Instances where roof material to the coal parting continued to fall are found near the portal. This may reflect weakening of the strata in this area due to weathering effects.

It is observed that a high frequency of roof falls occur at roadway and cross-cut intersections. It would appear that this is not related to mining practice but to the unusually high frequency of slip planes and roof thrusts being intersected at these junctions. The spacing between slip planes may be statistically similar to the diagonal width of the pillars; the evidence underground would suggest that this is the case. Hence, with the thrust fault structures trending at approxi-

mately 45° to the heading directions, it is possible, with extreme bad luck, to encounter a thrust plane at each intersection.

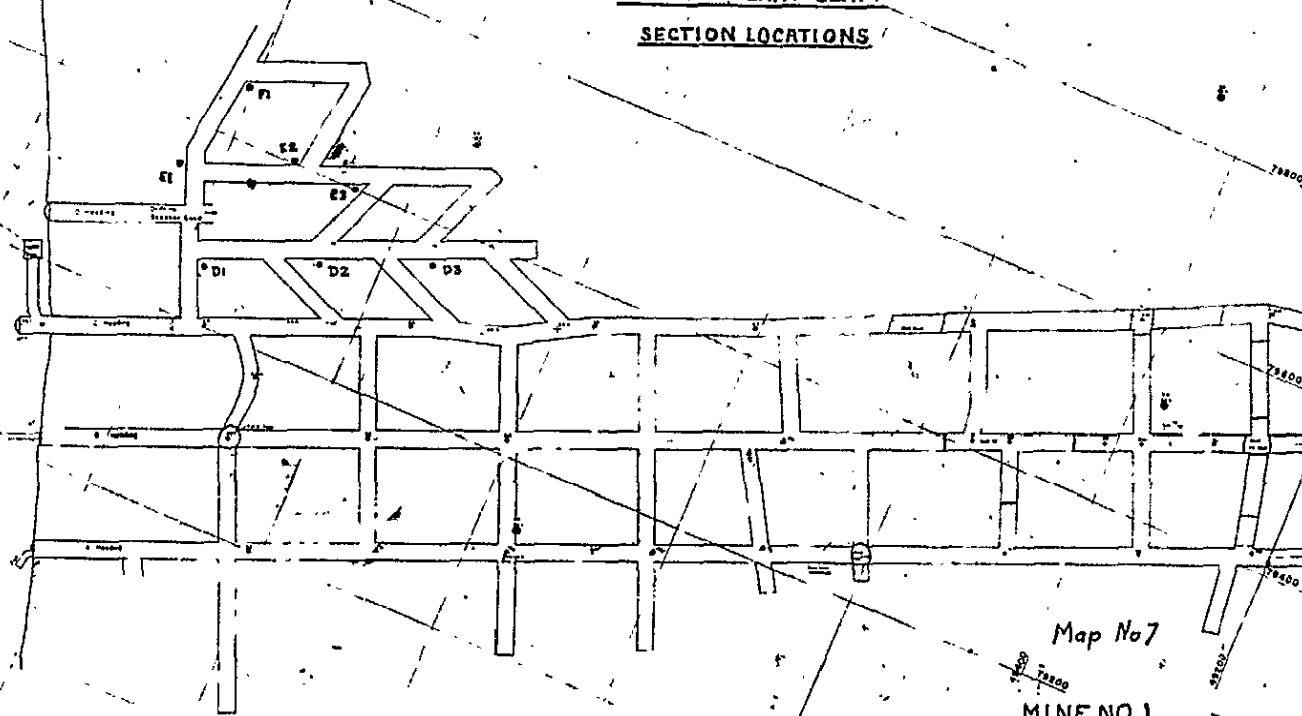
Map No 7

Map No. 7 shows the location of seam sections measured in the Chamberlain seam workings of Mine No. 1. The graphic sections prepared from these measurements are included within Appendix "A". In the more recent workings of the Chamberlain seam, laminite was again the only immediate seam roof lithology observed.

During an inspection of the Chamberlain seam workings it was observed that a large amount of the seam roof had failed and scaled off as bedding plane slabs or flakes. The same phenomenon was observed during the earliest workings of the Chamberlain seam at Mine No. 1 prior to the installation of heating equipment. At that time the rapid rate of deterioration of the seam roof caused considerable concern.

Subsequent to the installation of heating equipment it was found that roof deterioration was greatly retarded. It was concluded that the freezing of moisture in the roof was forcing the beds to separate and fail in a manner similar to frost heaving. In the new workings of Mine No. 1 flooding of the mine followed by removal of the mine water and freezing probably has resulted in the extreme amount of immediate seam roof deterioration.

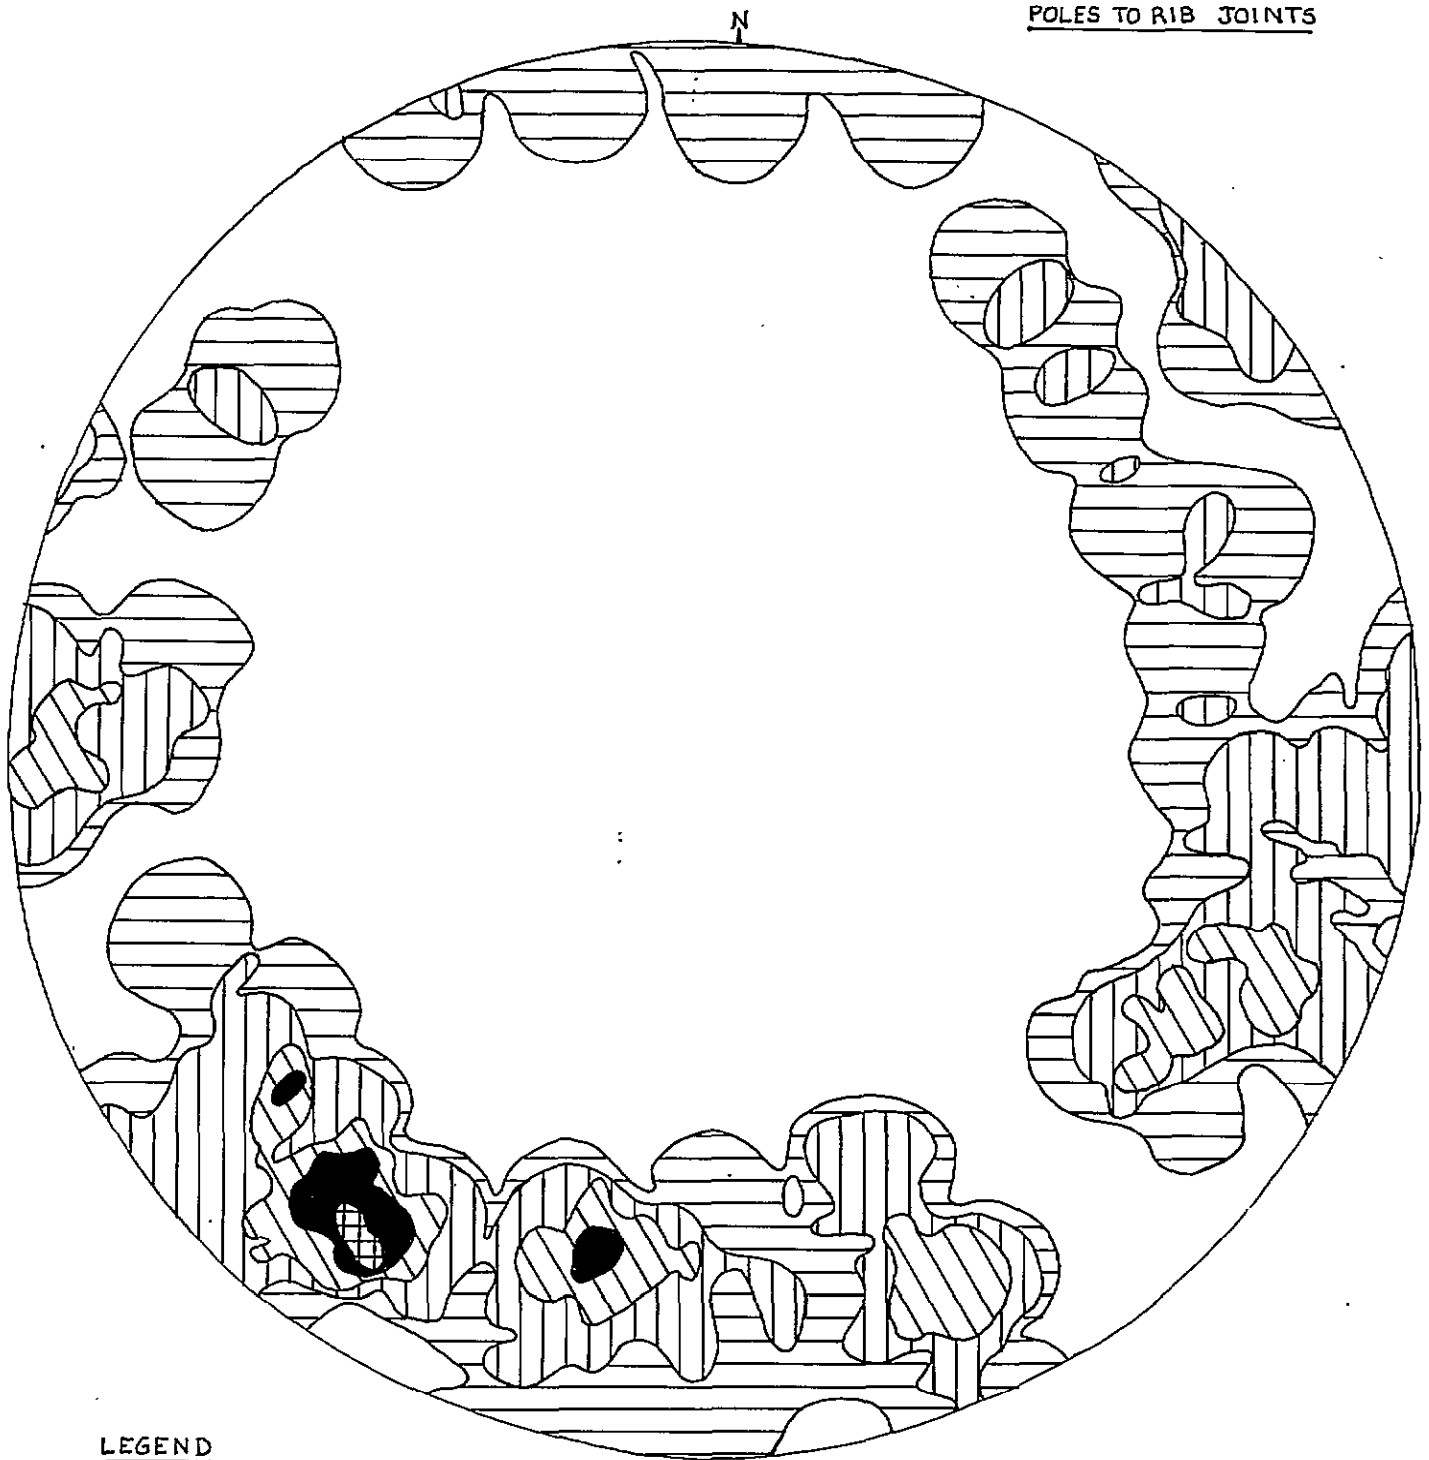
POLES TO RIB JOINTS

Map No. 5 shows an area selected for the measurement of intra seam joints. Seventy-five failure planes were randomly selected, measured and plotted as poles on the stereogram included in Appendix "B".

Both shear joints and coal cleats were anticipated to appear on the stereographic plot. No attempt is made here to analyse the results of this single plot since a thorough study involving measurements from numerous areas would be the only way to achieve any conclusive results. However, it can be observed that the plot is very similar to a plot of rib joints measured in the Chamberlain seam of Mine No. 1.

It is believed that the great scatter of results compared with results from the Chamberlain seam of the "Window Mine" area reflects the increased tectonic deformation at Mine No. 1. The principal coal failure plane, a near vertical cleat, has a bearing of 135° .

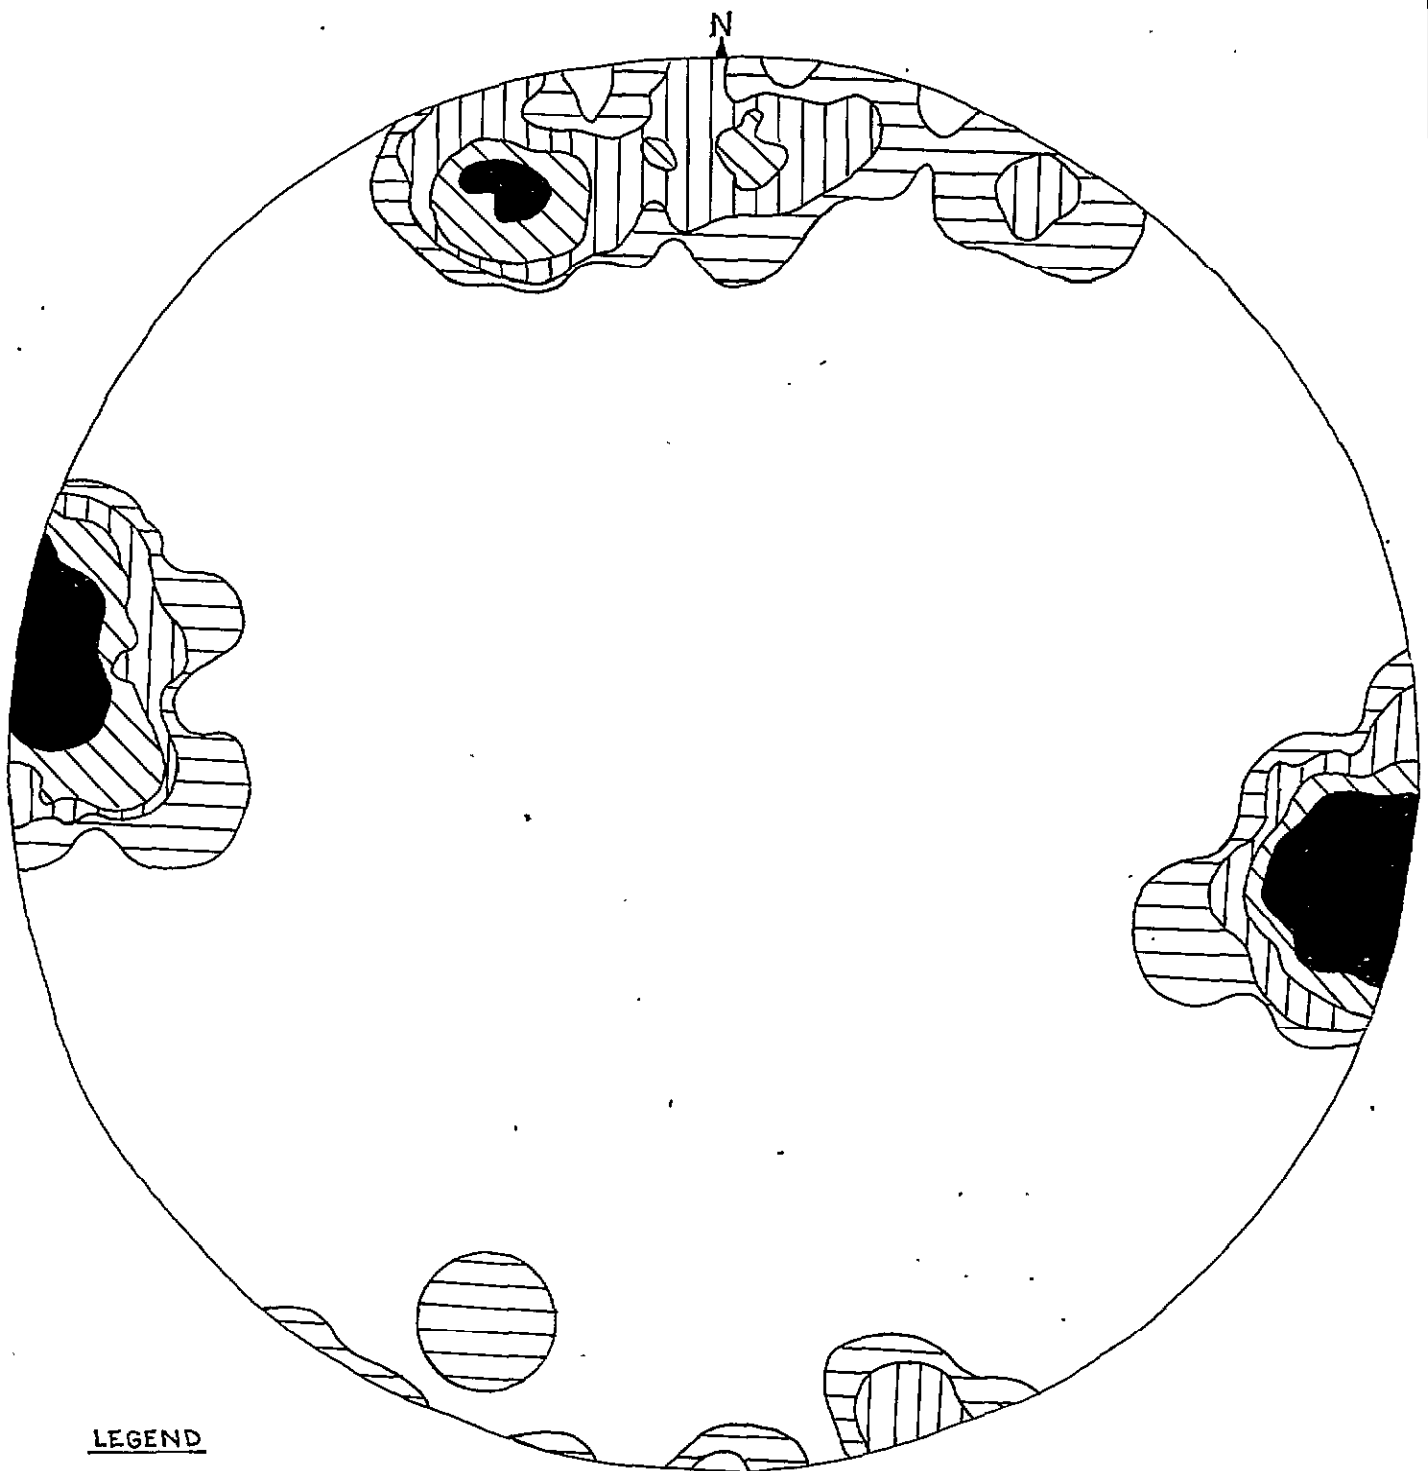
POLES TO RIB JOINTS

An area shown on Map No. 13 was selected for the measurement of rib joints. Seventy-five measurements were made in this area and the results, plotted as poles, are shown on the stereogram included in Appendix "B". The stereogram shows that there are two principal joint directions of near vertical structures. These structures are cleats, with the principal orientation being 020° .

The coal of the pillars is very hard except for the layer of sheared coal near the floor. The stereogram of the rib joints shows only a few concentrations and these are well defined as opposed to those found at Mine No. 1. This suggests that the coal of the "Window Mine" area has experienced much reduced tectonic deformation.
