HISTORIC MINE SITES IN BRITISH COLUMBIA

By Lisa N. Barazzuol and
Gregg G. Stewart, PGeo

FEBRUARY 2003

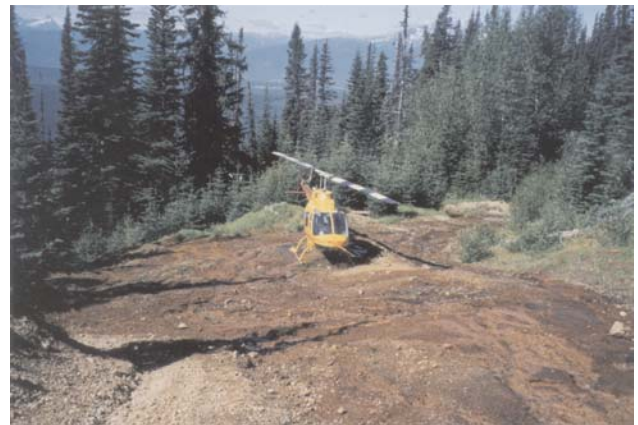
The water flowing from the 2 adits was draining at a net rate of approx. 80 L/min. The field pH = 4.5 and the conductivity = 430 μ S. The water had no discernible odour. White, green and red precipitates and salts

Photo 3. Downstream of the Big Onion adits

were observed. The Fe precipitates were prolific, depositing a clay-like substrate. The outcrop was covered in moss, the only vegetation within the flow of the water. The water was sampled.

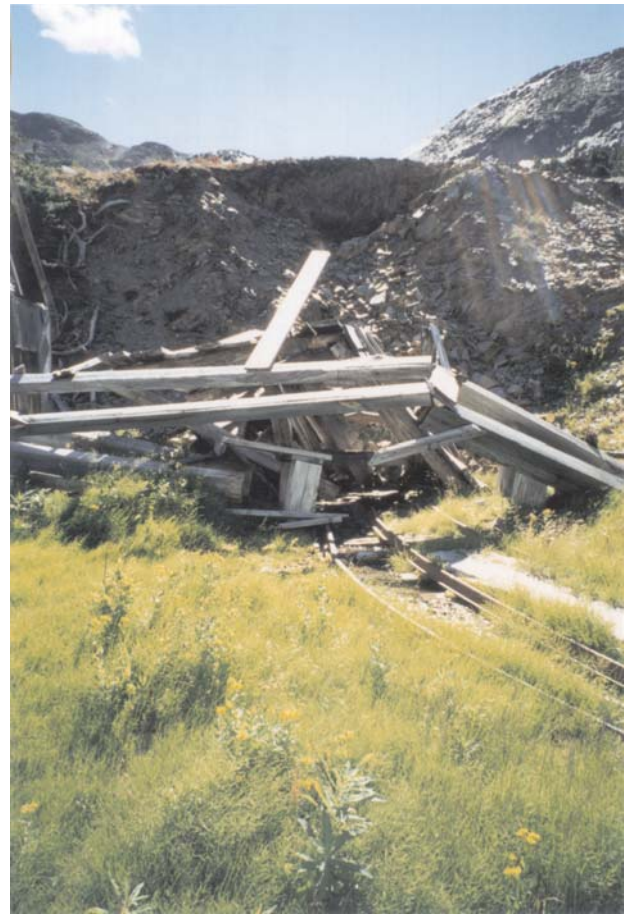
Trickle of drainage from the adit.

Photo 4. Native (Lorraine) caved portal and waste rock dumps. Drainage flows from the adit.

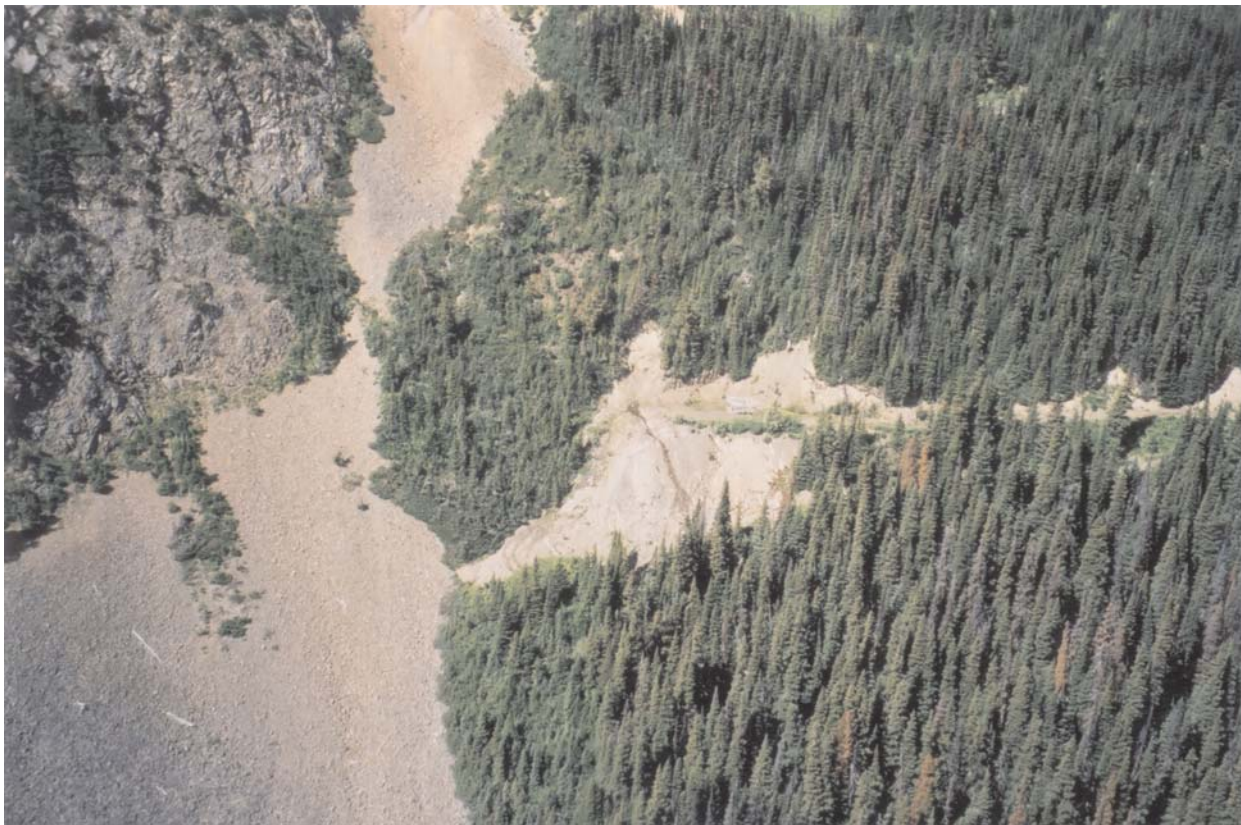
The lower adit (elev. 4720 feet) is backfilled with a small metal pipe to drain the adit water. Some drainage was flowing through the pipe, but most was seeping through the backfill material. The drainage was sampled. The adit is inaccessible.

Photo 5. Cronin lower portal. Note the adit drainage flowing over the dump.

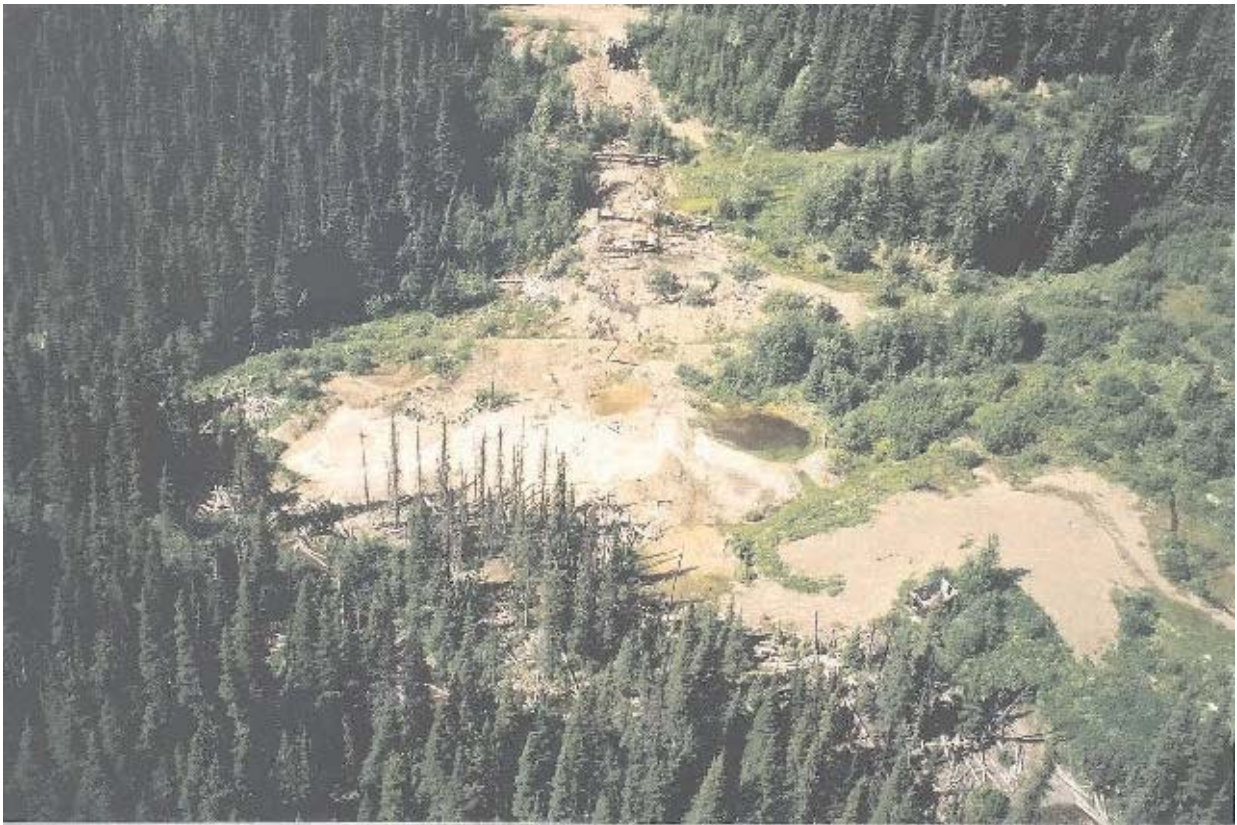
Photo 6. Cronin mill and tailings.

The tailings are situated at the foot of the mill in 3 impoundments alongside Cronin Creek. The tailings are sand sized and appeared unoxidized. There are 2 ponds present, both with horsetail. No seeps were observed. At the time of the inspection the constructed spillways contained white salts and/or thick moss. The area of the moss and salts extended beyond the spillways and into the areas of ephemeral drainage flow. The salts will dissolve and the metals will be transported when they next interact with water. Scrap wood is embedded in the tailings. A small, intact, wooden shack is adjacent to the tailings. Its stability is unknown.

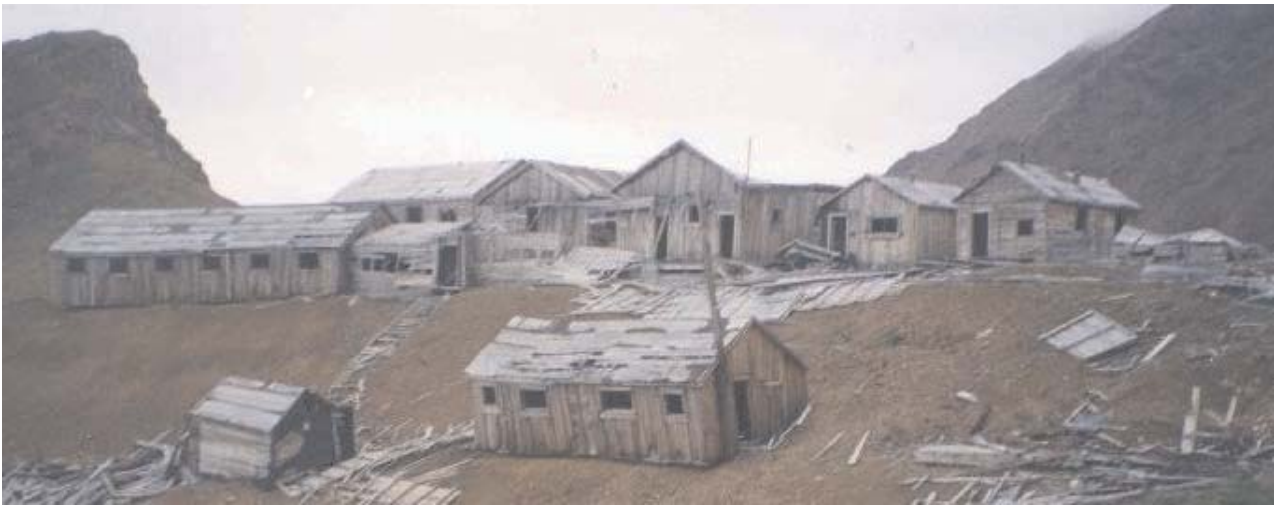
Numerous decaying wooden buildings are on site, including the former bunkhouses, assay lab, core shack, maintenance buildings and tram structures. No tram machinery was observed. Core, scrap metal and garbage were littered around the camp.

Photo 7. Upper camp of the Red Rose mine. The site is a favoured backcountry destination.

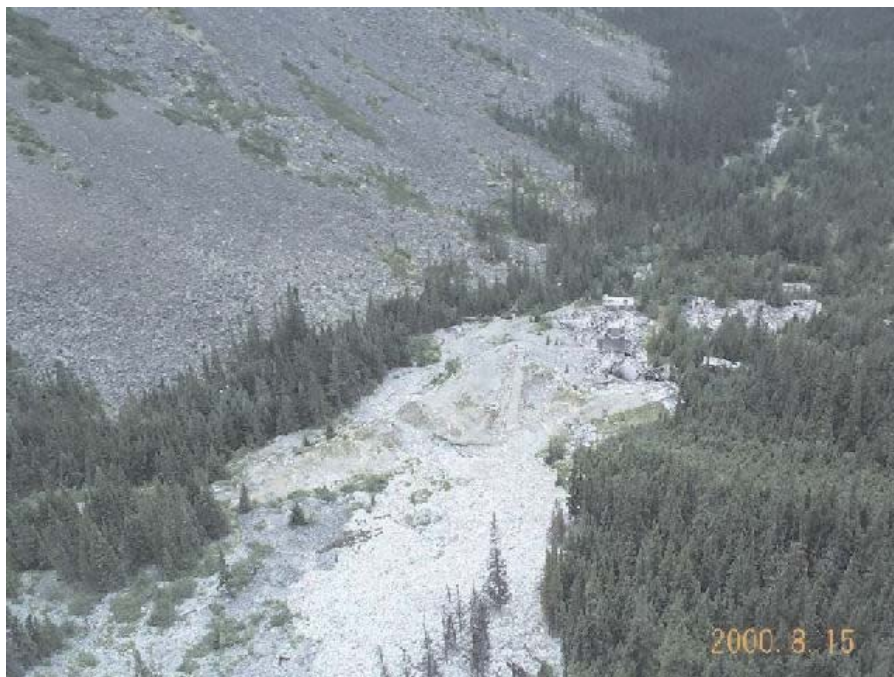
The mill site is located in the valley at an elevation of 4080 ft. The ore was brought to the mill site via the tram. The mill site is in a state of disrepair with numerous decaying, collapsed buildings that are potential health and safety risks. The wooden structure, possibly a load out station is still erect. Fine and coarse ore bins are on site but no ore piles were found. Wood debris, core and core boxes, concrete foundations and scrap metal (cars frames, bikes) noted on site.

Photo 9. Rocher Deboule mill site.

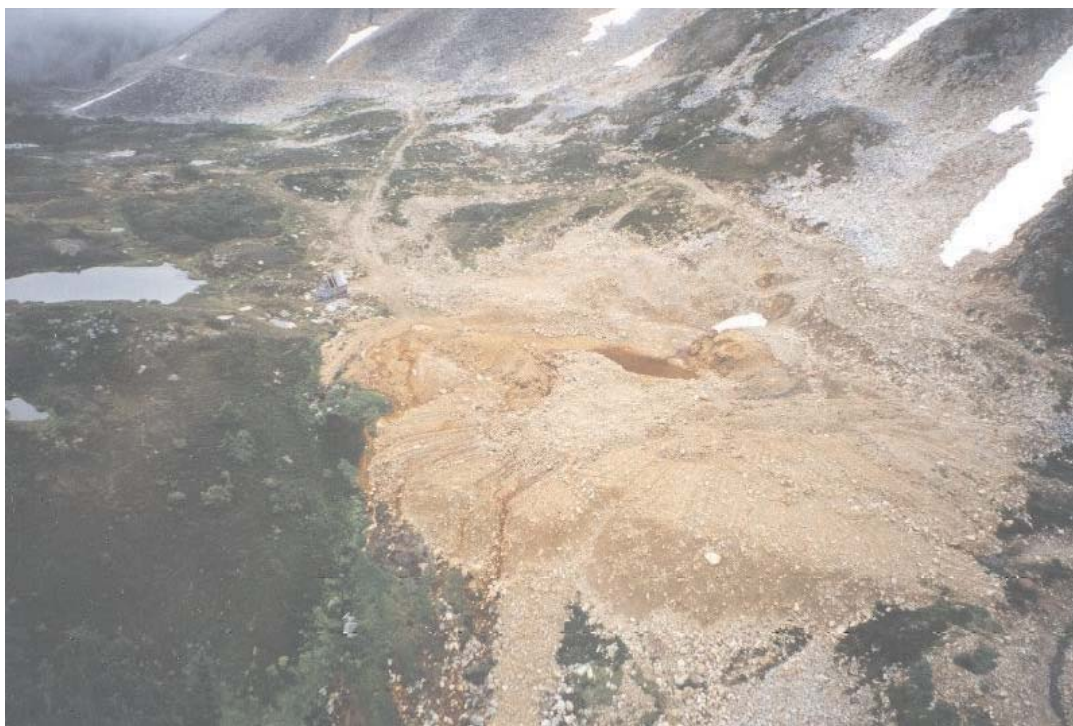
Drainage from the adit was flowing at an approximate rate of 30 L/min. The field pH = 5.0, conductiv-

Photo 10. Area of disturbance at the Sultana mine site. The portal is located under the patch of snow. Note the drainage pooling and draining from the portal (dark red).

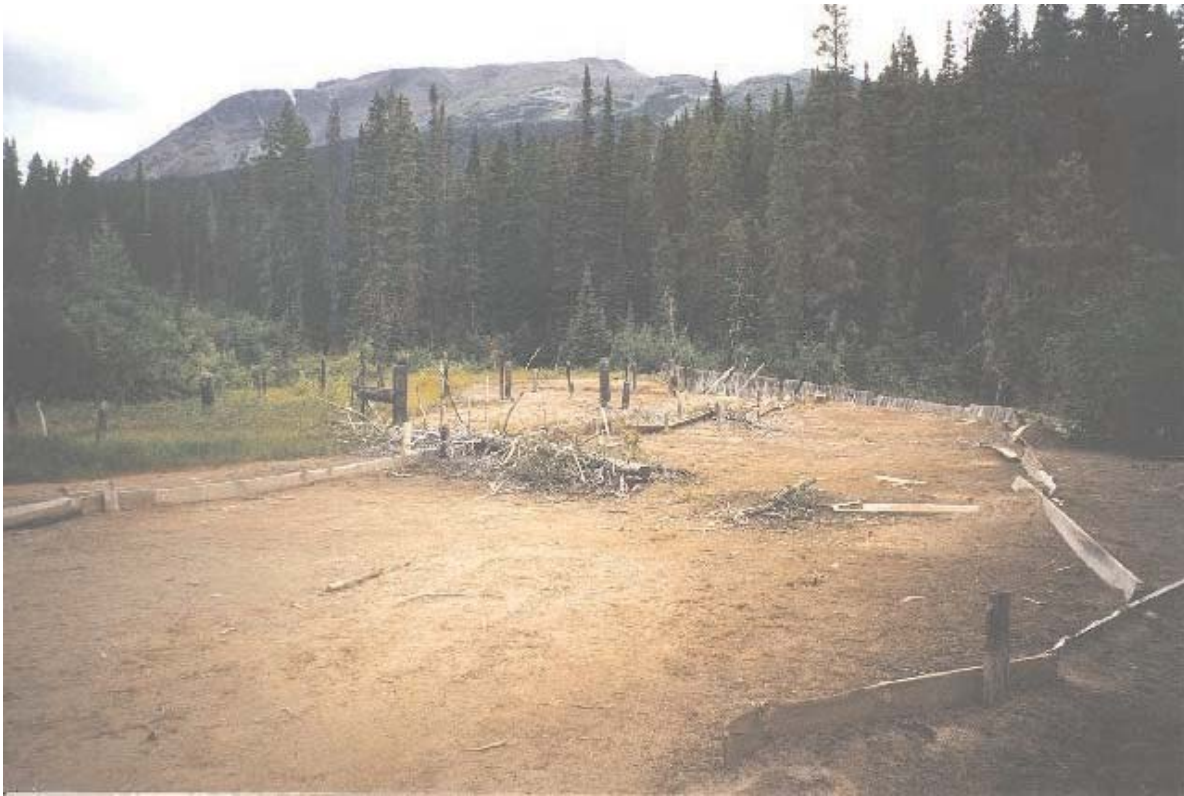
Photo 11. Emerald Glacier tailings. The workings are located on Mount Sweeney, located in the background.

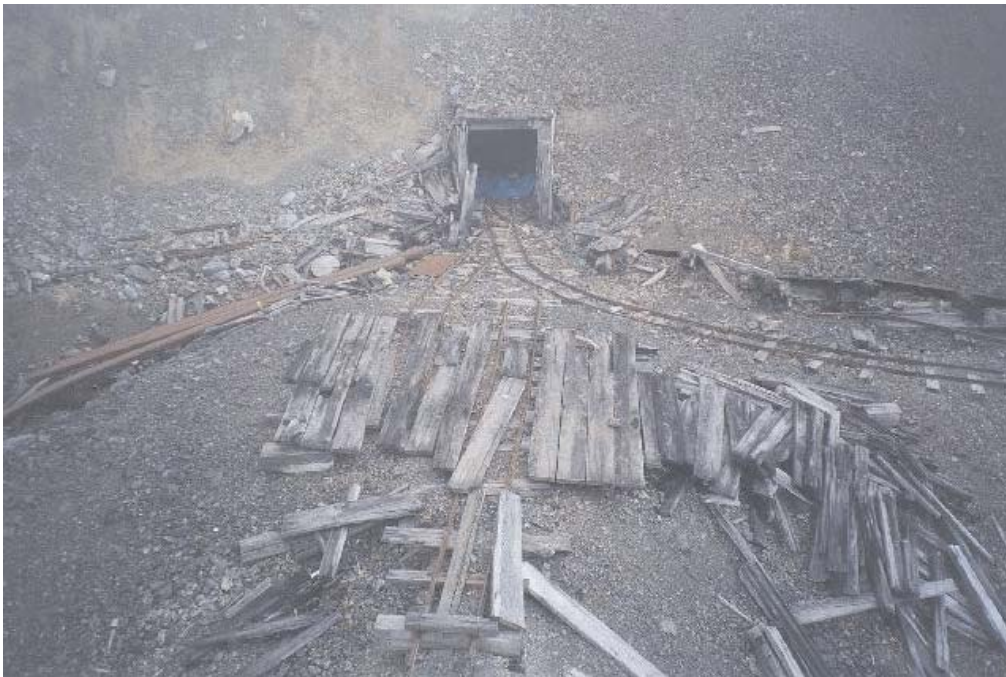
Photo 13. Porter-Idaho portal (unknown level). The drainage flowing from the adit was sampled.

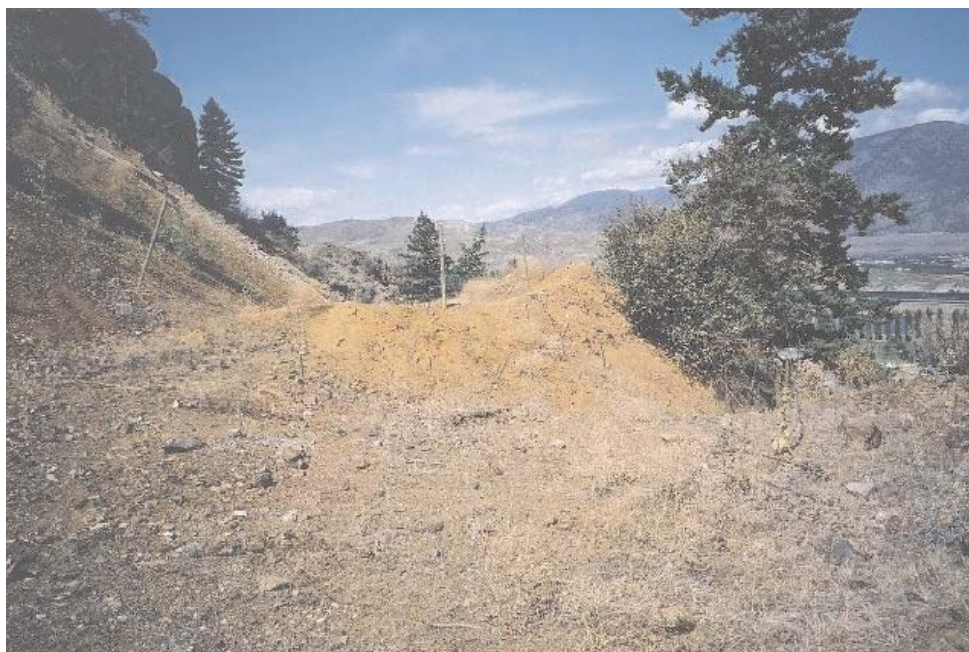
Photo 17. Oxidized waste dump at Dividend-Lakeview.

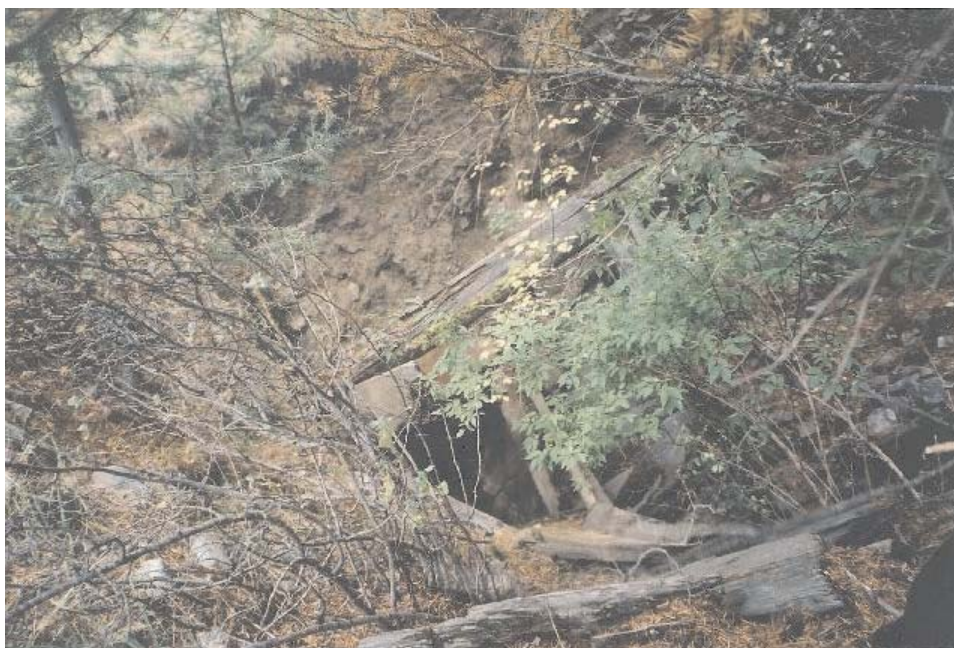
At the east end of the tailings, near the road is a 2 by 2 foot, flooded shaft with a timber frame. The shaft is accessible.

Photo 19. Open, flooded shaft near the glory hole at Twin Lakes.

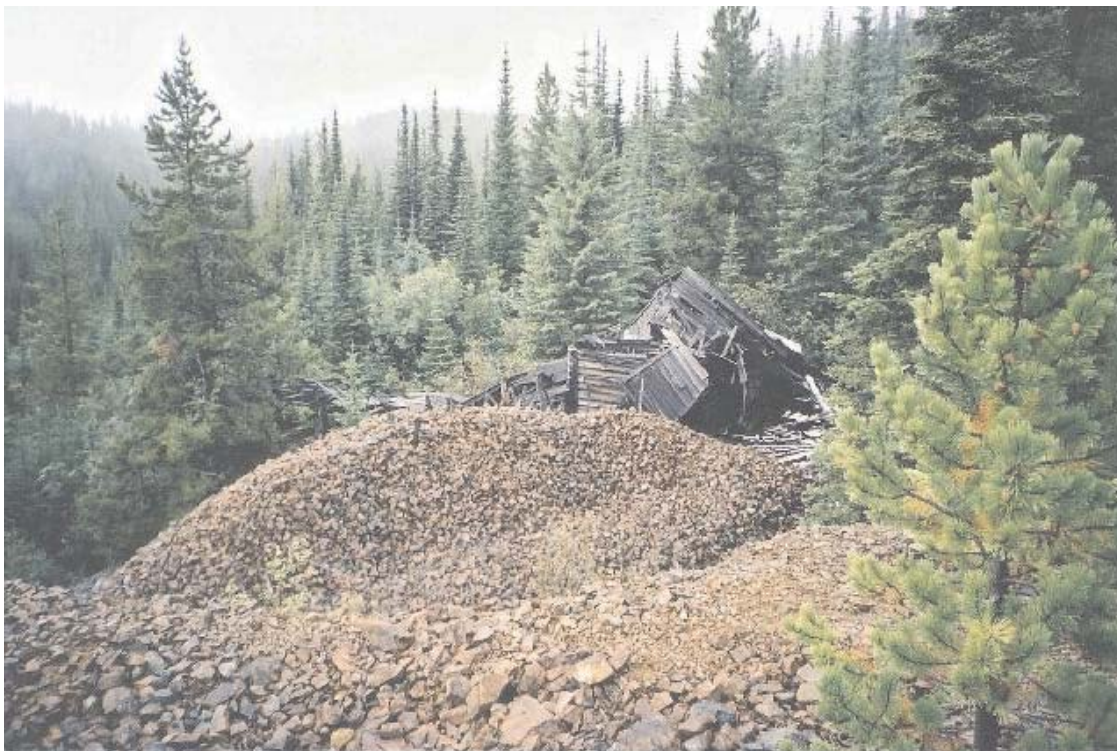
Photo 21. Sweethome dump and decaying wooden structure (tram?).

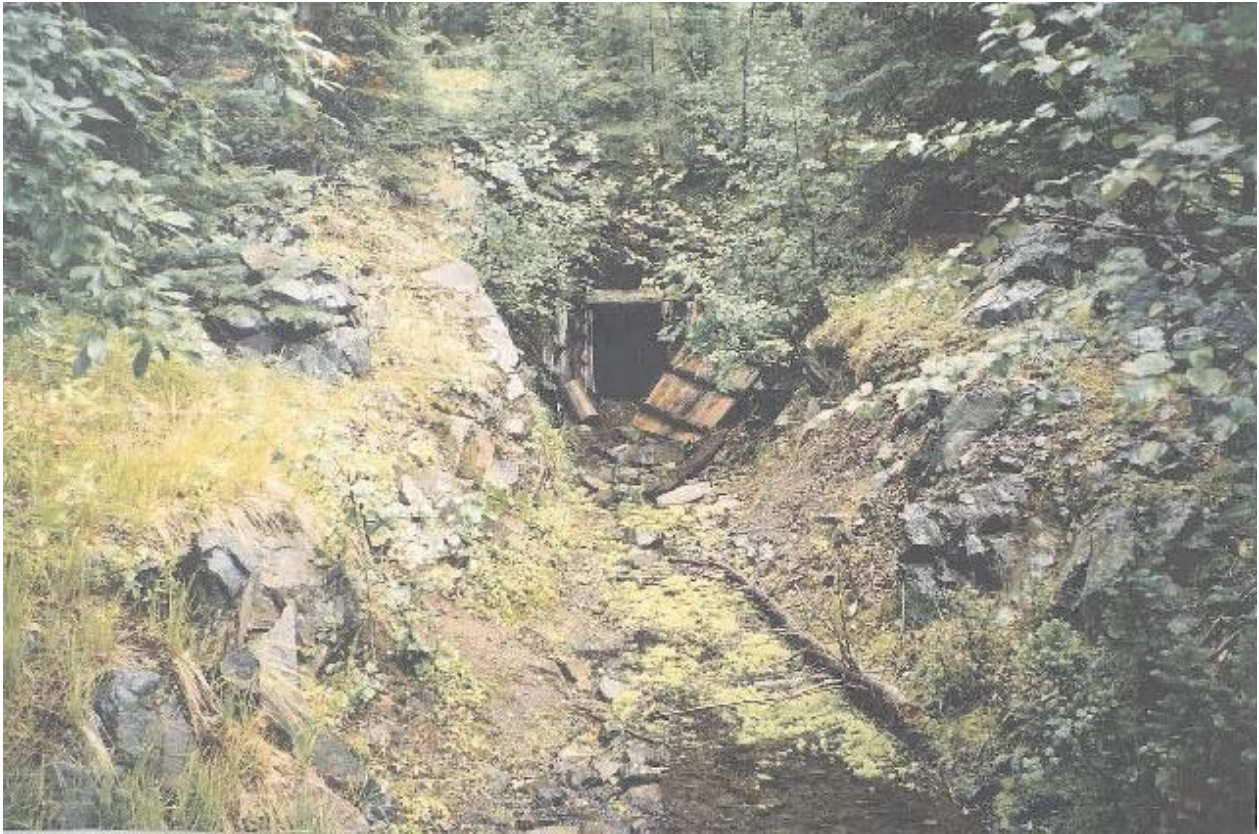
Photo 22. Windpass portal and drainage.

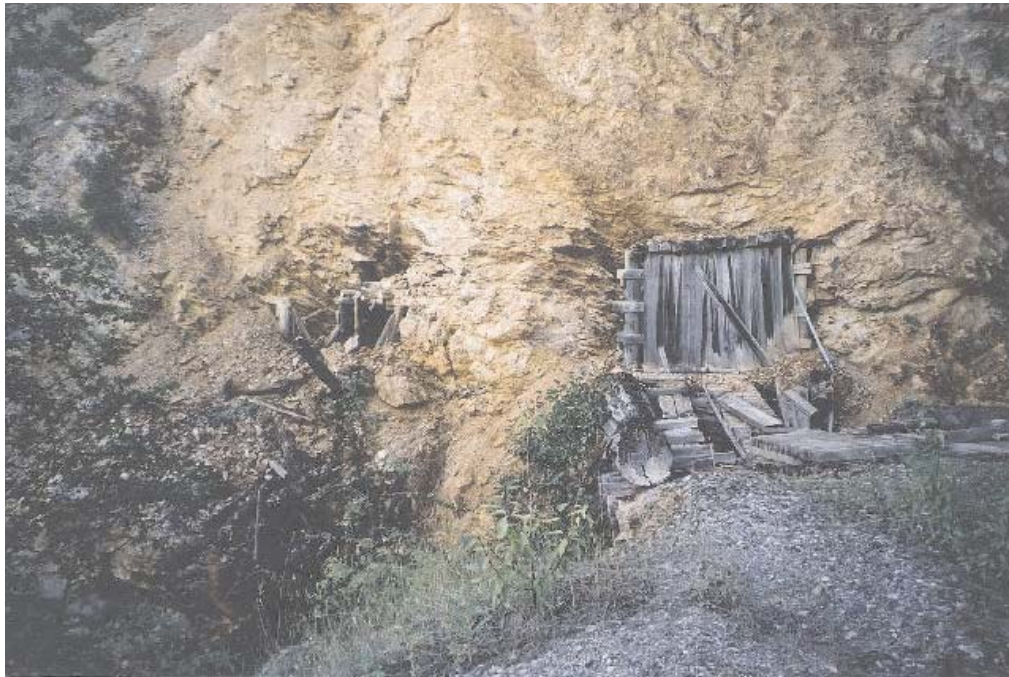
The Homestake adit has 2 openings: the main portal, which is timbered with a wooden door, and another small, timbered portal, which is accessible. A rotting, unstable wooden bridge crossing Homestake Creek

Photo 23. Homestake (Kamad) partially flooded upper adit. Homestake Creek flows beneath the bridge leading to the portal.

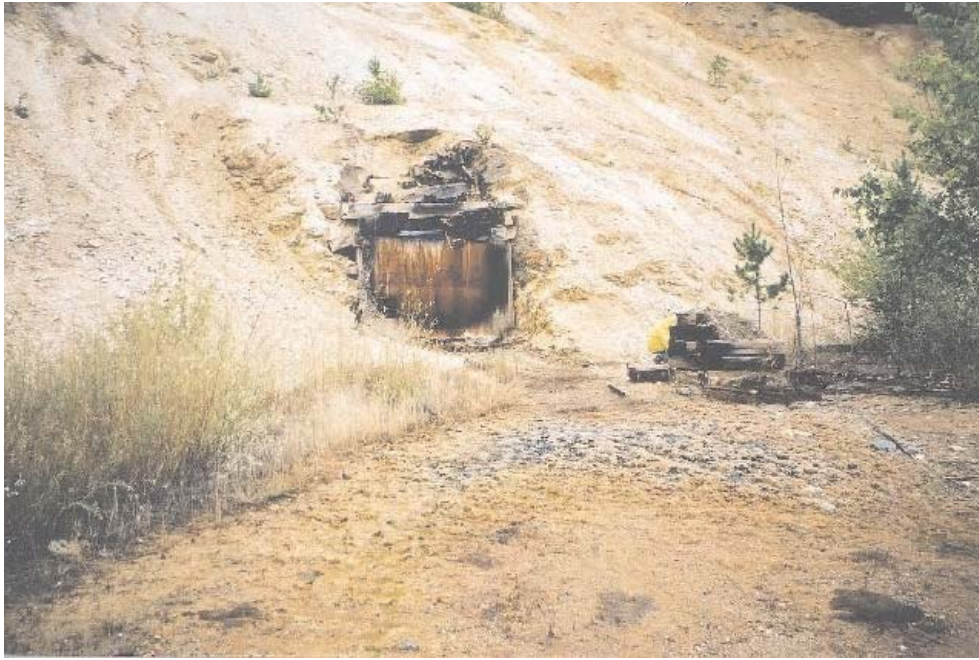
Photo 24. Homestake (Kamad) lower adit. Note white salts in front of the adit.

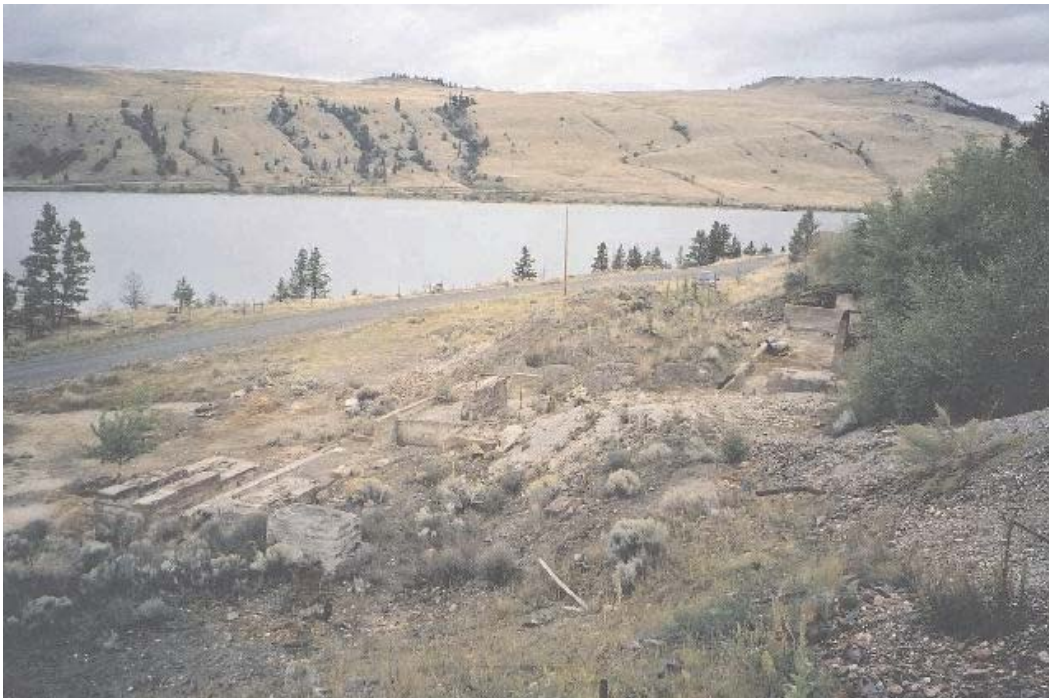
Concrete mill foundations remain. No equipment was noted. About 15,000 m³ of processed ore is at the mill site. The ore is strongly oxidized to an orange colour with trace amounts of malachite.

Photo 25. Enterprise mill foundations.

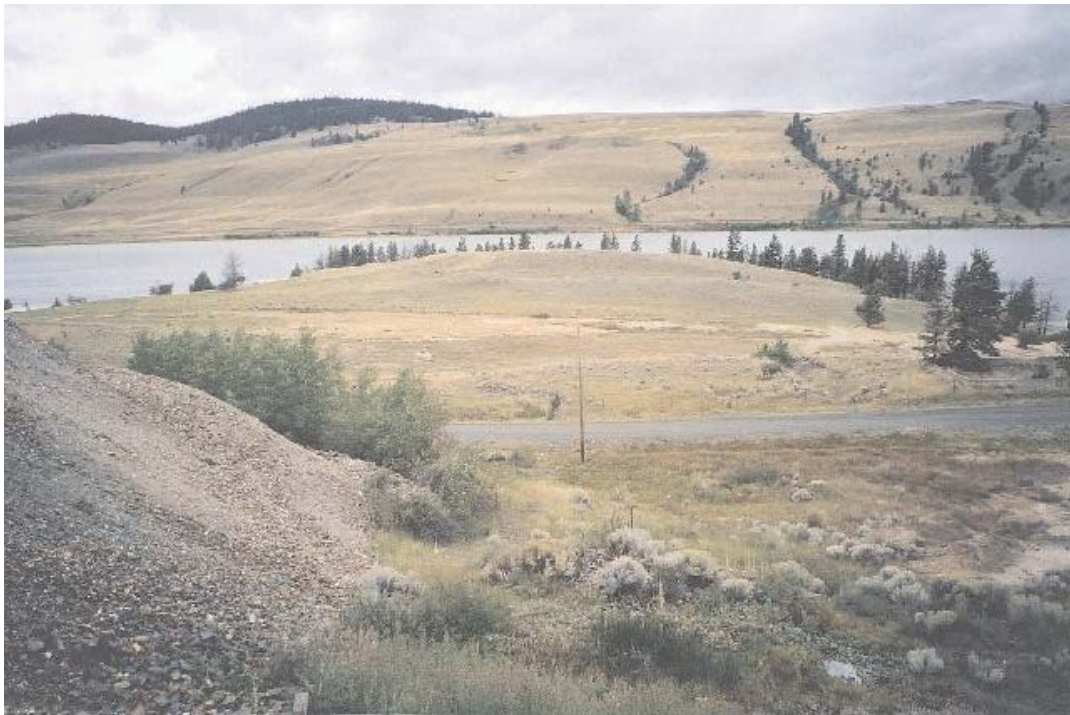
Photo 26. The partially revegetated Enterprise tailings facility (across the road). Dump is in foreground.

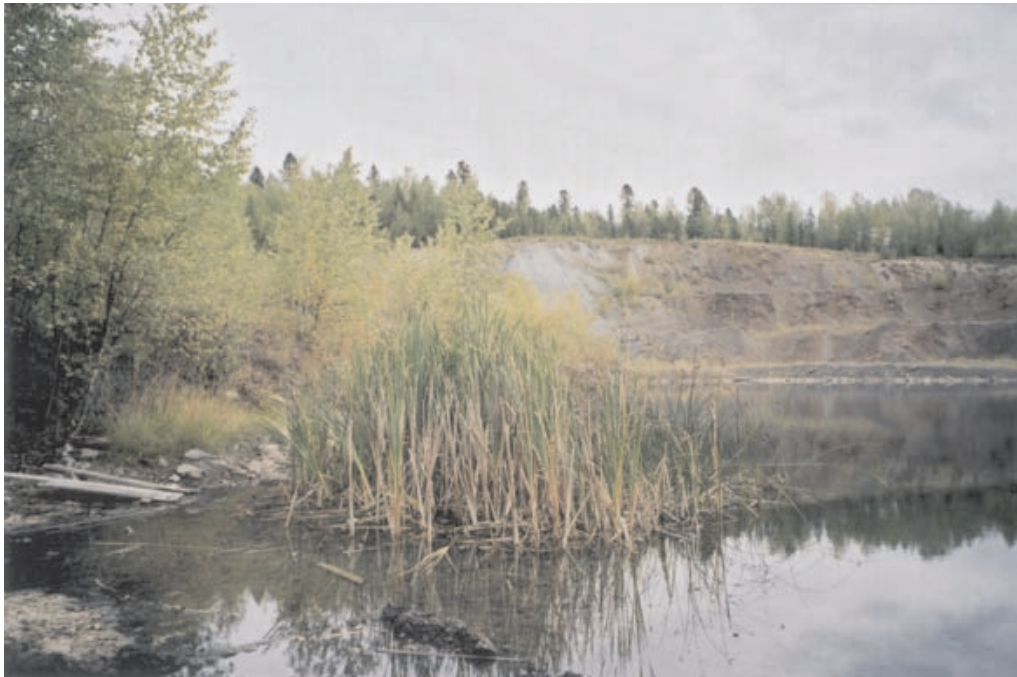
Photo 29. Motherlode flooded open pit.

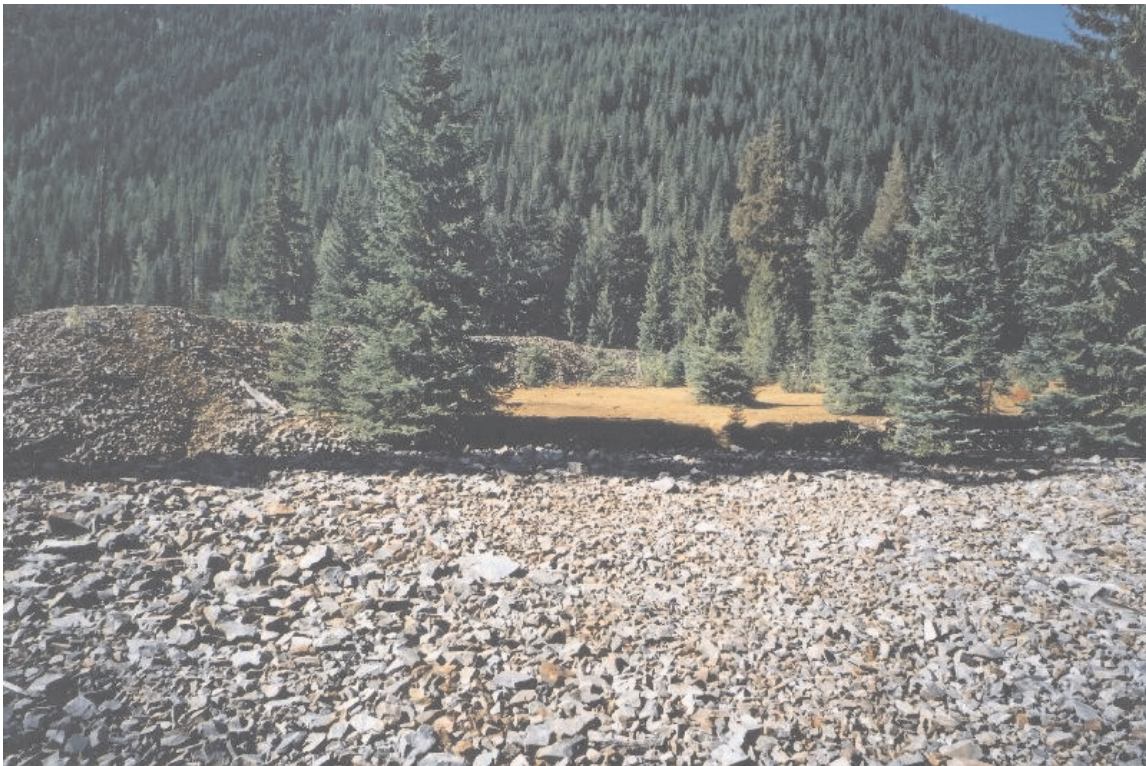
Photo 35. Waste rock dump and oxidized tailings impoundment.

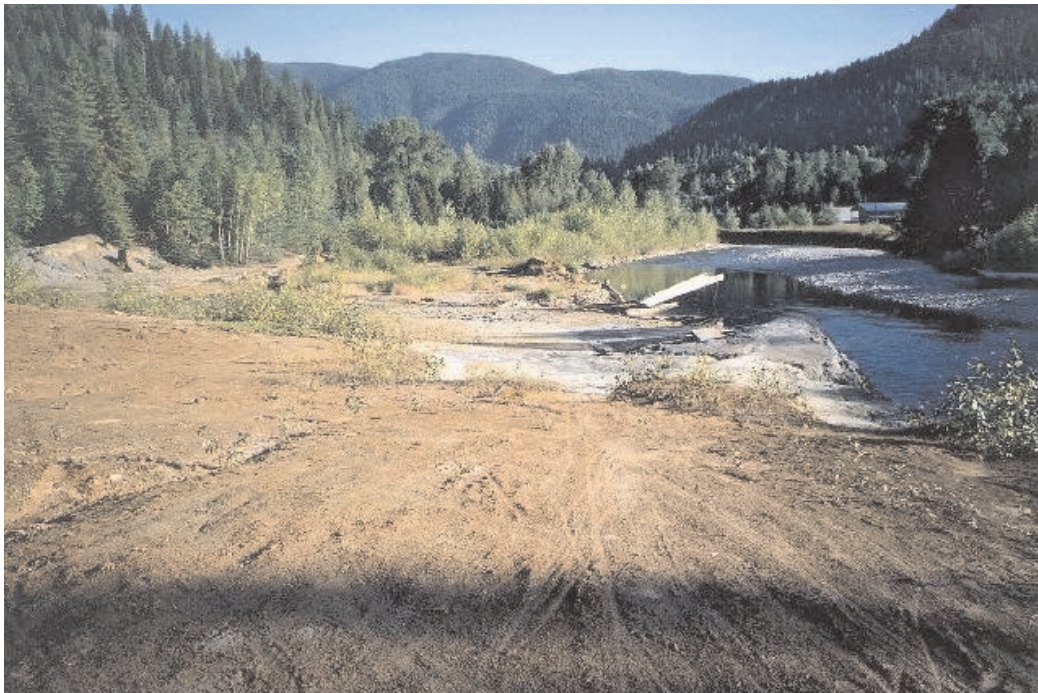
The tailings form the riverbank and are seasonally flooded during freshet.

Photo 36. Ymir tailings impoundment on the Salmo River.

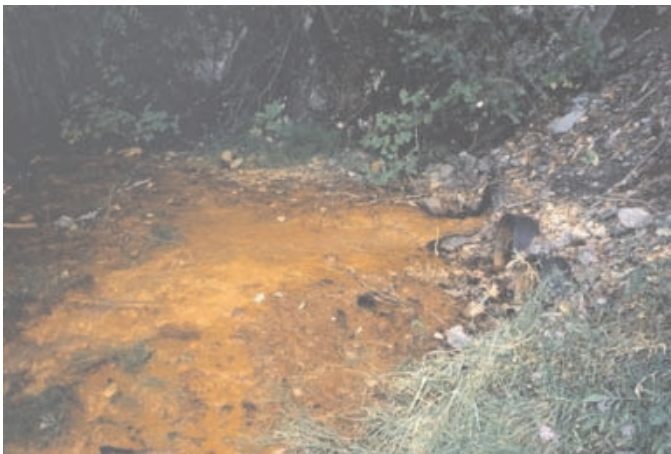
Photo 39. Mine drainage from Kootenay Florence adit. The portal was backfilled and 3 culverts installed.

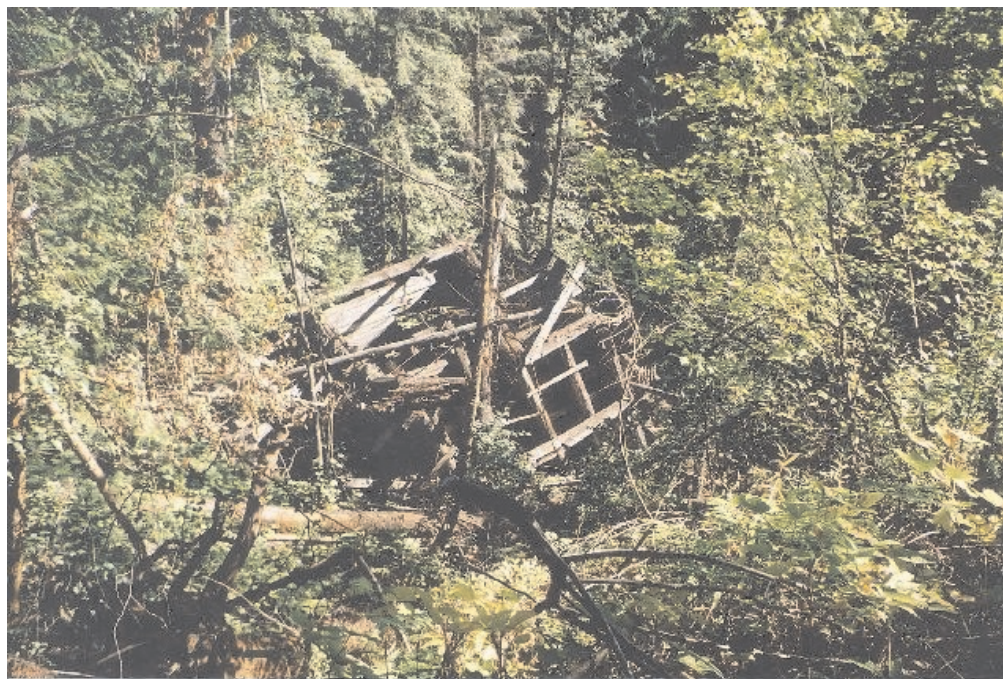
Photo 40. Collapsed tram load out station at Highland mine site.

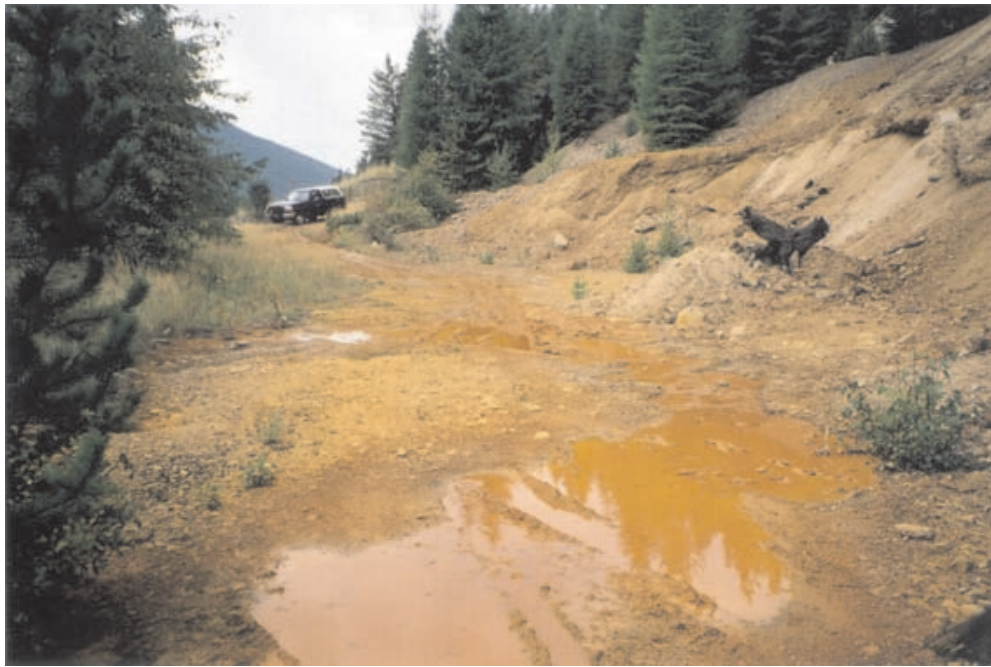
Photo 42. Mine drainage at the foot of the lower dump. The drainage originates from the lower adit and terminates in a field of horsetail.

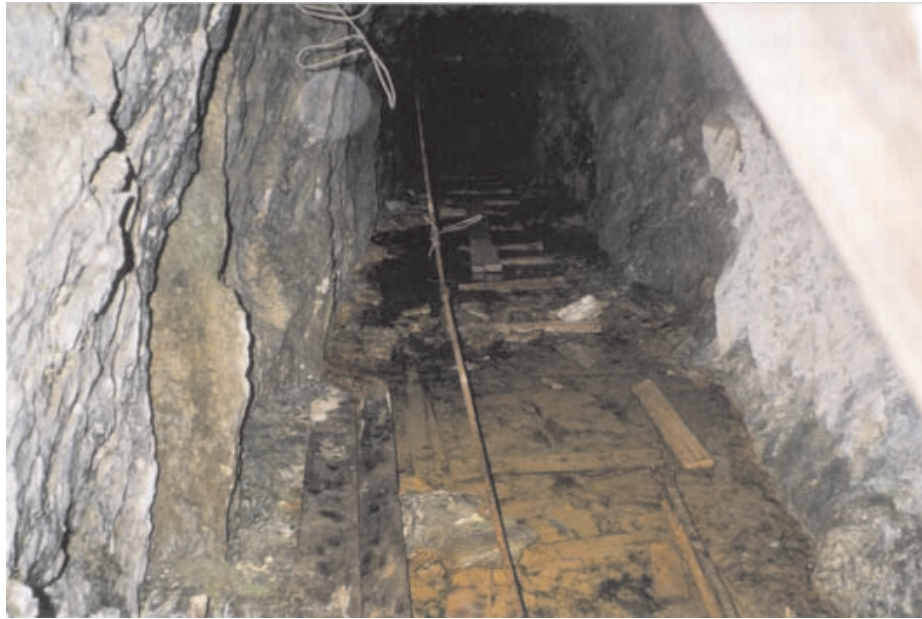
Photo 46. Camborne adit. The mine water was stagnant when sampled.

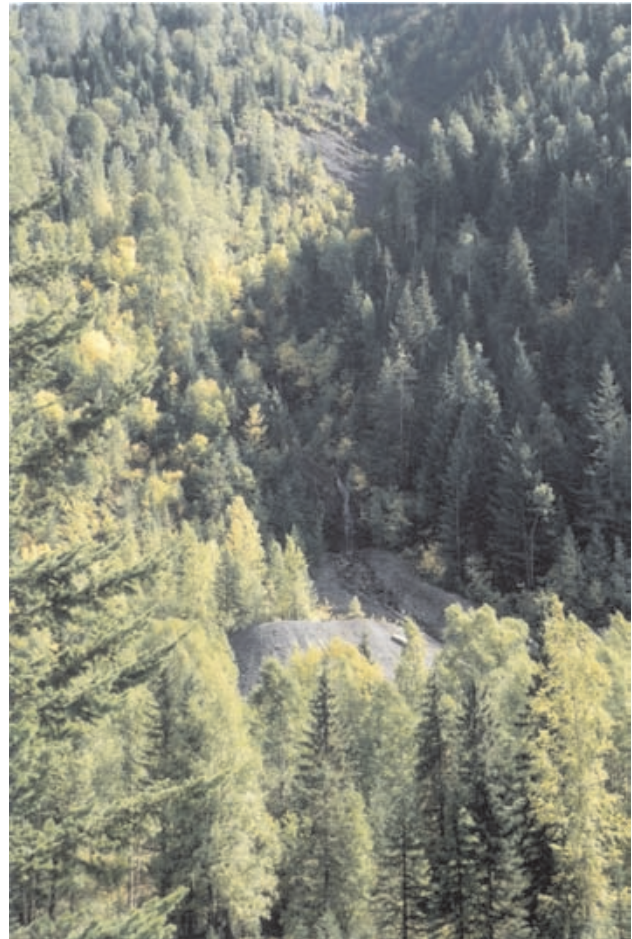
Photo 49. Dumps at Lucky Jim property. Drainage is visibly flowing over the middle dump.

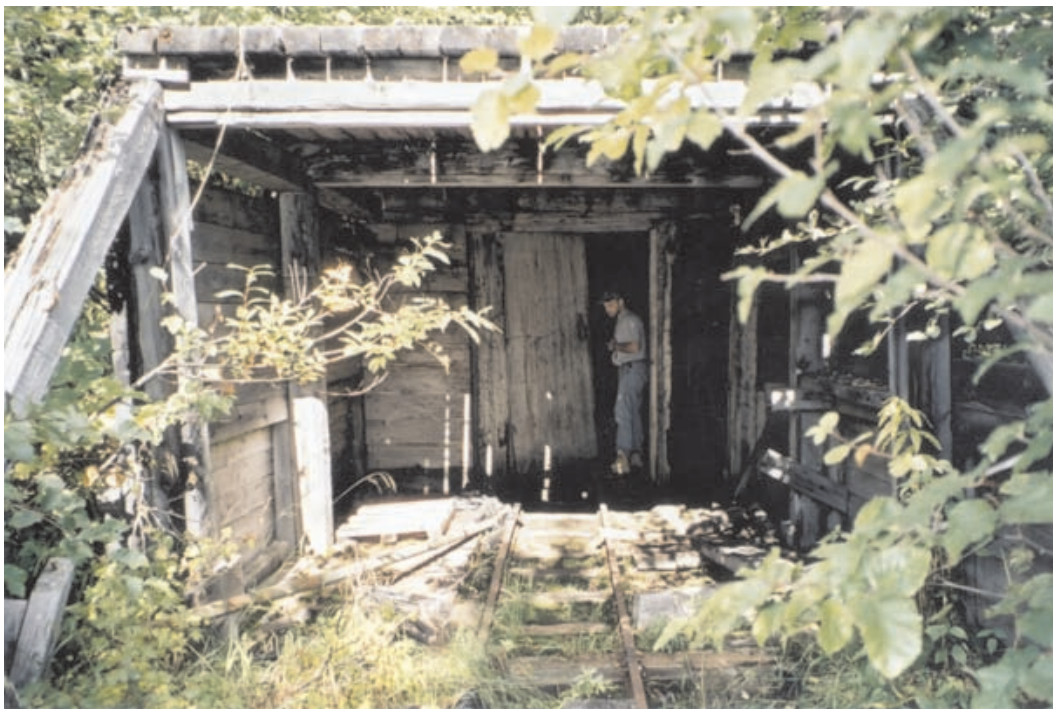
The drainage from the upper portal was draining at a rate of ~ 60 L/min. The field pH=5.5 and conductivity= 340 µs. No visible precipitates or salts were present. Bright green, stringy, individual moss-like plants

Photo 50. Slocan Sovereign adit with flowing drainage.

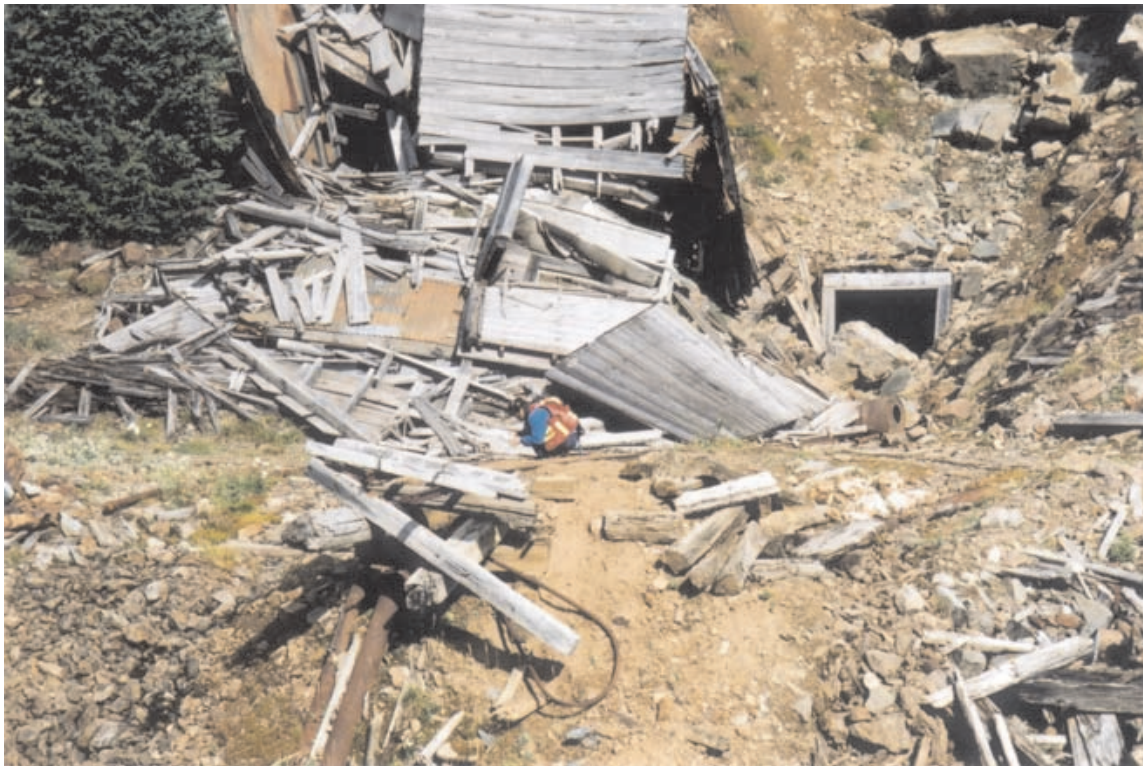
Photo 52. Lower adit. The drainage from the adit is being sampled.

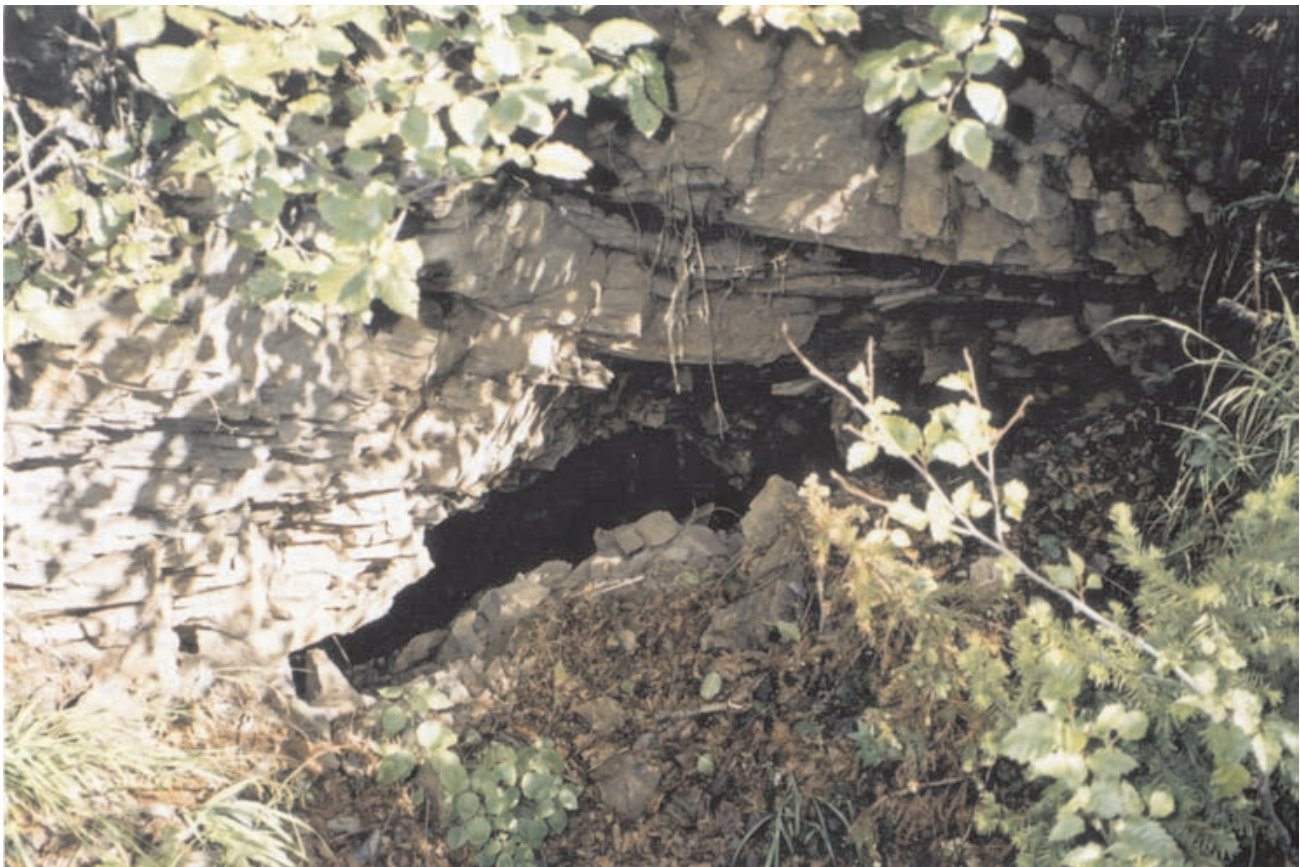
A partially collapsed portal with drainage was inspected. The pH of the drainage was 5.5 and conductivity 170 μ s. The flow was ~ 5 L/min and the drainage odourless. No oxidation was visible around the portal. A small waste rock dump was situated to the west of the portal. The UTM coordinates: 481630, 5536572; elevation 1316m. The workings could be part of the New Springfield (082FNW199) mine site.

Photo 54. Unknown adit on Idaho Peak, elevation 1419 m.

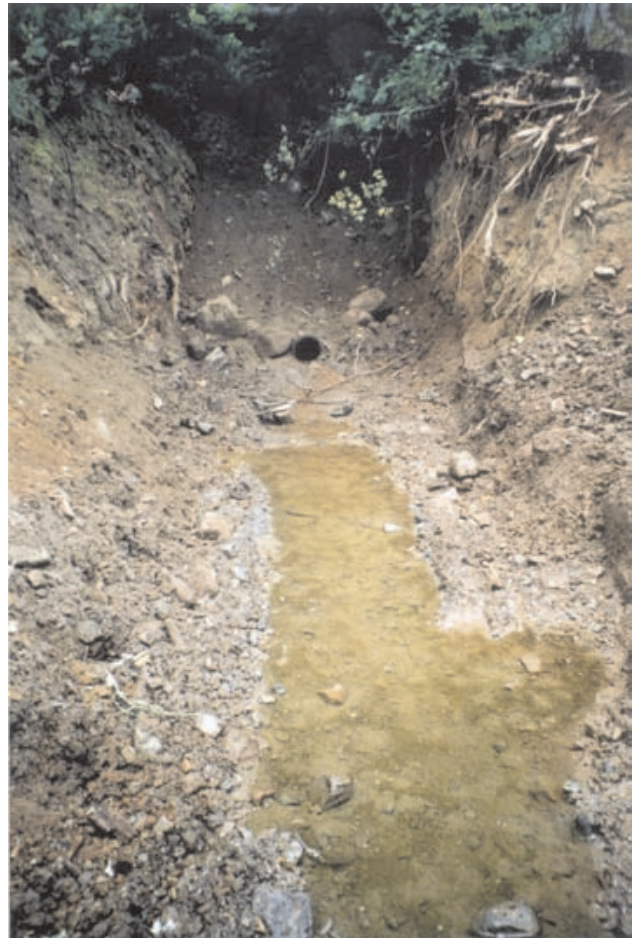
- located on the east side of Monte Cristo Mt.
- the portal entrance was driven ~west.
- the adit is possibly connected with the "Evening Star" workings.
- portal recently backfilled with a culvert installed. Work performed by Granite Mountain Excavating.

Photo 56. Unknown backfilled adit (UTM coordinates: 0441519, 5437741) on Monte Cristo Mountain., Rossland, B.C.
