HISTORIC MINE SITES IN BRITISH COLUMBIA

By Lisa N. Barazzuol and
Gregg G. Stewart, PGeo

FEBRUARY 2003

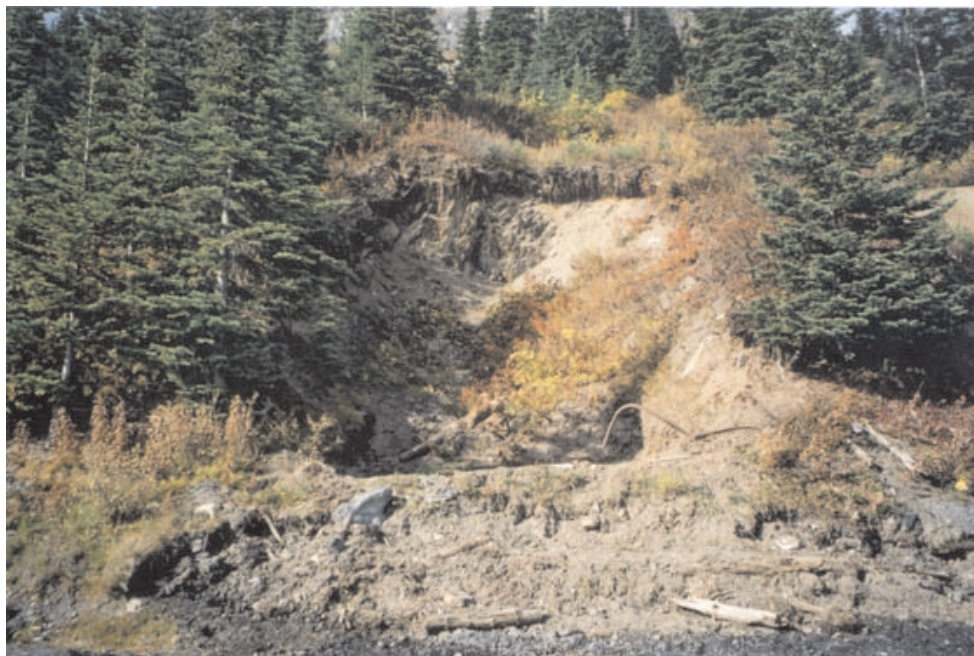
The drainage from the northern portal flowed east under the road, surfaced on the other side and then flowed down the waste rock dump into the surrounding forest.

Photo 57. Backfilled portal at Takla Silver mine site.

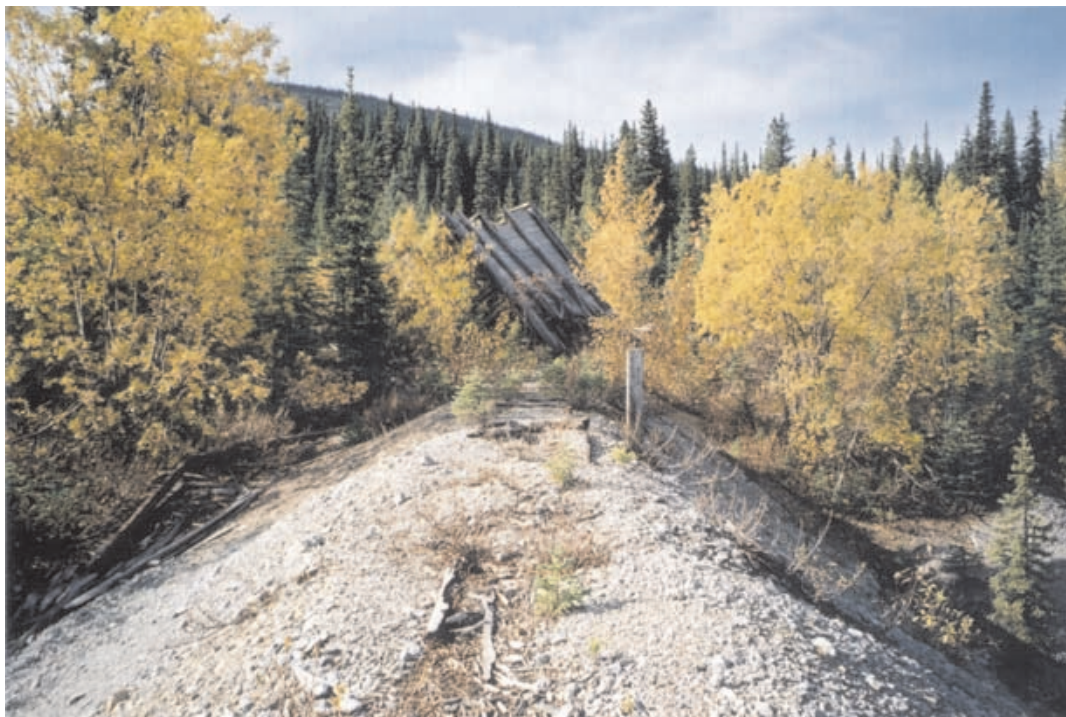
Photo 58. Bralorne-Takla dump and shaft headframe.

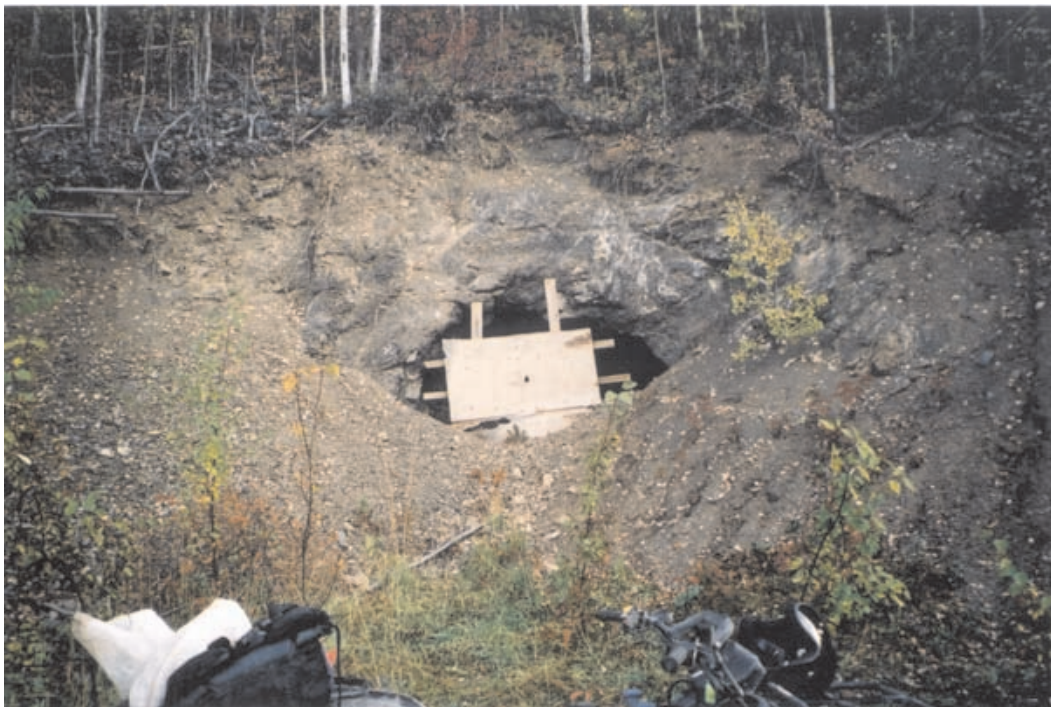
The flooded inclined shaft had a field pH=6.0. The water was odourless. No visible precipitates in the water sample. Observations were difficult as the

Photo 61. Northern portal at Snowbird mine containing a collapsed decline.

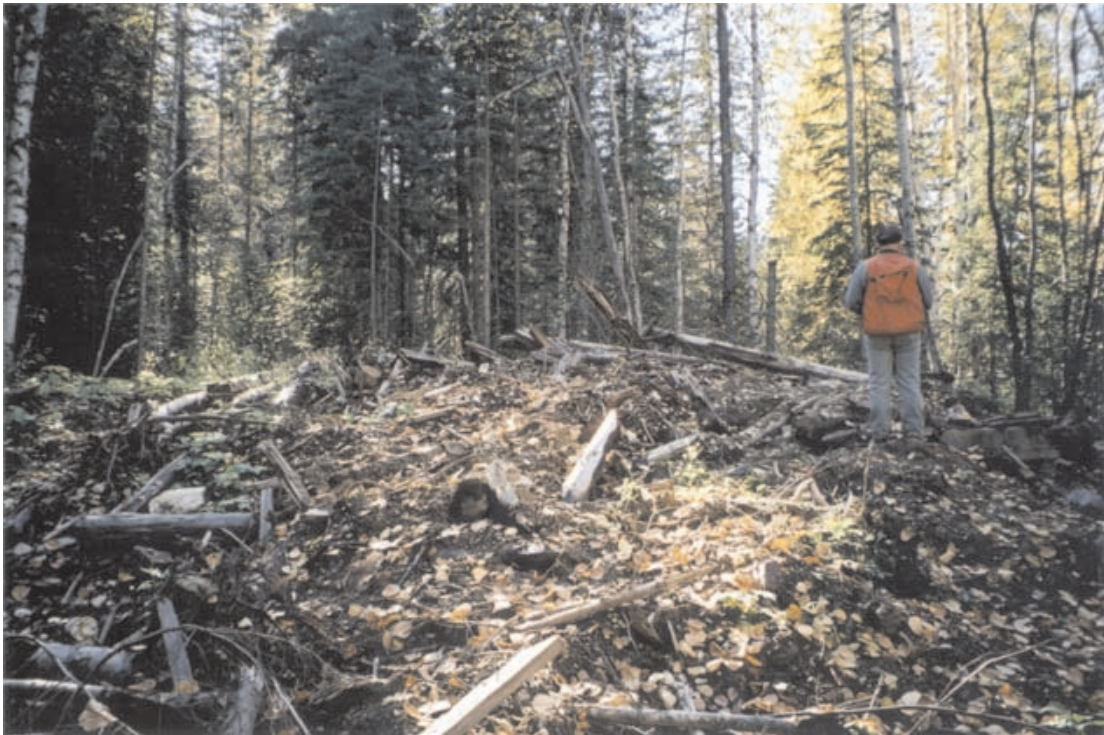
Photo 62. Site of former ore bin. Note ore and wooden debris scattered on ground.

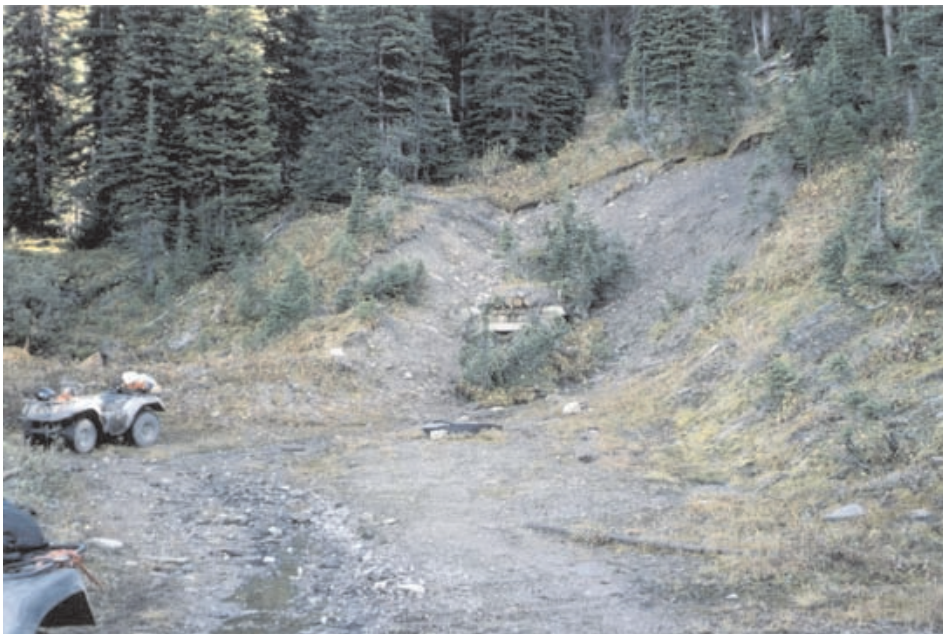
The drainage from the adit flows for 100 m on the surface before it merges with Pearce Gulch a tributary of Pearce Creek. Pearce Gulch flows through the waste rock dump.

Photo 64. Cariboo Hudson adit. Note drainage in foreground.

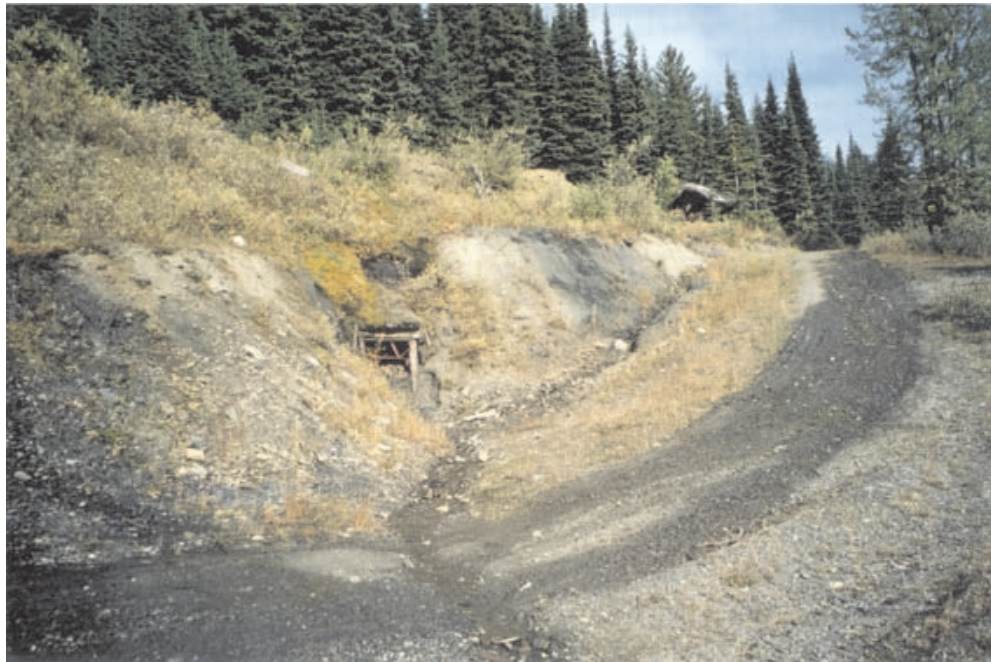
The upper portal drainage flowed over the road, down the lower waste rock dump and then merged

Photo 66. Lower portal at the Jane (Snowshoe) mine site. Note upper adit drainage path at the base of the bank and the hut at the road hairpin.

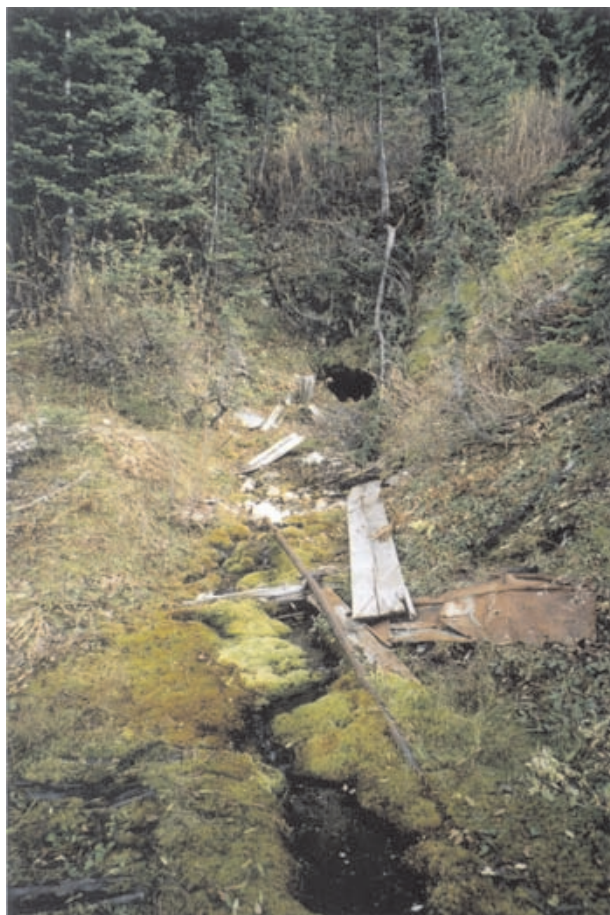
Photo 67. Midas adit and drainage.

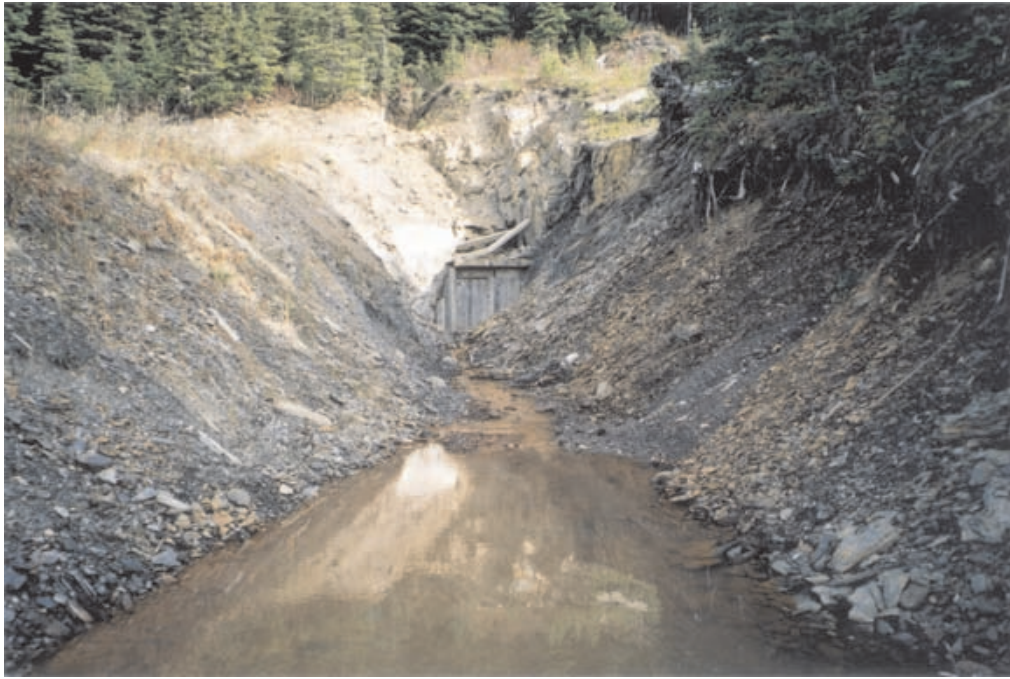
Photo 68. Drainage, heavy in iron precipitate flowing from the Warspite lower adit.

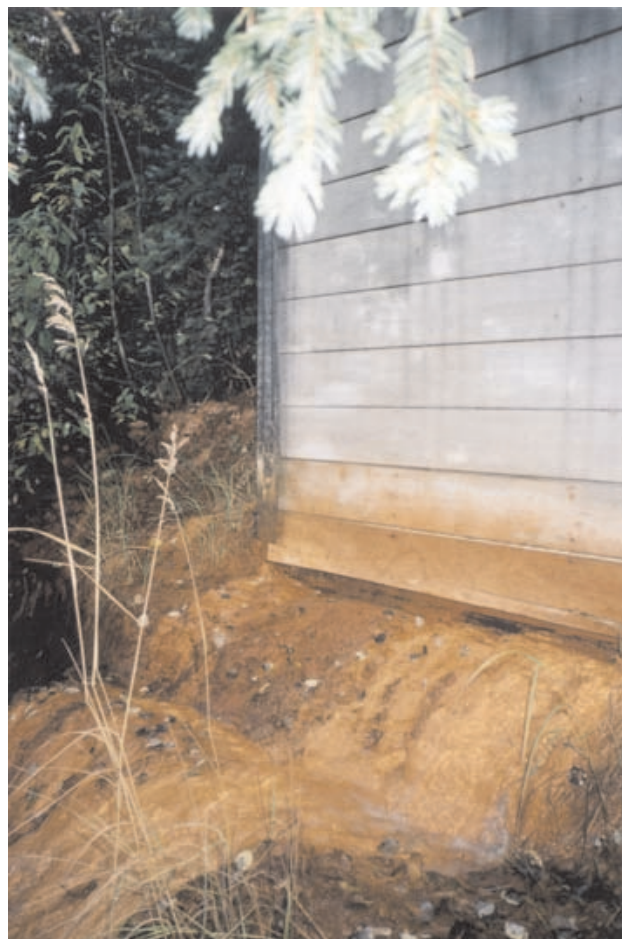
Photo 70. Red drainage flowing from the pump house at Island Mountain.

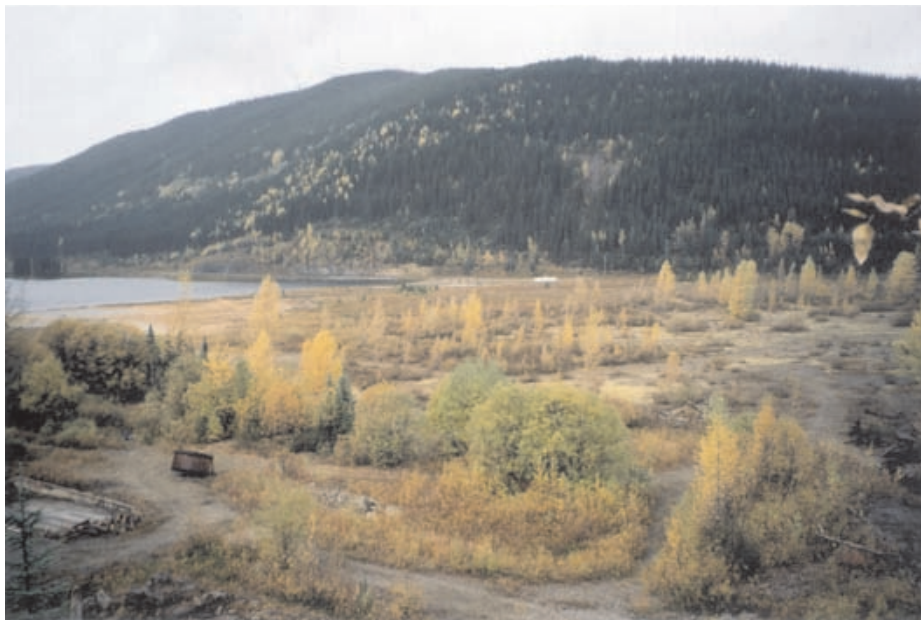
Photo 72. Cariboo Gold Quartz tailings. Note the corner of the mill foundation in the foreground.

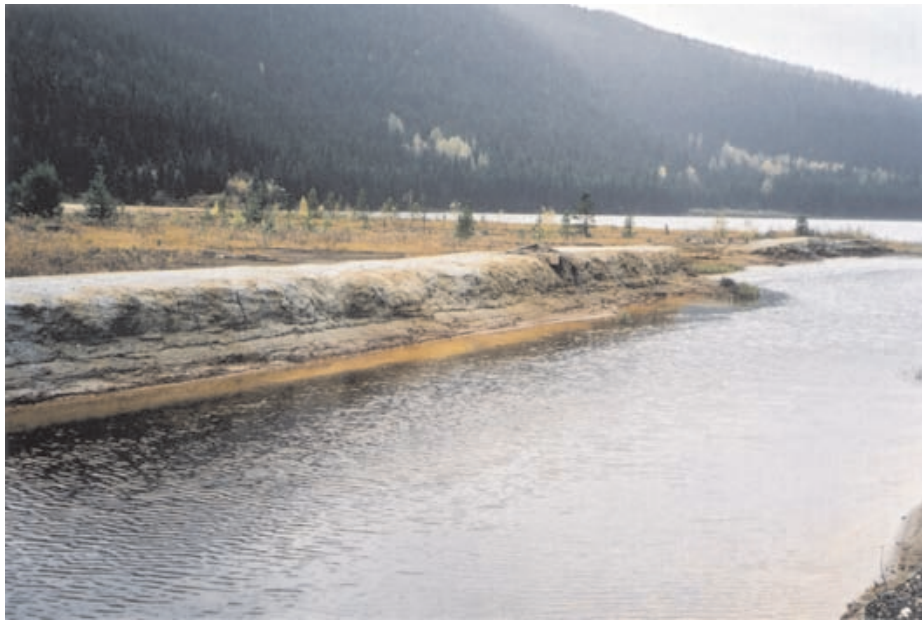
Photo 73. The Cariboo Gold Quartz tailings are submerged in Jack of Clubs Lake and the Willow River. Note the oxidized tailings along the bank of the Willow River.

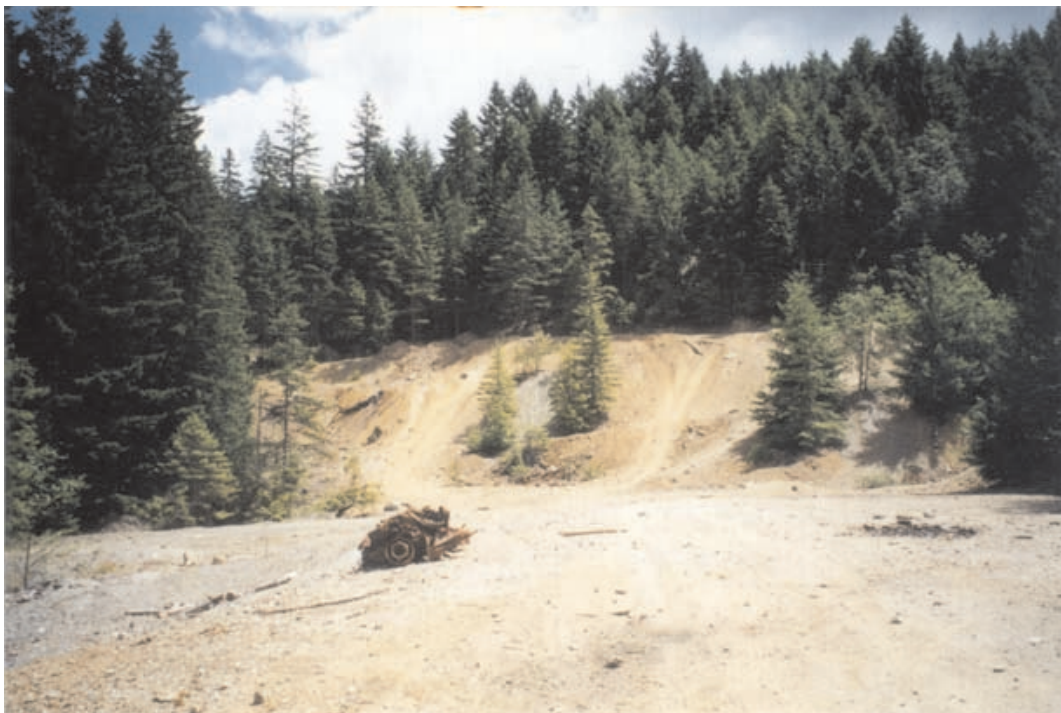
Photo 74. Lenora waste rock dump. The drainage flowing over the dump and seeps was sampled.

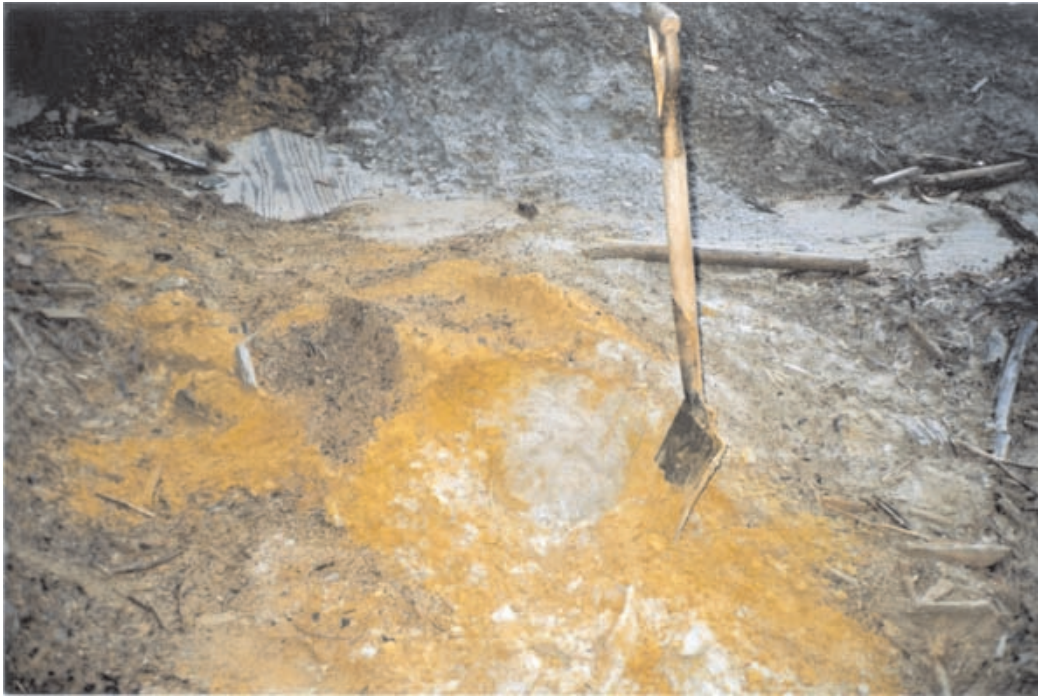
Photo 75. Oxidized subsurface of the Lenora tailings.

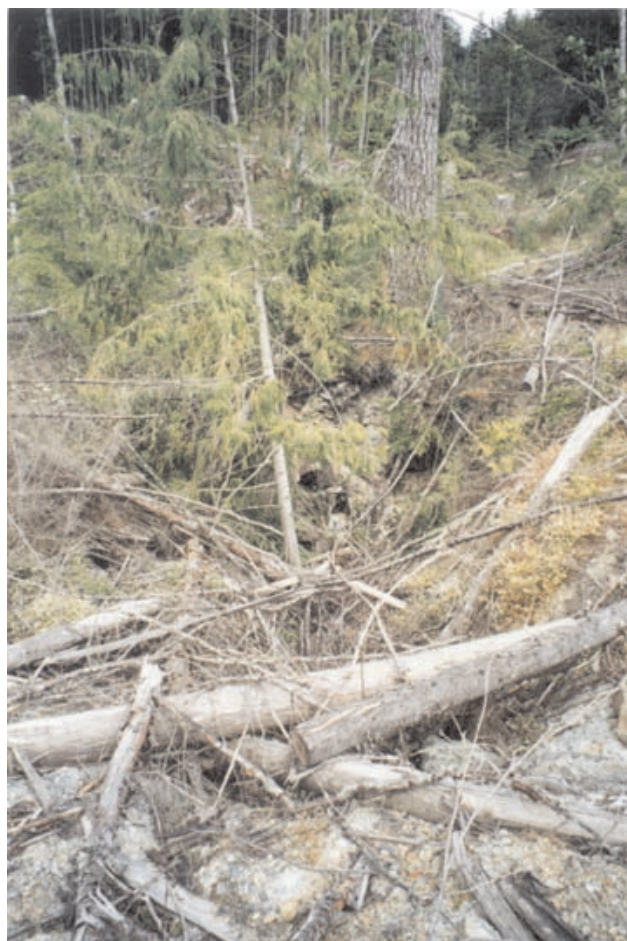
Photo 77. Richard III open shaft.
