NICKEL HILL MINES LTD.

Report
on the
Coal Deposits of Pink Mountain, B. C.

by
F. J. L. Guardia, P. Eng.

November 30, 1971

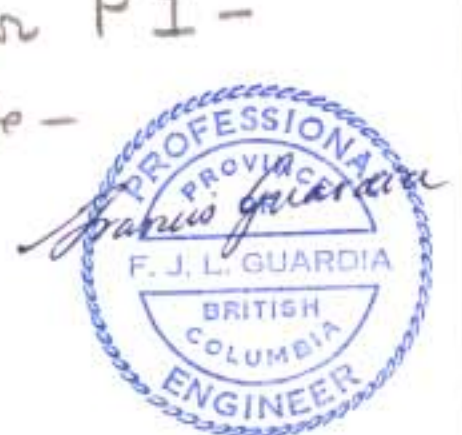
ALRAE ENGINEERING LTD. CONSULTING ENGINEERS & GEOLOGISTS - VANCOUVER, CANADA	
NICKEL HILL MINES LTD.	
PINK MOUNTAIN (2)	
MEASURED STRATIGRAPHY	
SCALE: 1" = 20'	DESIGNED: F.G.
DATE: NOV 1971	DRAWN: ALTAIR
REVISED:	MAP NO:

In the course of the present mapping an attempt was made to measure and describe a complete section through the Gething Formation. Figure 2 is a compilation from

three localities; a road cut on the access road up the southeast flank of the mountain, cliffs at the south end and at the saddle located approximately one mile south of the summit of the mountain. Due to a series of persistently recessive beds close to the base of the formation the section is not complete and although most thicknesses measured are thought to be reliable the thicknesses of the coal seams on the diagram are shown as those measured on the actual section, which, in some cases, for reasons discussed later, are thought to represent local tectonic thickening of the seams.

The overall thickness of the Gething Formation on Pink Mountain was measured to be close to 1020 feet. Details of the lithologies are listed on Figure 2, but for the purposes of mapping the Gething was divided into seven units (figs. 2 and 3) as follows:

Several coal seams and partings previously unsuspected were found in the course of the mapping and trenching on Pink Mountain. The majority of these are shown on Figure 2 with the stated thickness being that actually measured in compiling the section. However, it is apparent that thicknesses measured are very local and are largely controlled by local structural features previously described. In addition the situation is made more complex by several of the better coal showings having a readily demonstrable cross-cutting relationship to the surrounding strata.

Sample No.	Seam (as indicated on Fig. 2)	Seam width sampled (feet)	Description
534	P - 1	22 (approx)	Sampled 42 feet horizontally in crushed and friable coal with minor shaley lenses.
536	P - 1		Coherent coal lumps from above, lacks highly crushed material that has admixed shale.
535	P - 2	3.5	Broken friable coal with clay wash from surface weathering.
537	"P - 10"	10 (approx)	15 feet horizontally across highly crushed, friable and dirty coal. The exposure is apparently a lense formed by coalescence of 4 seams (see fig. 2)
538	Bottom seam)	12	0 - 15' horizontally
539	")	"	15 - 25' "
540	")	"	25 - 30' "
541	Bottom seam)	20	Two samples taken across 20 feet wide coal, cross cutting strata. Believed to be derived from same seam as samples 538 - 540. Each sample 10 ft. wide.
542	injection)	"
