**SAND AND GRAVEL RESOURCE STUDY**  
OF THE  
**CUMBERLAND & T'SABLE RIVER AREA**  
**VANCOUVER ISLAND -**  
**BRITISH COLUMBIA**

**By: BAYROCK AND REIMCHEN**  
**SURFICIAL GEOLOGY LTD.**  
**North Vancouver, British Columbia**

VANCOUVER ISLAND RESOURCE STUDY  
SAND AND GRAVEL SURVEY OF THE  
CUMBERLAND AND T'SABLE RIVER AREA

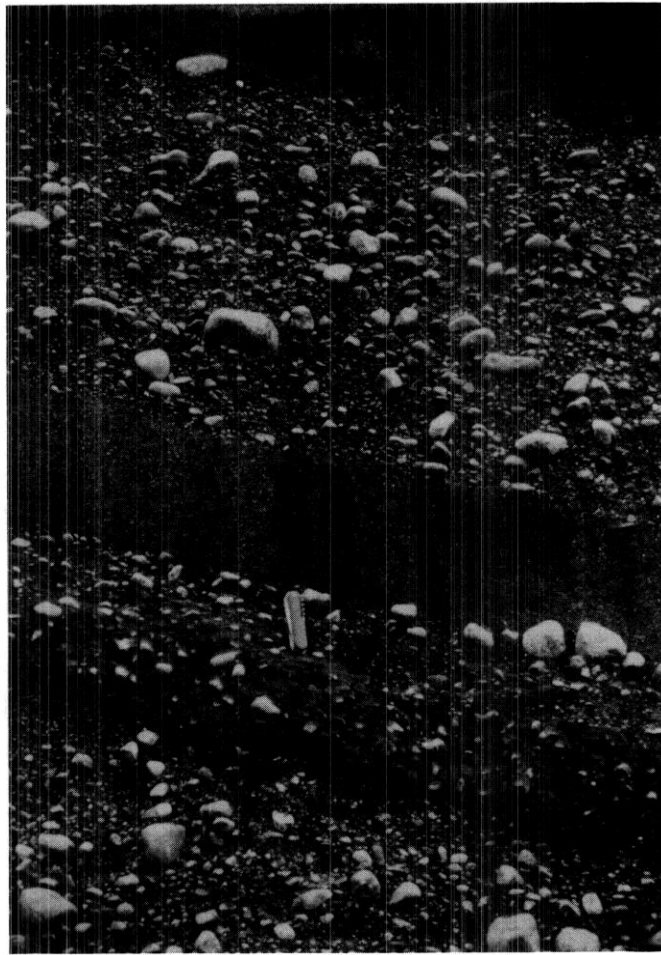
FIGURE 4:        Locality W-36; Close-up of alternating beds of clean, coarse sand and pebbly sand and gravel.

0 - 120 feet<sup>±</sup> This gravel pit is similar to W-35, although there seems to be more clean, coarse sand in beds ranging from 1 to 4 feet in thickness, (Figure 4). A channel sample was taken of the alternating beds of sand and sand and gravel as shown in Figure 4.

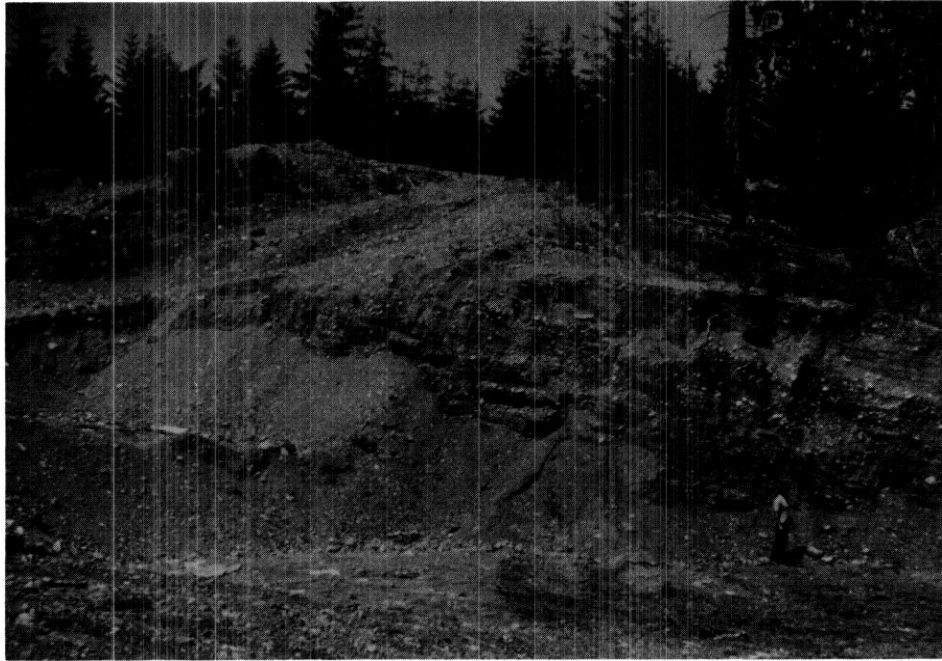
FIGURE 5:           Locality W-37; Panoramic view of the top one-half of a kame near the Pigeon Pond sanitation land fill. The bedding on the right-hand side of the photograph shows post-depositional slumping resulting from the melting out of ice after deposition.

Locality W-37 (Figure 5)

- 0 - 35 Feet+ Sand and gravel, poorly sorted, well-graded, granule to cobble size; modal size is 1 inch and comprises 30 per cent of the pebbles; 10 per cent of the pebbles are over 3 inches; the matrix is relatively clean, about 3 per cent would pass through a 200 mesh sieve. The iron staining seems to be concentrated near the base of the pebble layers, and around Recent rootlets which extend 8 feet down from the surface (Figure 6). The sands and gravels are loose and uncemented and the pebbles are sub to well-rounded. They consist predominately of volcanics (99 per cent) with minor amounts of granites, quartzites and the odd chert pebble. Channel sample taken.

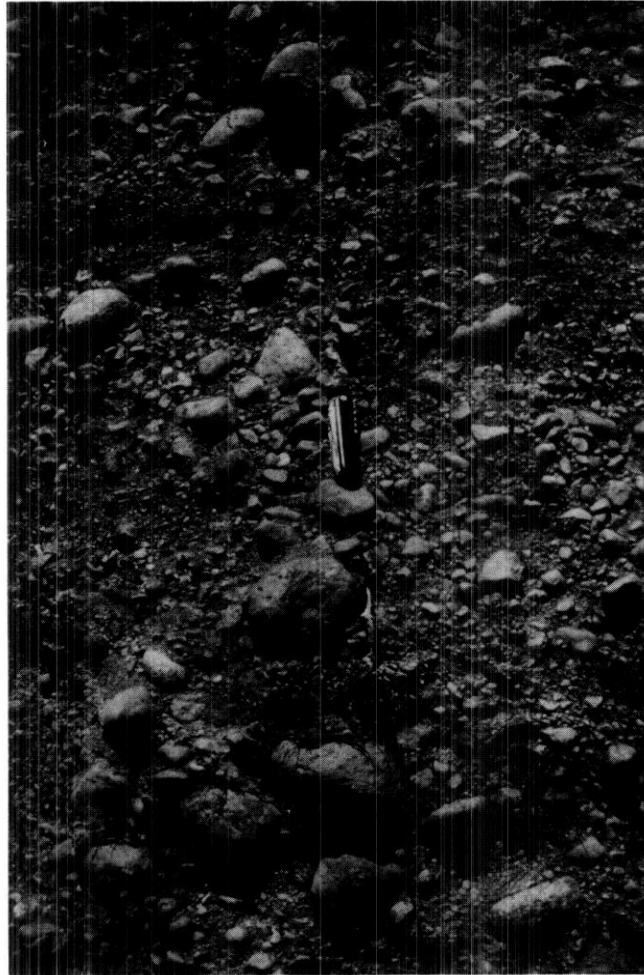
FIGURE 6:        Locality W-37; Close-up of gravel  
and sand in the upper six feet showing iron stain-  
ing and recent rootlets.

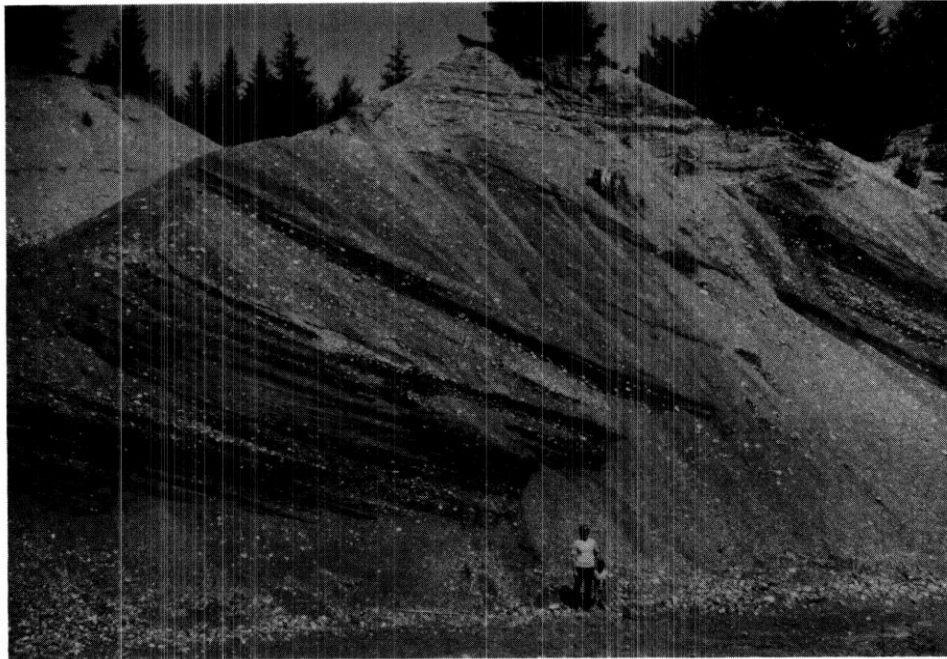
FIGURE 7:        Locality W-38; Panoramic view of abandoned gravel pit by Comox Lake. Note horizontal top set beds near top which truncate cross-beds below.

Locality W-38 (Figure 7)

0 - 60 feet+ Sand and gravel in mounds, some greater than 80 feet in height - kames. The upper 10 feet of these deposits are horizontally bedded and tends to be coarser than the underlying cross-beds it truncates. The cross-beds dip 20 to 30 degrees in a south-westerly direction. The cross-beds consist of alternating bands of coarse granular sand and granules with pebble to cobble size bands, poorly sorted (well-graded). No large rocks over 4 inches in long diameter are present (Figure 8). About 80 per cent of this deposit would probably pass through a 4 inch sieve. Some of the cross-beds are disrupted and show signs of post-depositional slumping. This faulting is most likely caused by ice melting out from below the gravel after deposition. The sands and gravels are loose and uncemented and consist predominately of volcanic rocks (78 per cent) and granites (18 per cent), minor amounts of quartzites and chert are present. Channel sample was taken.

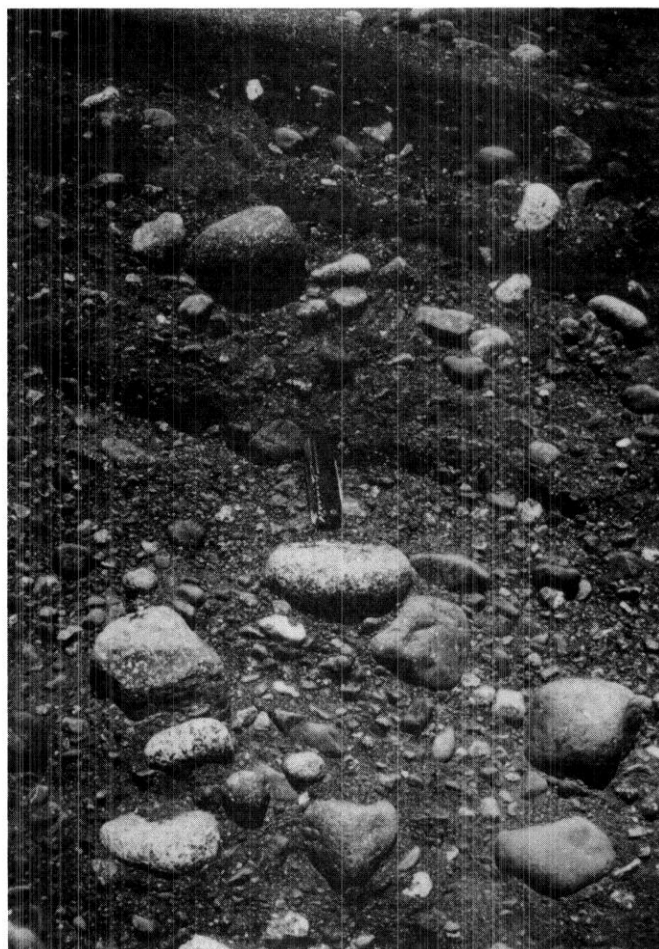
FIGURE 8:        Locality W-38; Close-up of alternating beds of clean sand and sand and gravel.

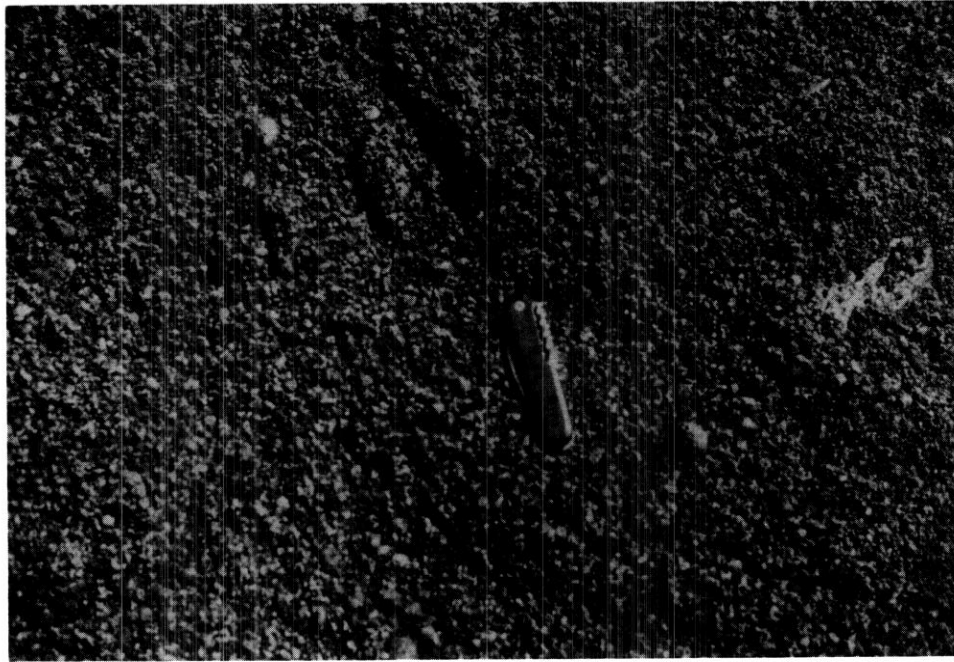
FIGURE 10: Locality W-44; Close-up view of sand size material near bottom of hole.

in size, (Figure 10). Channel sample taken from 0 - 10 feet.
