Report on 2014 Exploration Program

Quinsam Coal Mine

Quinsam Coal Fee Simple Holdings

March, 2015

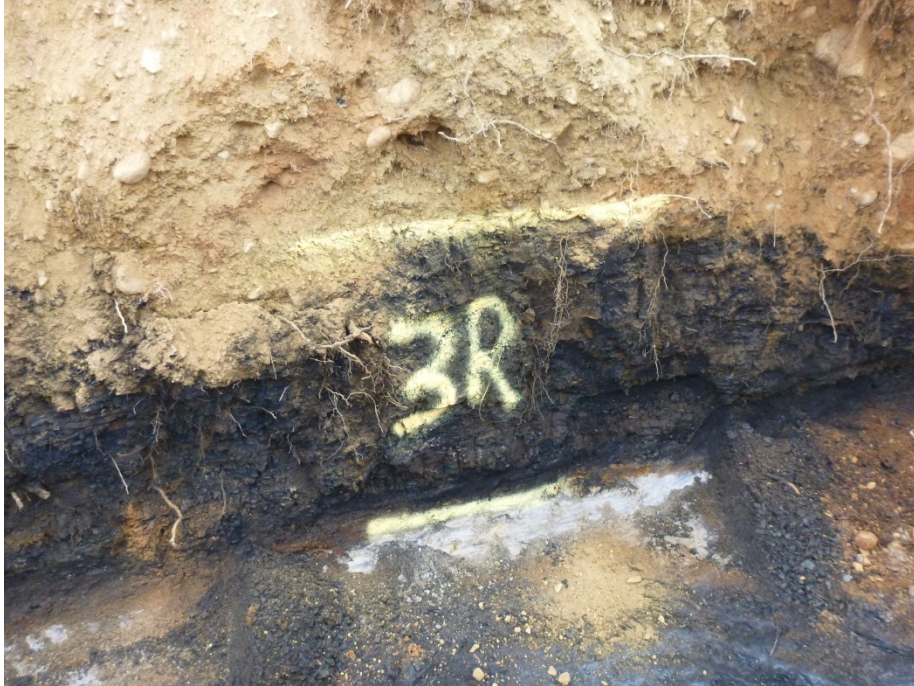
Figure 1: 3R Seam exposed in the rib of the trench, in direct contact with the overlying till

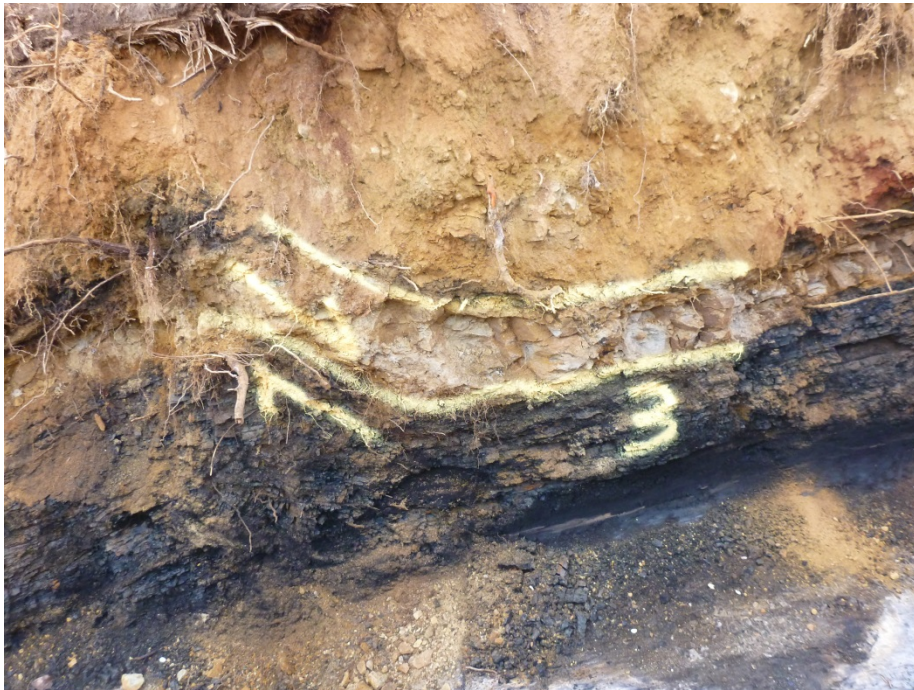
Figure 2: The sandstone (sometimes just sand) parting between the 3R and 3 seam. In this location, there is no 3R present likely due to glacial erosion

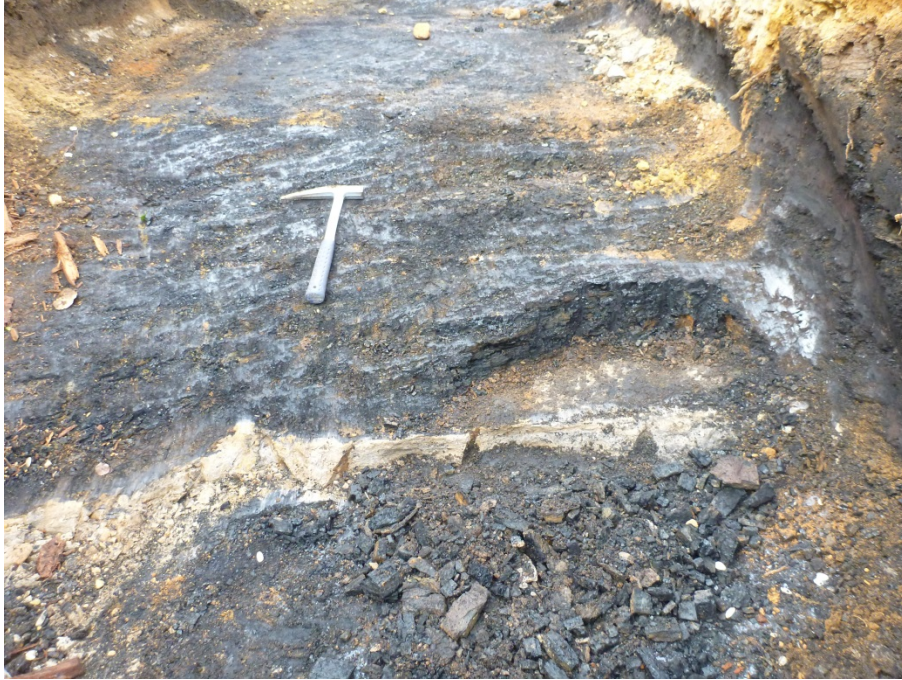
Figure 3: The rock hammer is lying on the top of the #3 coal seam, but also shown in this picture is the top sandstone parting within this seam

Survey: As noted in pictures below, a thin layer of till, the 3R seam, and the 3R-3 Parting were stripped within the trench, down to the top of the 3 Seam. Survey points were taken within the trench at the top of the 3 seam, and a list of the survey points are shown below.

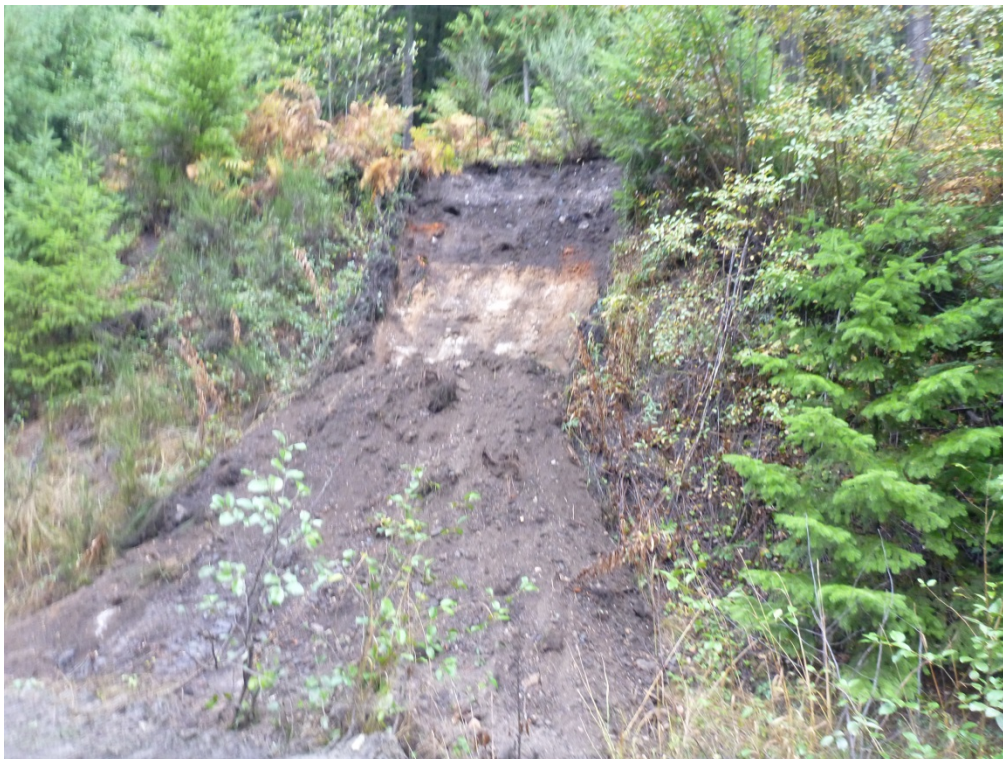
Figure 1: First Pit, displays the exposed bottom of the #1 Coal zone

The original trench that was located on the side of the 2S access road near the turnoff for the Rock Quarry, was excavated ~4 vertical metres, and was found to only expose the base of the #1 coal zone. This point was surveyed for the purpose of modelling, as the seam can be projected up, and the exposure can be seen in figure 1.

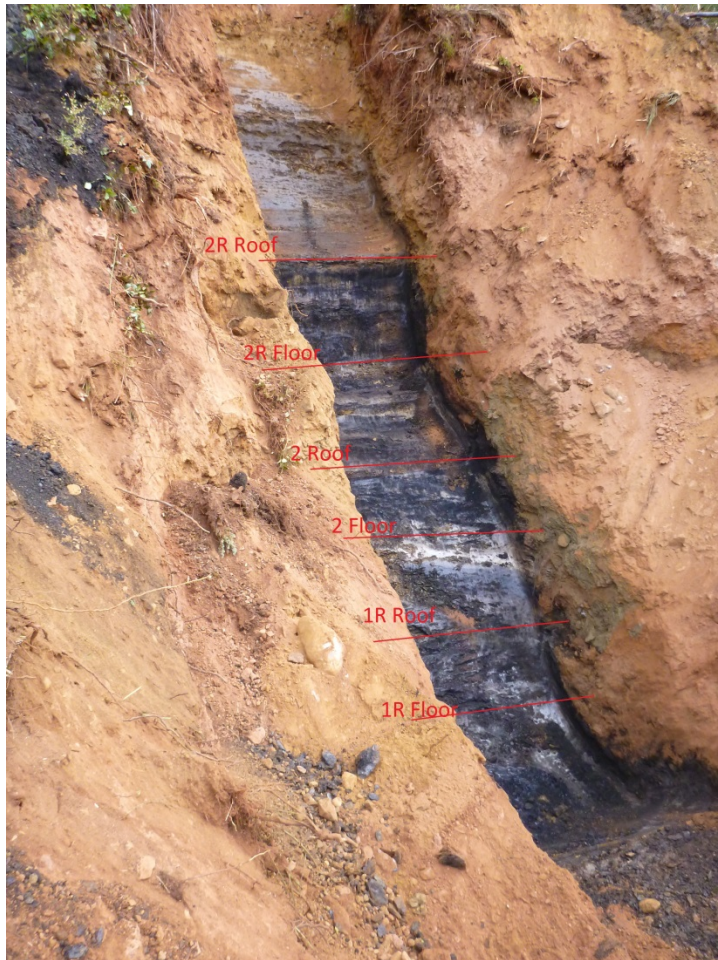
Figure 2: Exposure of the #2 coal zone, overriding the #1 coal zone

The first pit was used to project where the #1 seam would be better exposed, and the second trench was dug, exposing the entire #2 coal zone, sitting on top of the entire #1 coal zone. The #2 coal zone can be seen in Figure 2.

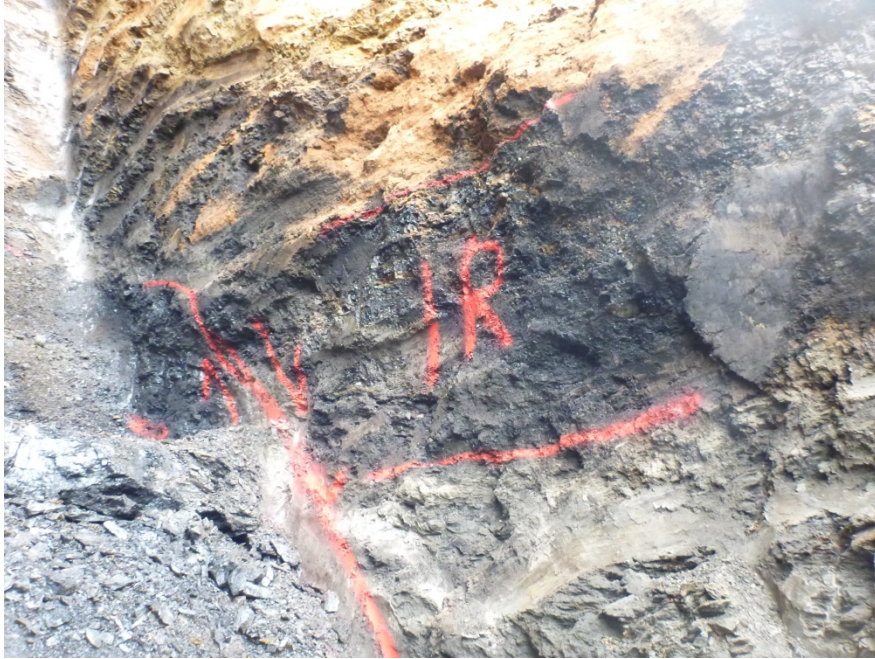
Figure 3: Fault offset through the coal zone, noted mostly through the 1R seam and the 1R-1 Parting

Below the #2 Coal zone, the #1 coal zone was exposed, and appears to have a fault offsetting the seam locally by up to 3.0m along the fault plane (1.5m vertically), and this fault can best be seen in Figure 3. No strike was measured, but the apparent dip was ~ 45 degrees. Above the fault, the dip of the coal seam was 002/12, and then below the fault, the apparent dip steepened to 24 degrees, but then by the base of the coal seam, the orientation of the 1L seemed to be at 339/12. It is common in the 2N/5S mine to have a 'rolling' coal seam prior to a fault, suggesting a listric fault (curved normal fault, concave upwards, dip decreases with depth, common in extensional regimes, often preceded by rollover anticlines).

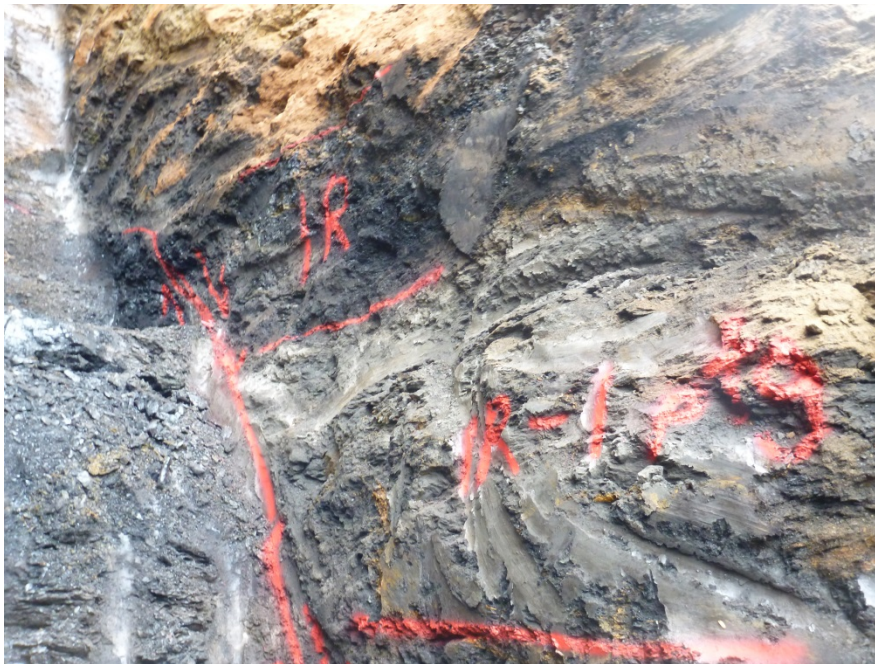
Figure 4: 1R seam overlying the 1R-1 parting

Figures 4-8 depict the #1 coal zone on the right hand rib of the trench, facing the hillside. The base of the coal zone is likely where the 'floor line' is labelled in Figures 7 and 8, although there was a carbonaceous zone 40cm below that line that was 25cm thick that may develop into the 1L coal ply laterally further into the coal seam. This seam (ply) was sampled in this location as well as TR-5S-2.

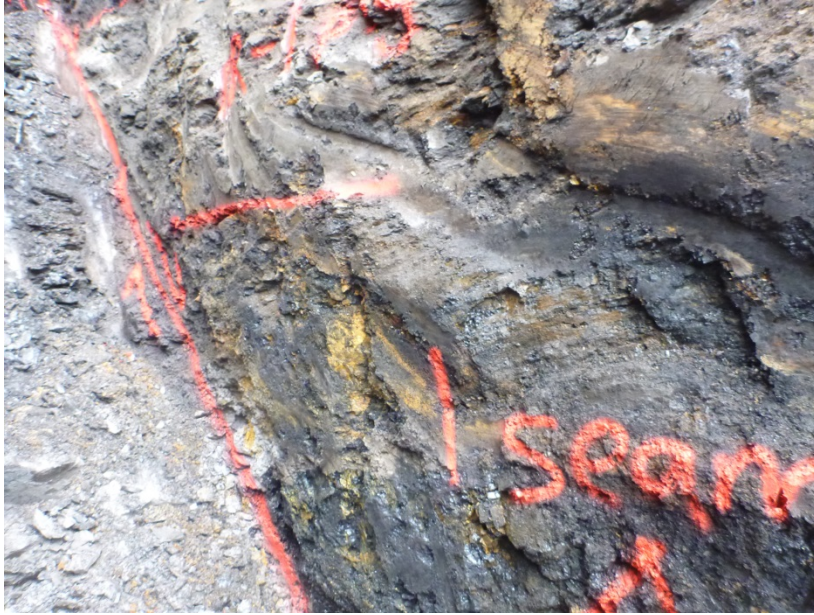
Figure 5: 1R-1 Parting overlying the 1 Seam

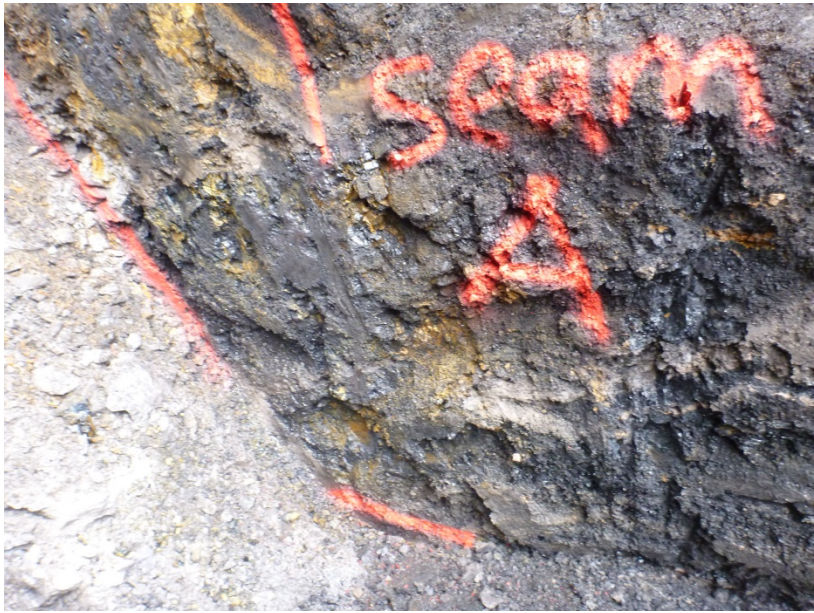
Figure 6: The top part of the 1 Seam, labelled 1 Seam A only for sampling purposes.

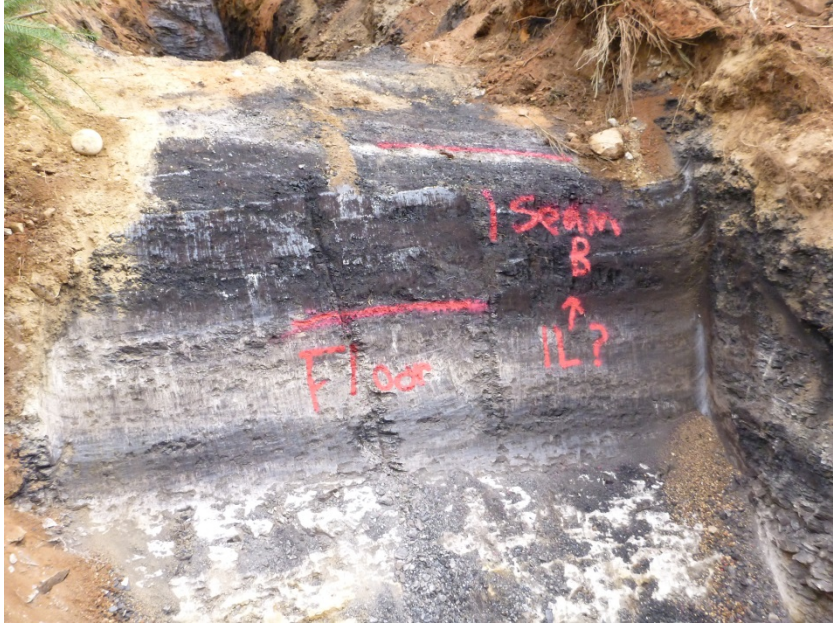
Figure 7: The bottom part of the 1 Seam, labelled 1 Seam B only for sampling purposes.

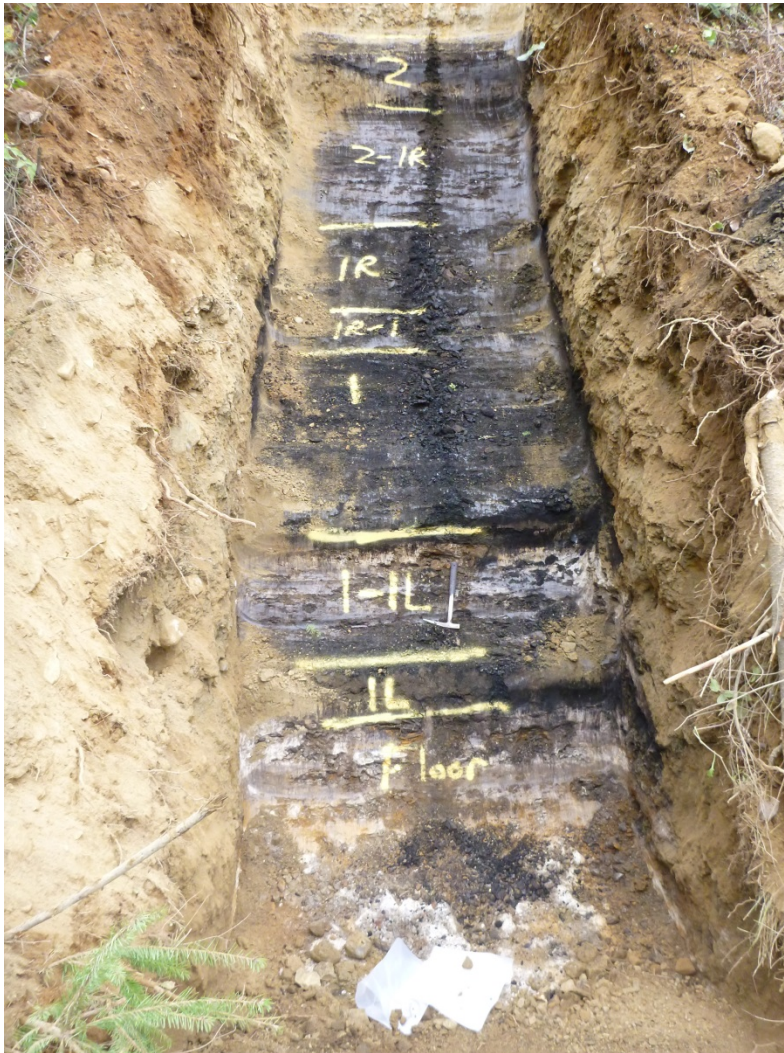
Figure 1: The entire coal zone

Following up on the positive results found in TR-5S-1, the seam was projected ~30m along the existing road and excavated to see if the seam stayed on strike. As shown in Figure 1, the coal seam was again exposed, albeit an overall thinner coal zone, but with comparable results.

As shown in Figure 1, the exposure is interpreted as a thinned #1 coal zone in close proximity of the #2 coal zone, however, due to the variable thicknesses, and the eroded exposure above the labeled #2 zone, I am unsure if the zone interpreted as the #2 coal zone is in fact the #2 seam, rather than the 1R seam, and the displayed 1R, 1R-1 parting and 1 seam, could in fact all be part of the #1 seam. Either way, the coal zone was sampled based on the variable unit breaks displayed in Figure 1, and the results are shown below. Taking into account quality data rather than thicknesses, it is observed that as the seams are labeled, 1R through to the 1L seam, the only two seams that don't compare well are the 1R and the 1R-1 parting.
