# **Pine Pass Coal Property**

## **2005 Exploration Assessment Report**

**BC Geological Survey  
Coal Assessment Report  
1043**

**Pine Pass Coal Property 2005 Exploration Assessment Report**

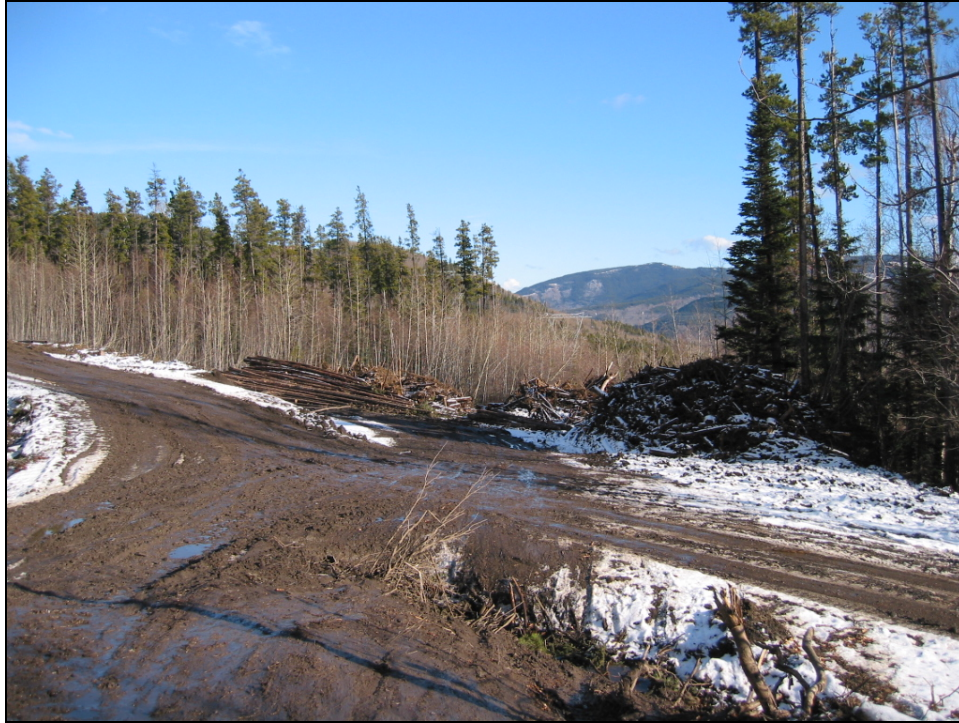
**Photo 1: Access to timber log deck areas**

Photos 1 and 2 show log decking of trees in preparation for hauling. Several stream crossings were existing in key areas, resulting in a limited number of crossings that needed to be constructed.

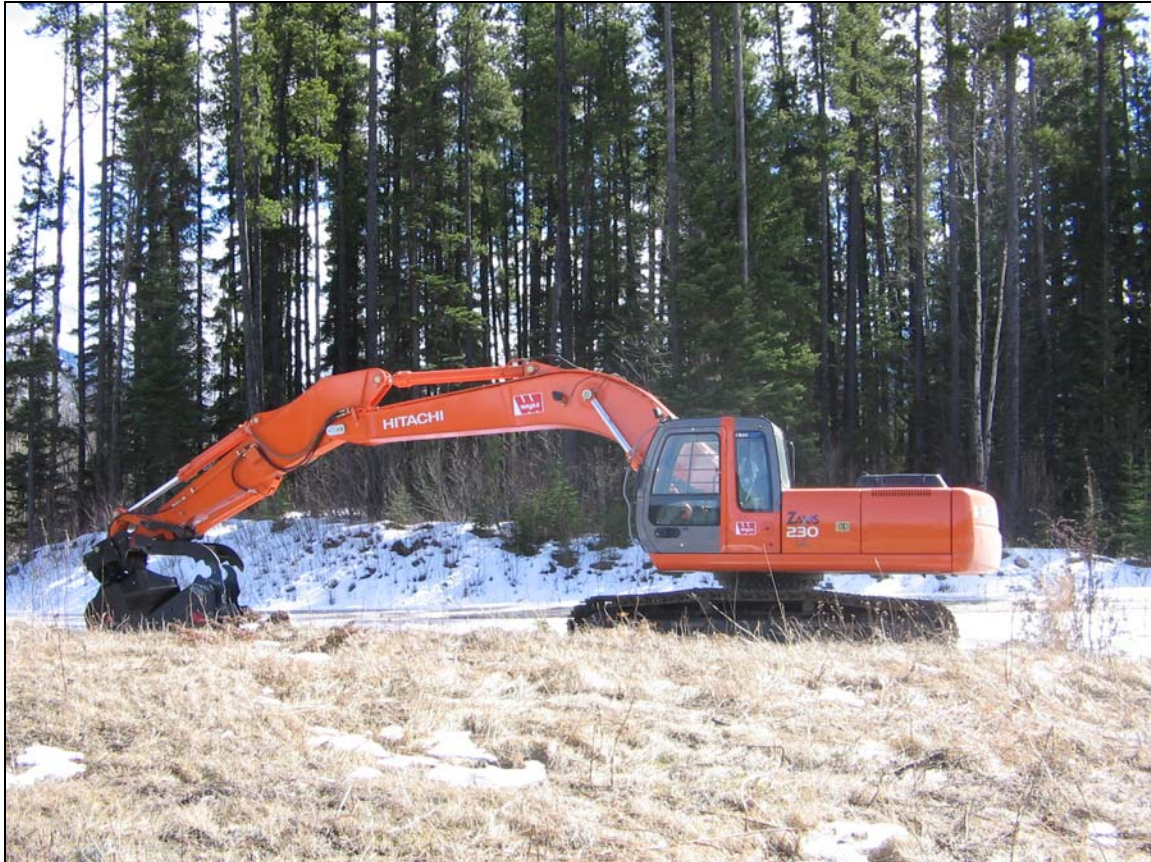
**Photo 3: Hitachi 230 excavator operated by Kearah & Weri Environmental Contracting Ltd.**

New accesses were built with the aid of Kearah & Weri Environmental Contracting Ltd. A 230 Hitachi Excavator (see Photo 3), and D65 Komatsu and D7 Caterpillar bulldozers were used for levelling roads and preparing the drill sites and sumps. See Photo 4, which shows drill pad construction and road building. Dunne-Za Ventures LP, of Moberley Lake, B.C. were also contracted for skidder, water trucks and logging services.

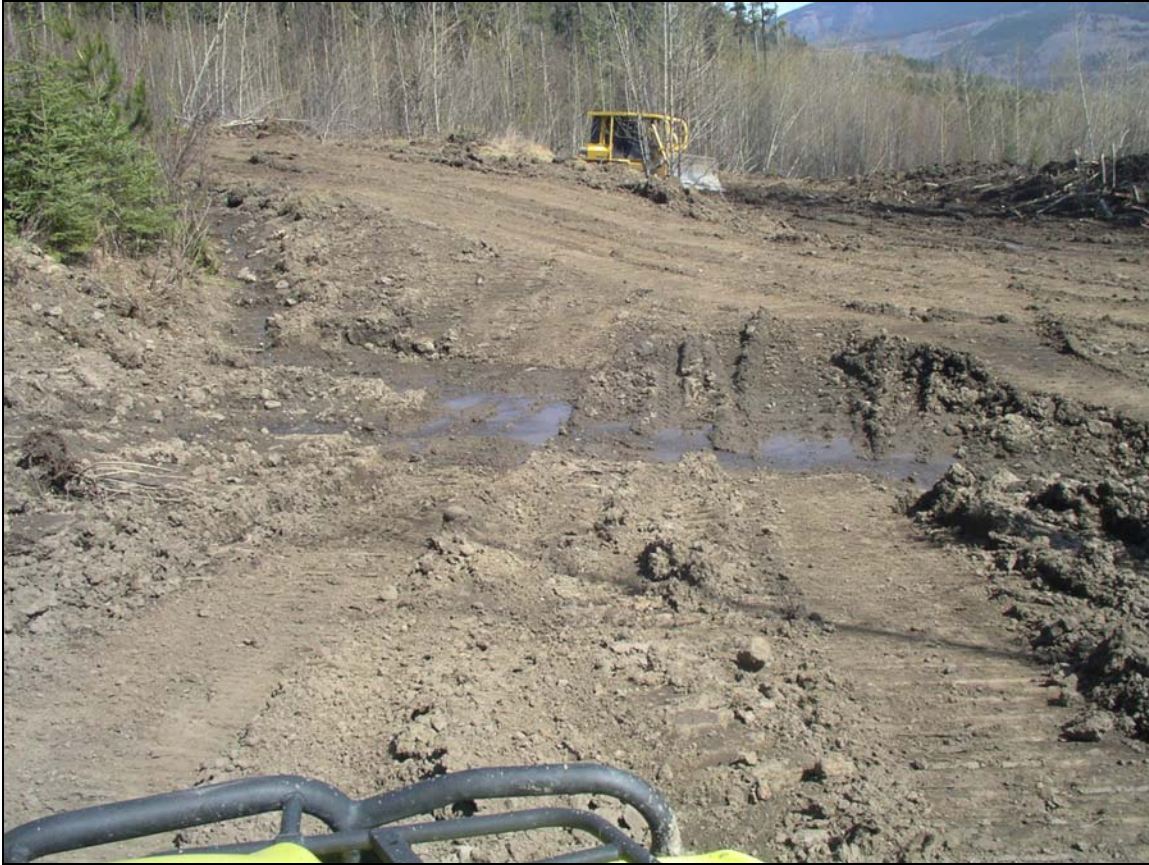
**Photo 4: Road and Drill Pad Construction**

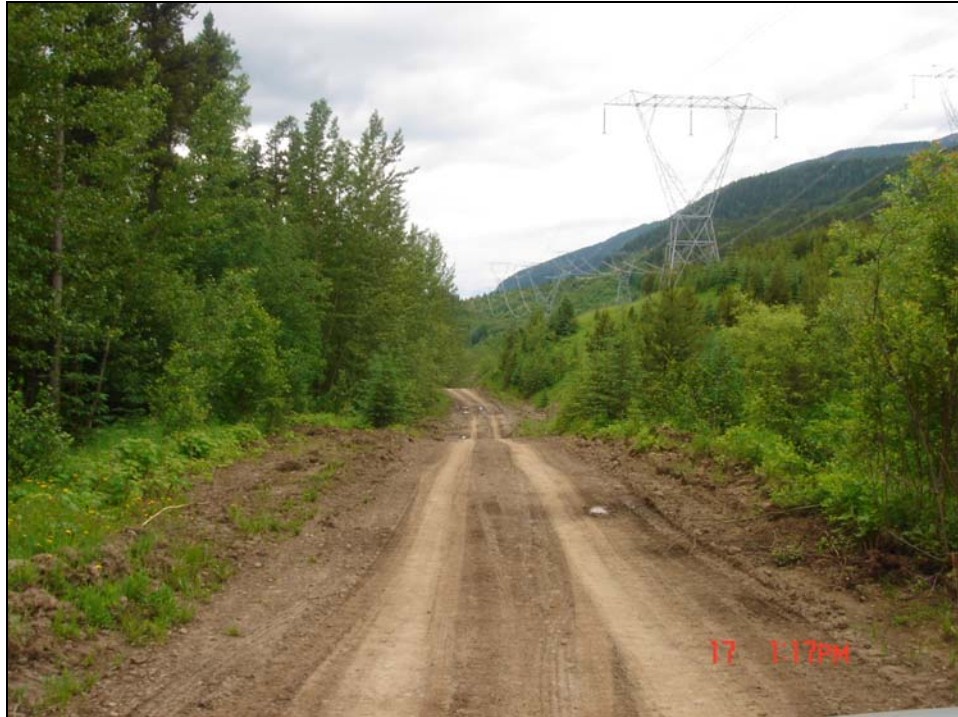
**Photo 5: Example of pre-existing access (very wide) that was re-opened.  
Note the utilized width was kept to a minimum.**

In many cases, it was noted that the existing trails were a bit wider than the standard 5 m common in the industry. Where these trails were re-opened, ResourceEye made every attempt to keep the new disturbance to a 5 m maximum.

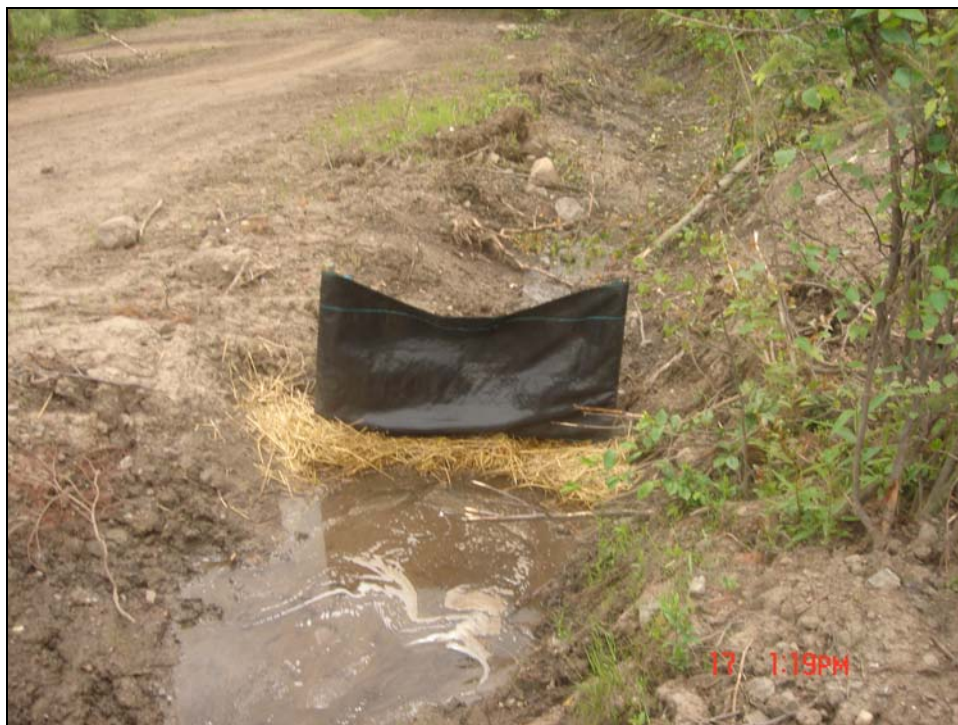
**Photo 6: Example of erosion control for roads**

Photo 6 displays an example of typical erosion / sedimentation control measures used on site.

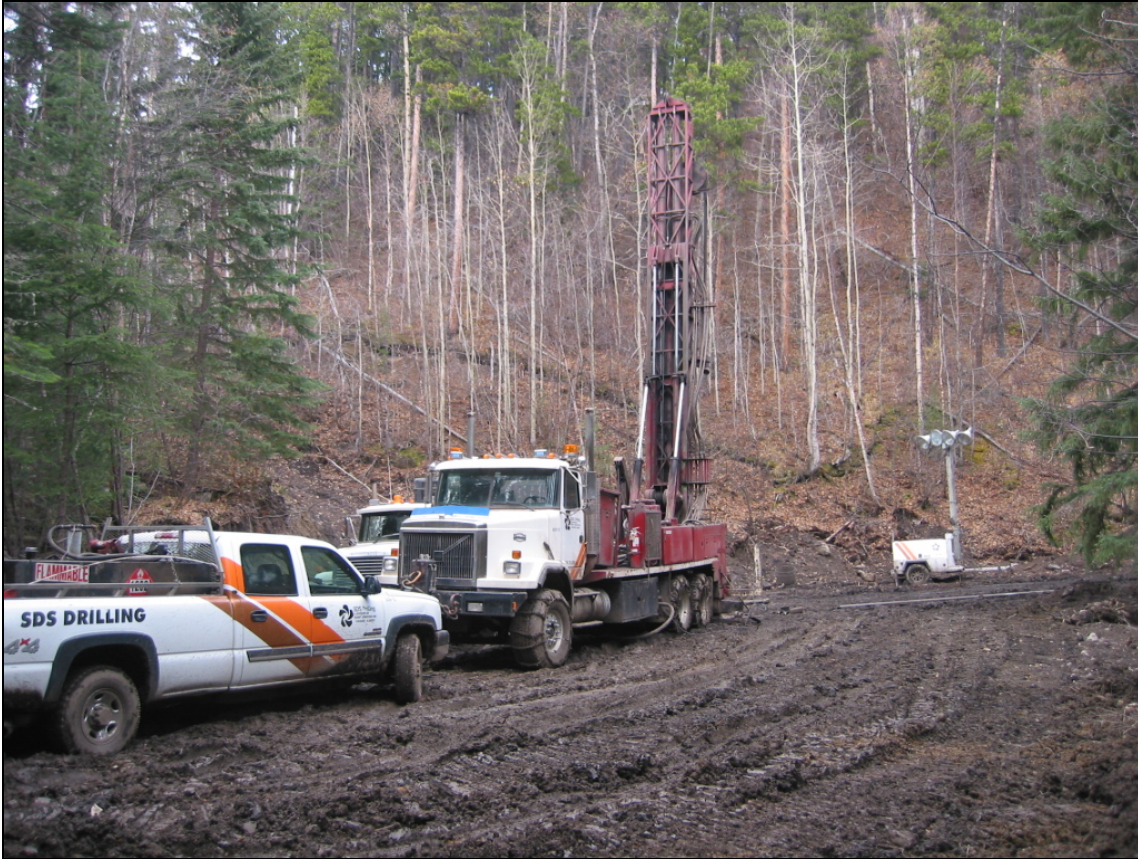
**Photo 7: Rotary drilling rig operated by SDS Drilling Inc.**

A two phase program concentrated on drilling on 300 m sections in the initial phase, with 150 m section line infilling during phase 2. Photo 7 shows an SDS rotary drill rig.

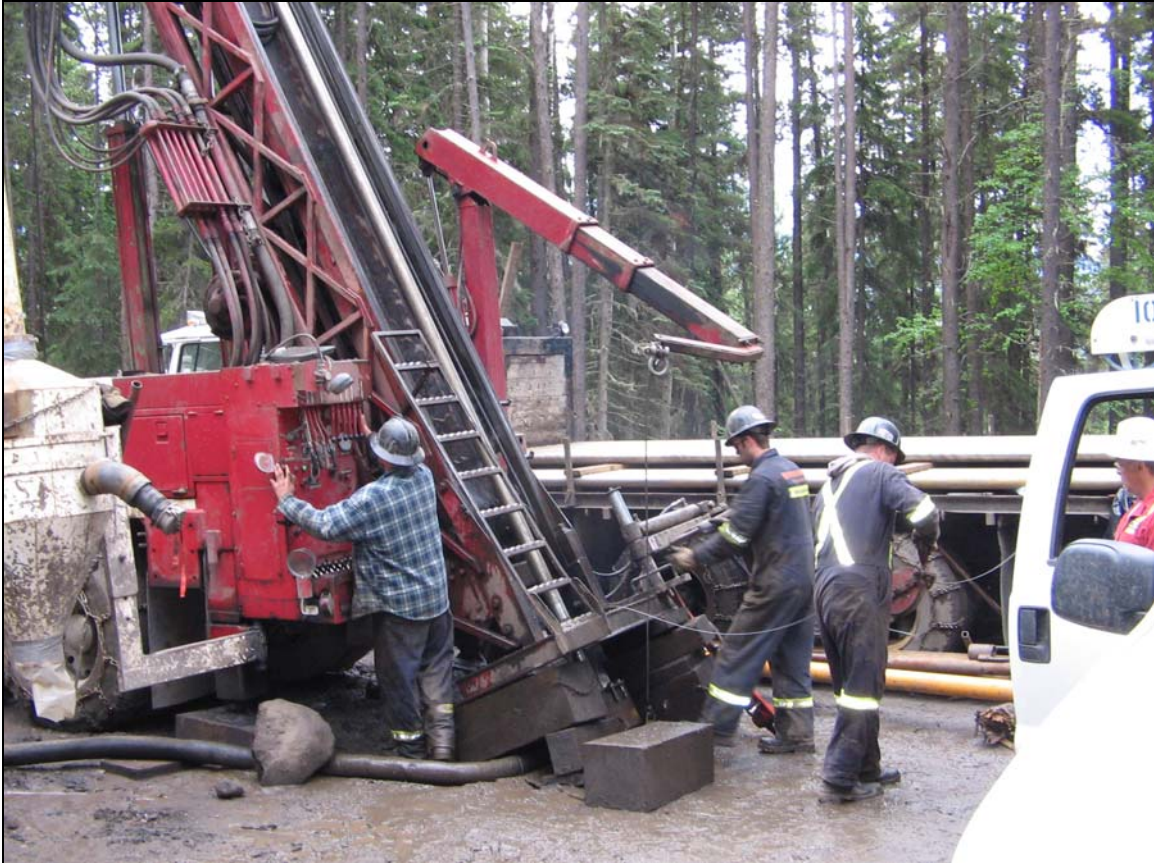
**Photo 8: SDS drill crew drilling angle hole**

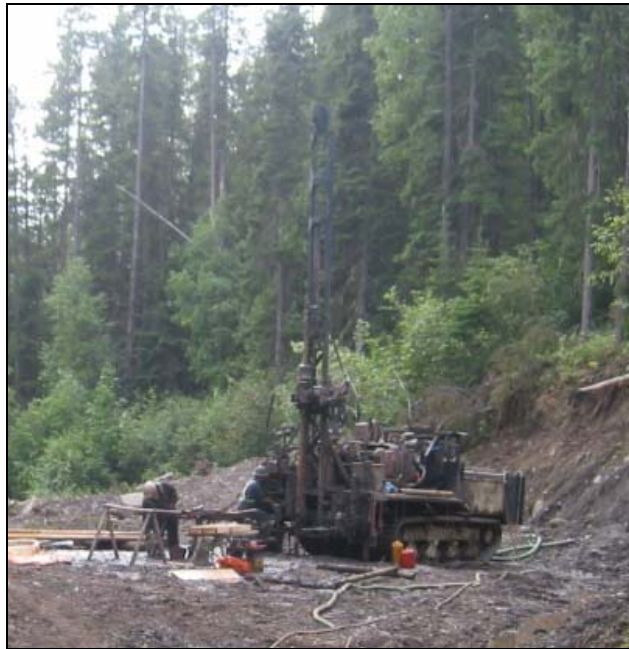
**Photo 9: GeoTech Ltd coring rig**

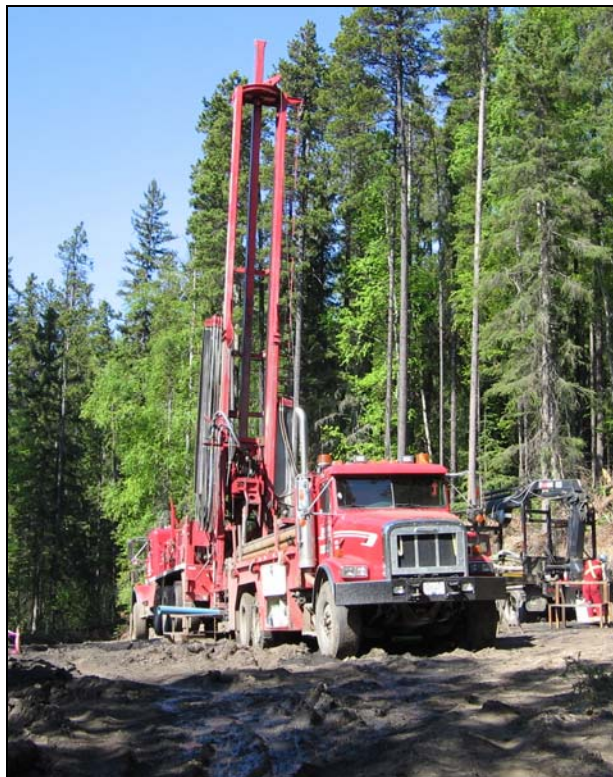
**Photo 10: Anderson drilling rig on site**

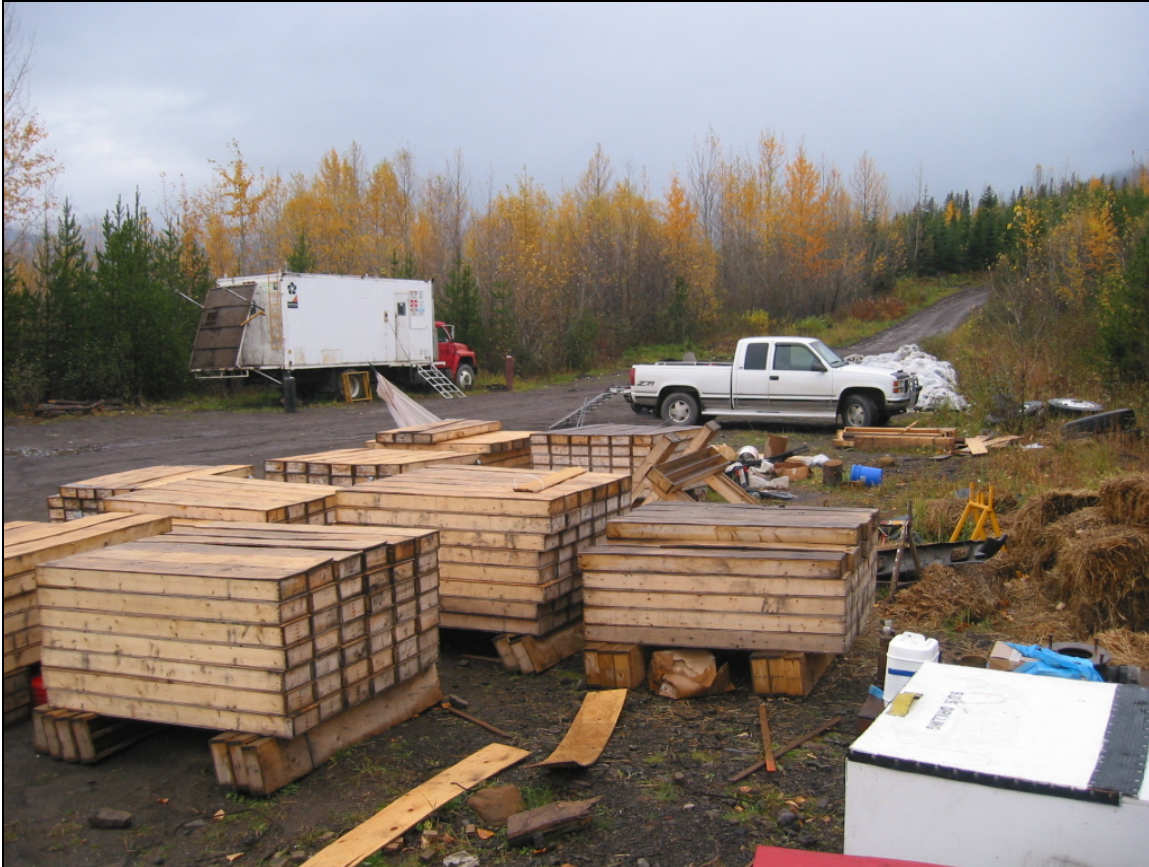
**Photo 11: Stacked boxes of core**

All core recovered was 3" in diameter and was stored in boxes for transportation to the core logging area. See Photo 11, which shows stacked boxes of core. On final completion of field work, the boxed core was moved to a specially constructed storage bin at the Willow Creek Minesite.

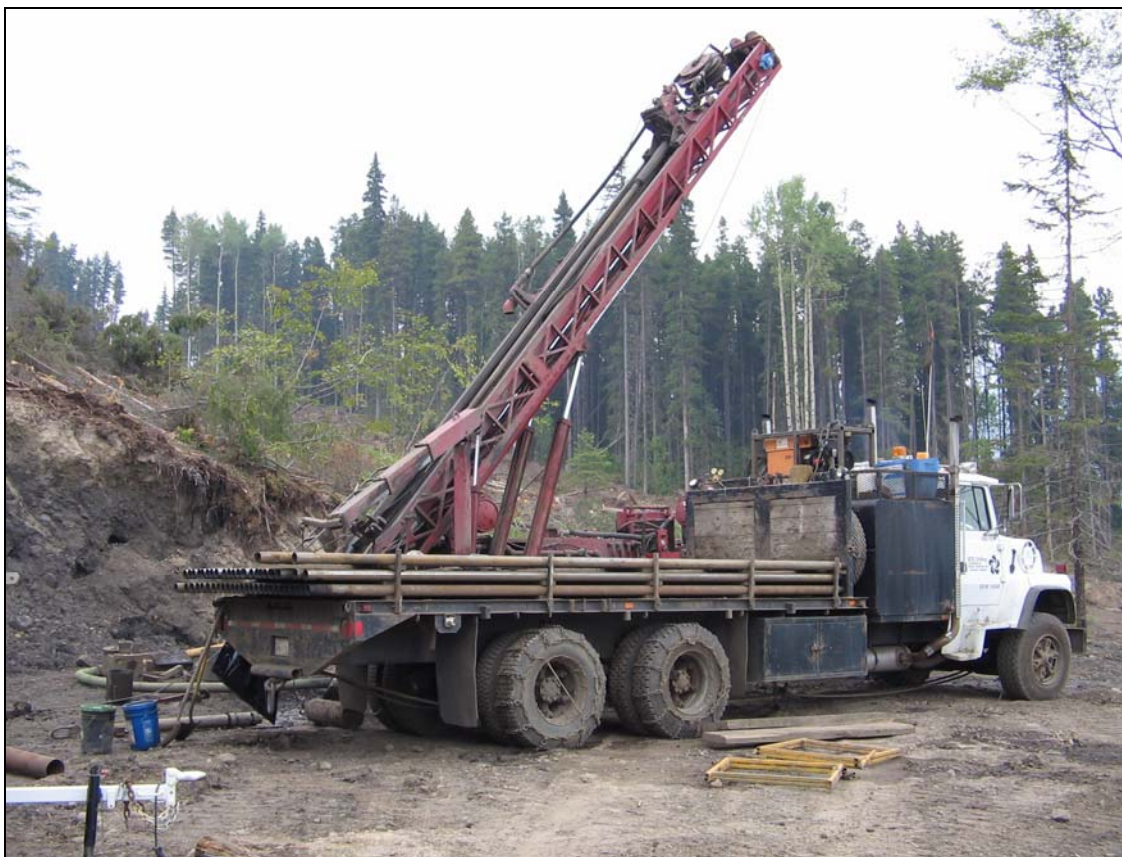
**Photo 12: SDS drilling rig set up on angle hole**

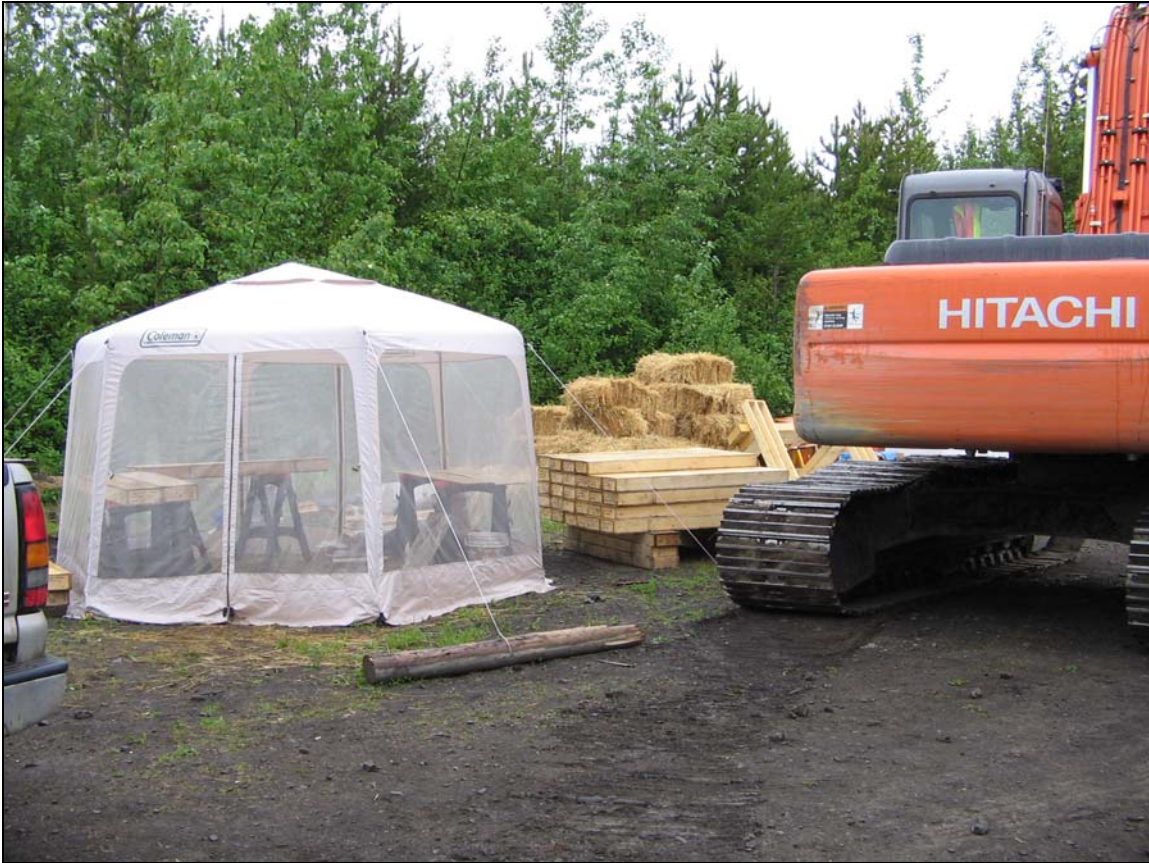
**Photo 13: Core logging tent**

Once the core was received at the core logging tent, shown in Photo 13, the boxes were photographed.

After the boxes of core were photographed, the core was logged for geological parameters including rock type, sedimentology and structural features and measurements, and geotechnical parameters including Rock Quality Designation (RQD%), core recovery, and core quality.

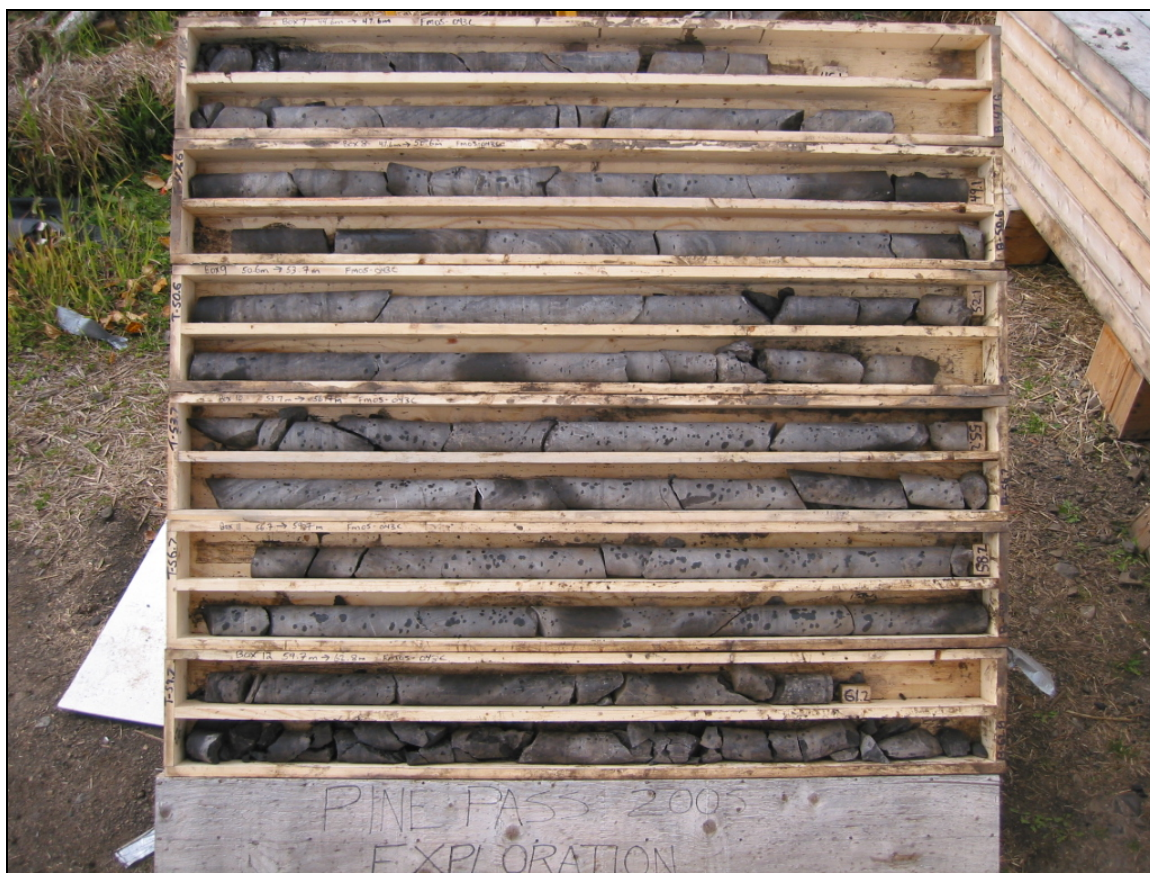
Photo 14: Example of drill core photography

Geological Core Log Reports and Geotechnical Core Log Reports are located in Appendix 2d and 2e respectively. Core photographs are found in Appendix 2c. A sample is presented in Photo 14.

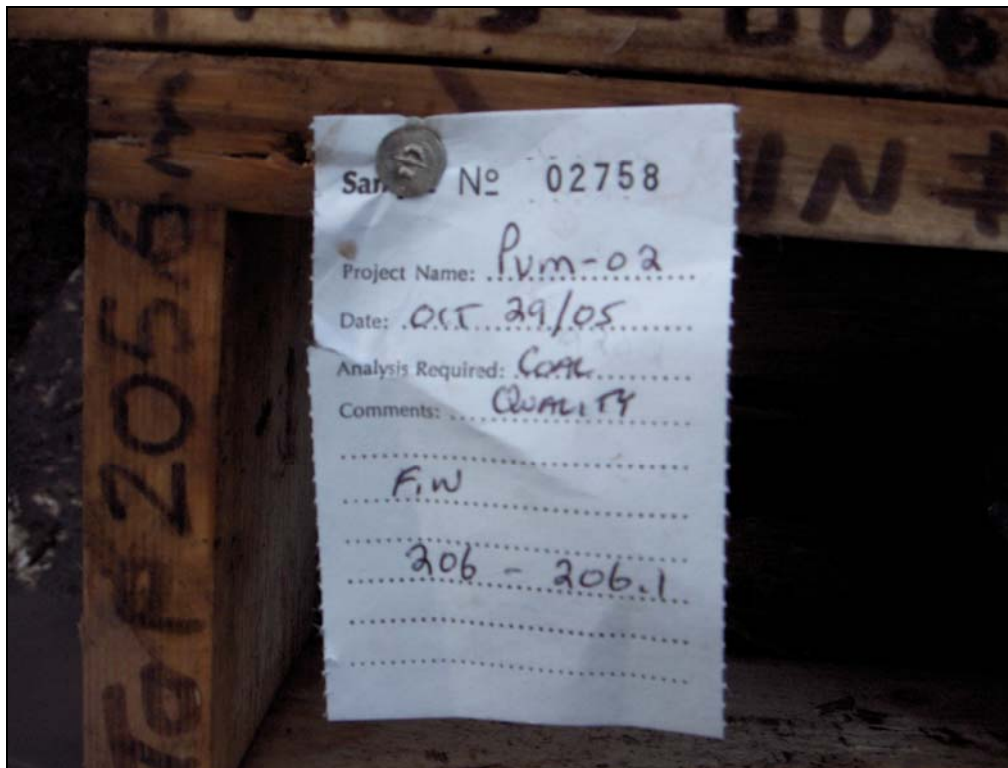
Photo 15: Core sampling tag attached to core box

Once marked for sampling, the sample tags are laid out on the core and photographed, as shown in Photos 15-18, below.

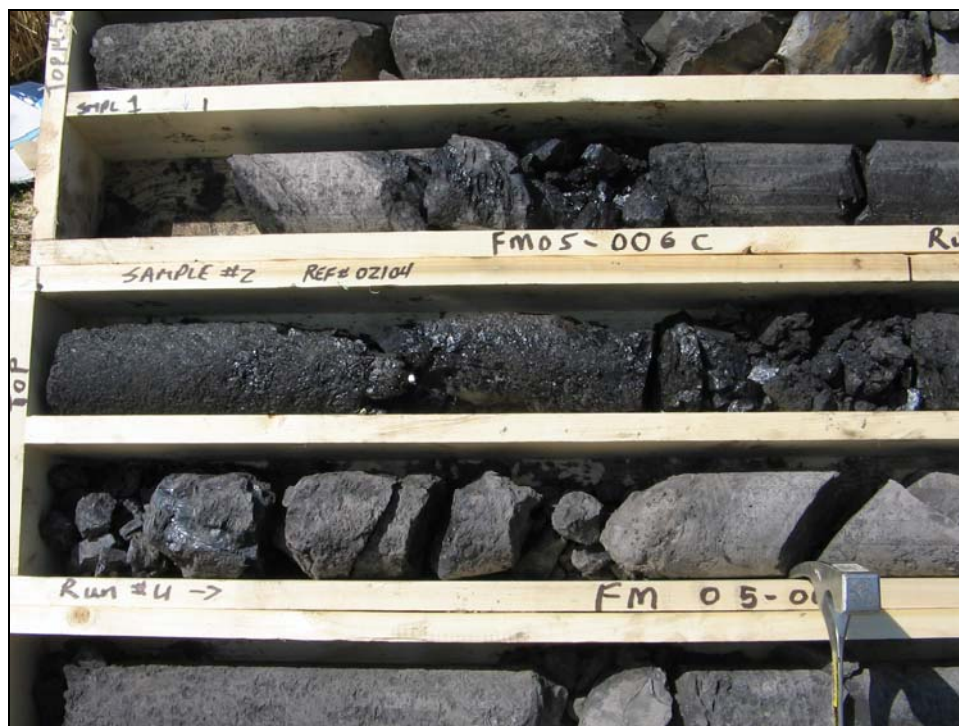
Photo 16: Core box with coal sample marked for removal

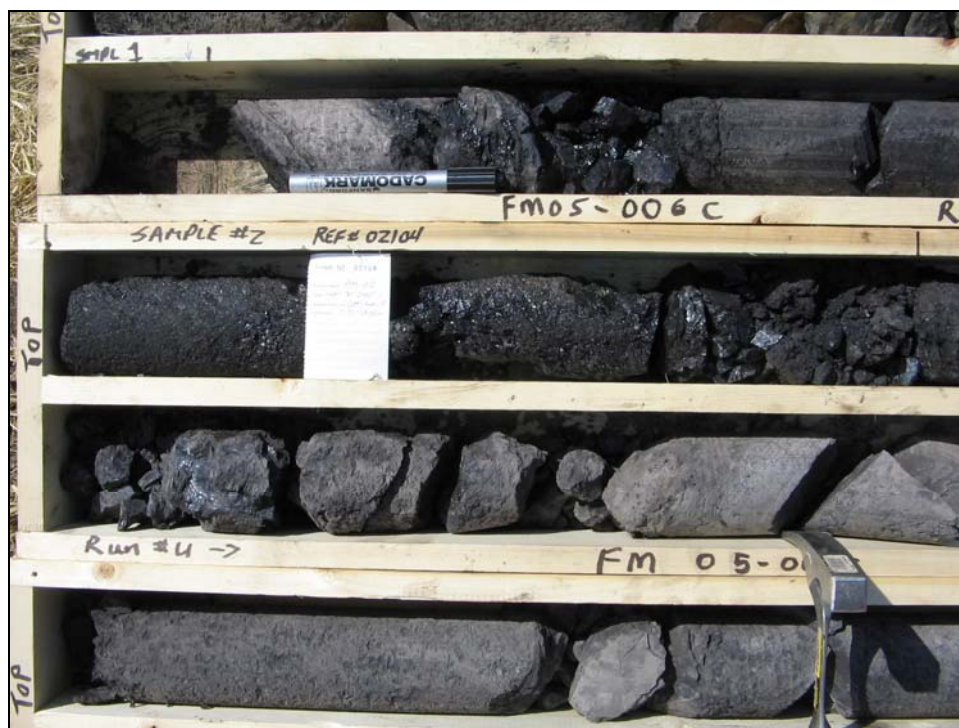
Photo 17: Core box showing core sample with sample tag attached

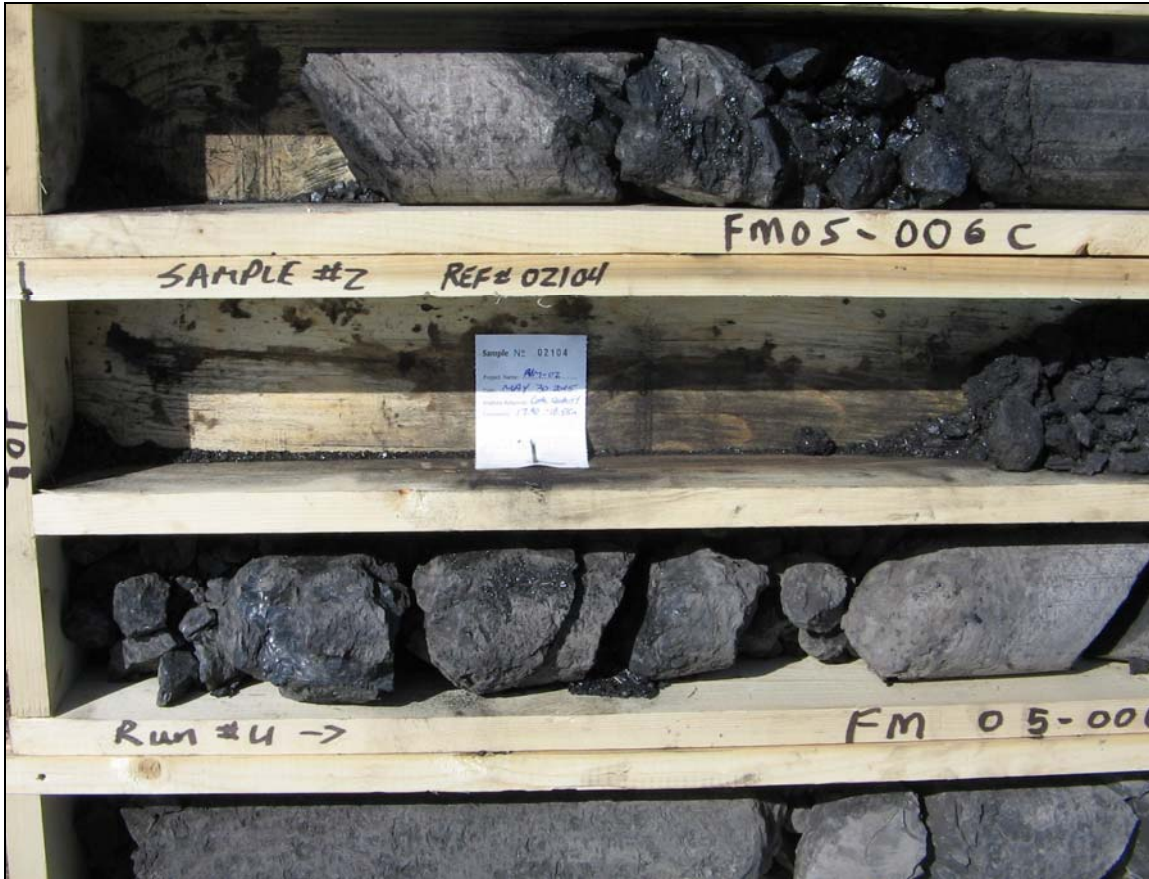
**Photo 18: Core box with coal sample removed and sample tag affixed to the core box**

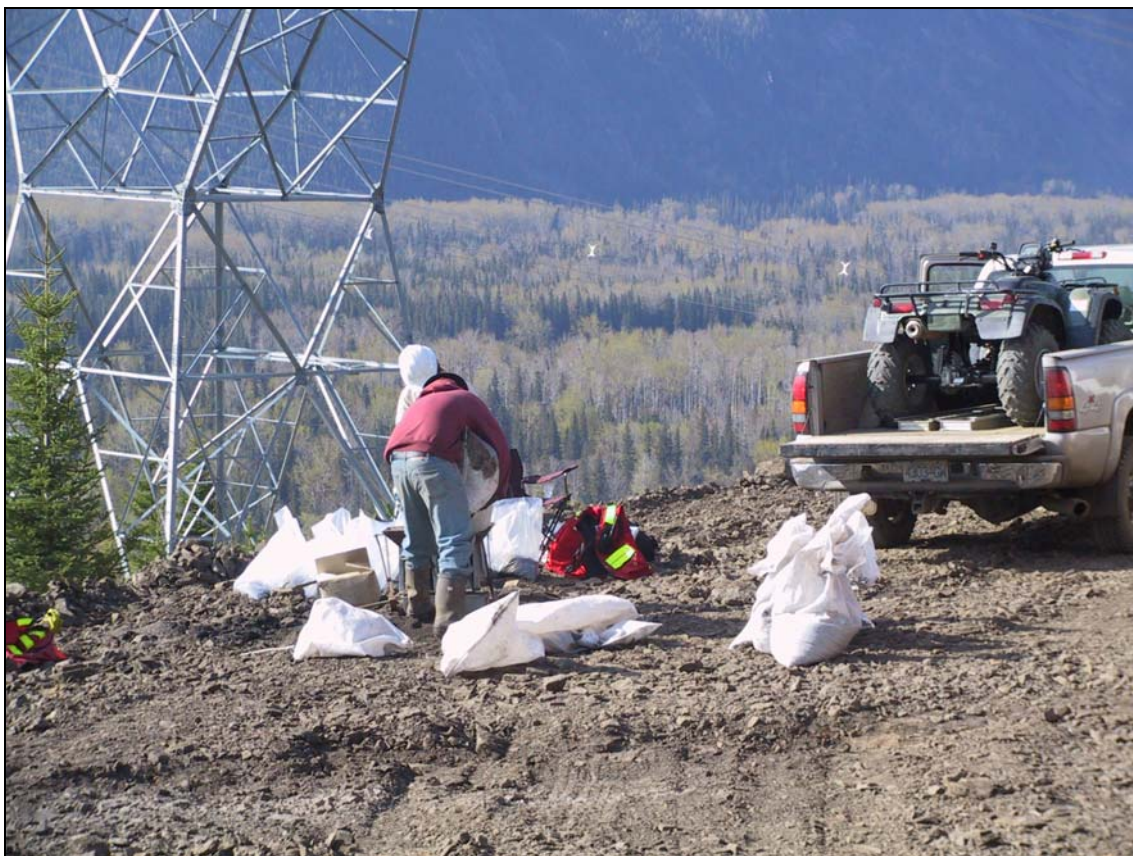
**Photo 19: ResourceEye personnel splitting, bagging and tagging ARD samples**

ARD sampling was undertaken in select holes and obtained samples every metre during drilling, where recovery allowed. These samples were stacked on pallets, shrink wrapped and are stored at the Willow Creek Plant Site.

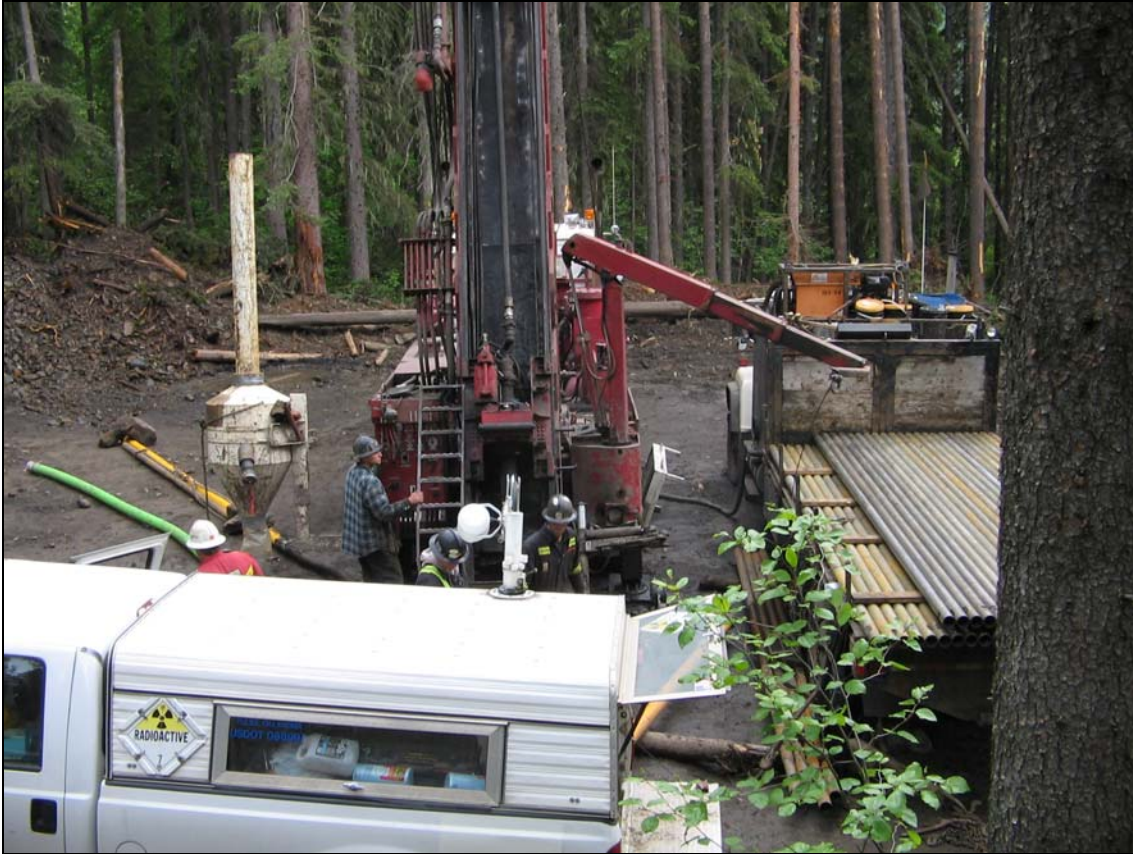
**Photo 20: Geophysical logging being performed on site by Century Geophysical**

Upon completion of each drillhole, Century Geophysical Ltd of Tulsa, Oklahoma, performed geophysical logging of the hole while the drill rig was still on the hole. See Photo 20 of geophysical logging in progress.

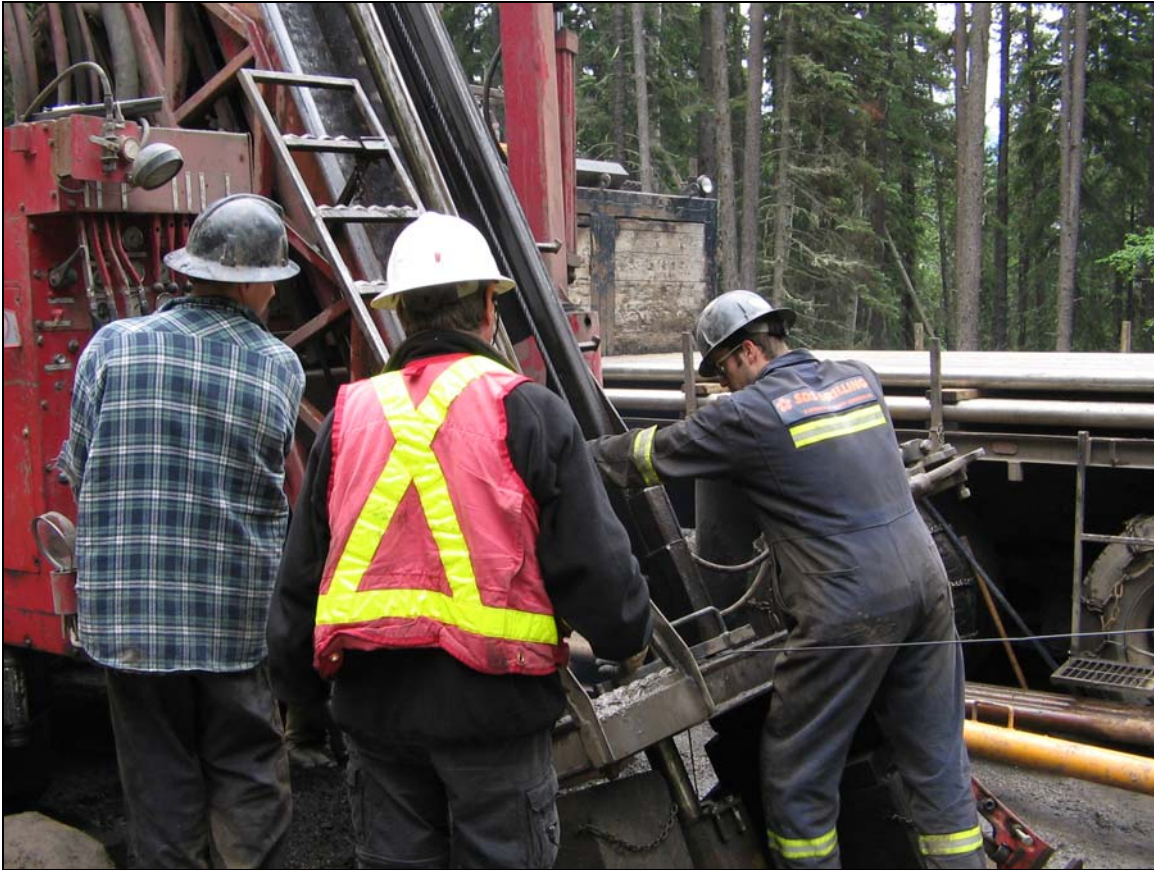
**Photo 21: Geophysical logging tool being retrieved by Weatherford Inc. of Grande Prairie**

Geophysical logging was completed on 87 of the 91 drillholes. At one point during the program, Weatherford Inc. of Grande Prairie, had to be called out to retrieve the tool, after it became stuck in hole FM05-012. See Photo 21.

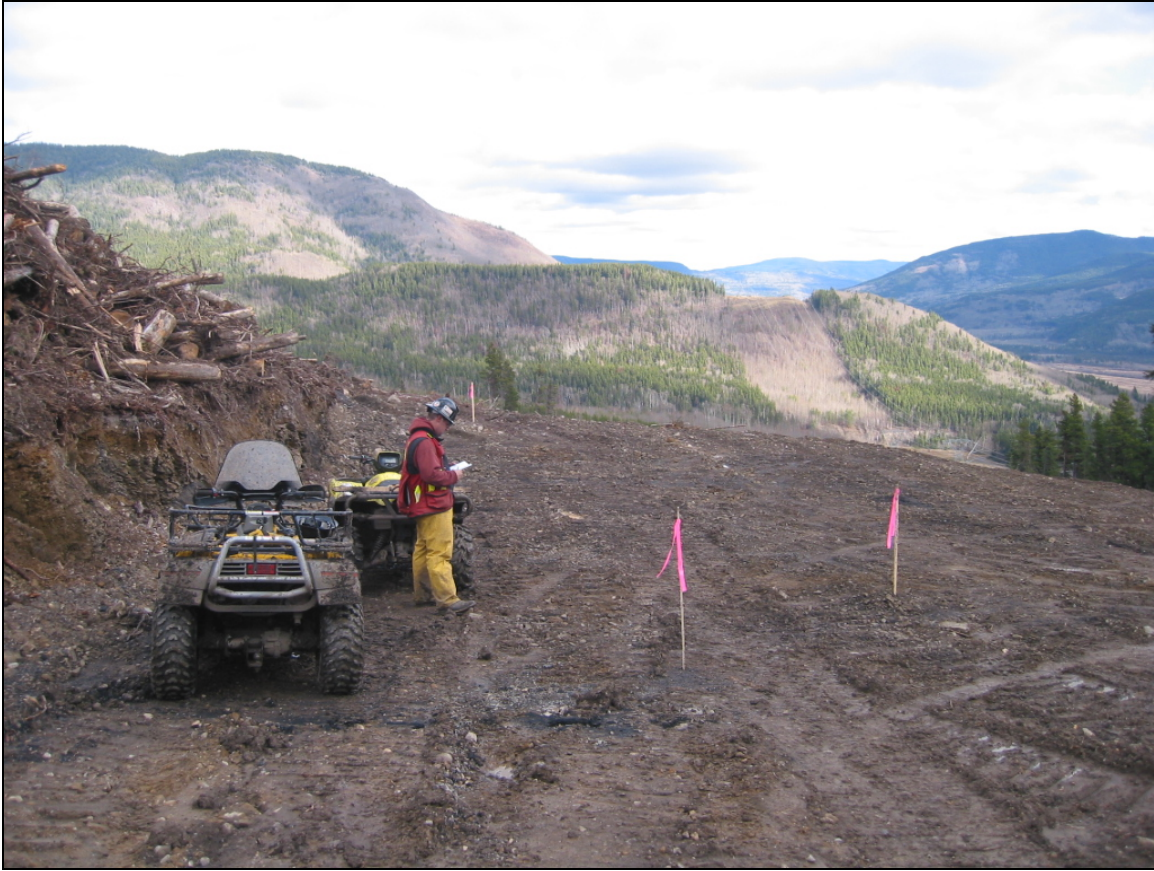
**Photo 22: ResourceEye personnel GPS surveying**

A GEOExplorer GPS unit was used to survey and layout all holes. See Photo 22 which shows ResourceEye personnel surveying.

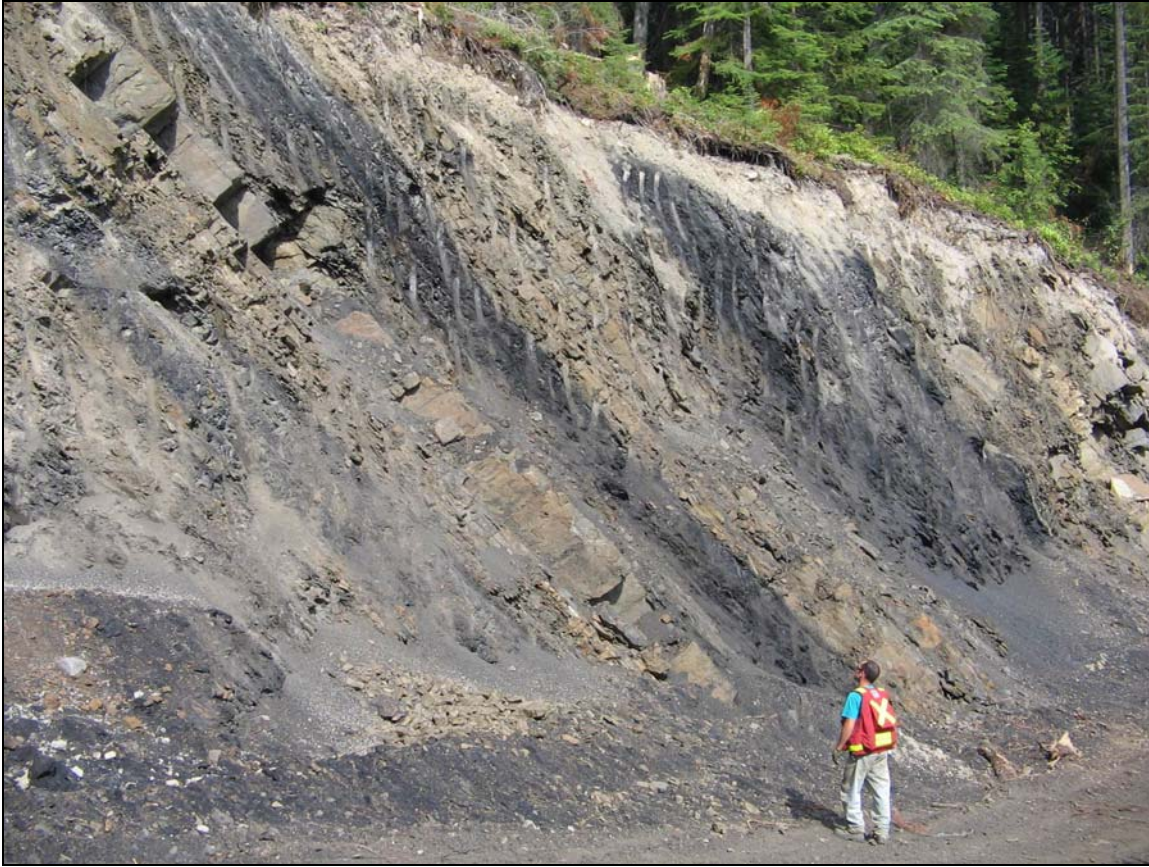
**Photo 24: Mapping outcrop of coal seams exposed at drill site**

See Photo 24 which shows outcrop mapping.

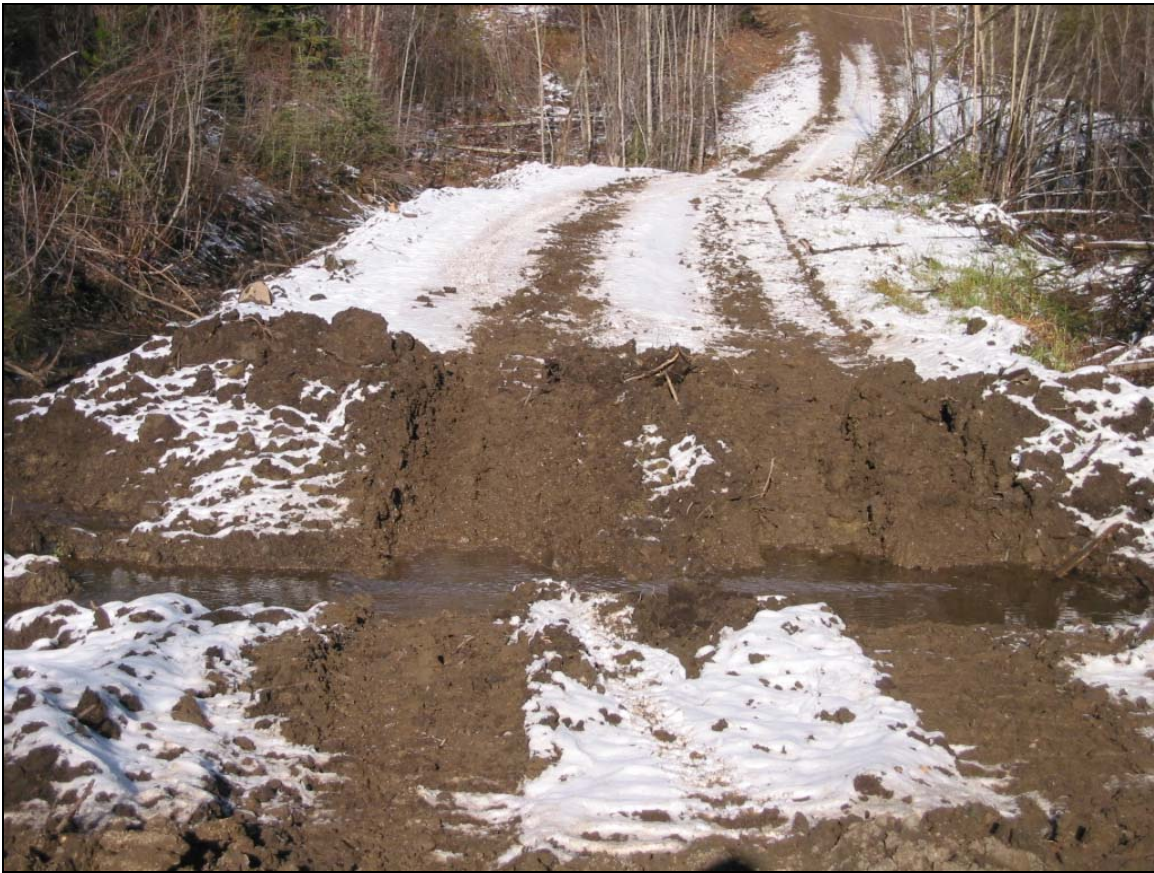
**Photo 25: Cross ditching for road deactivation**

Photos 25-27 below demonstrate cross-ditching and reclamation on a decommissioned road.

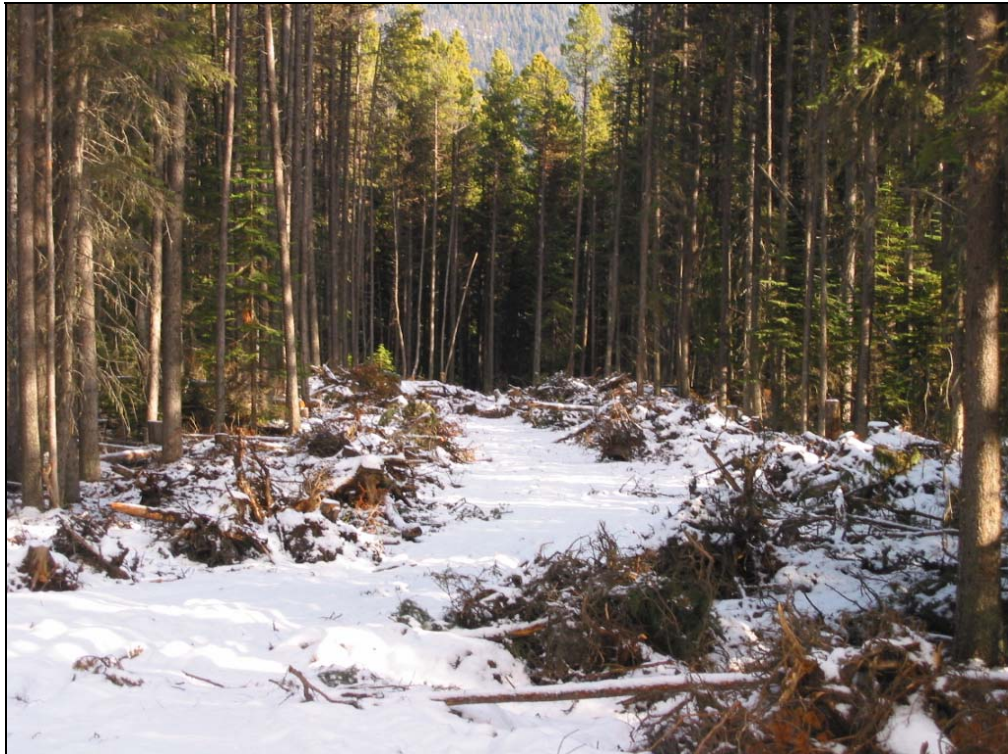
**Photo 26: Reclaimed trail access showing roll backs**
