# **Pine Pass Coal Property**

## **2005 Exploration Assessment Report**

**BC Geological Survey  
Coal Assessment Report  
1043**

**Pine Pass Coal Property 2005 Exploration Assessment Report**

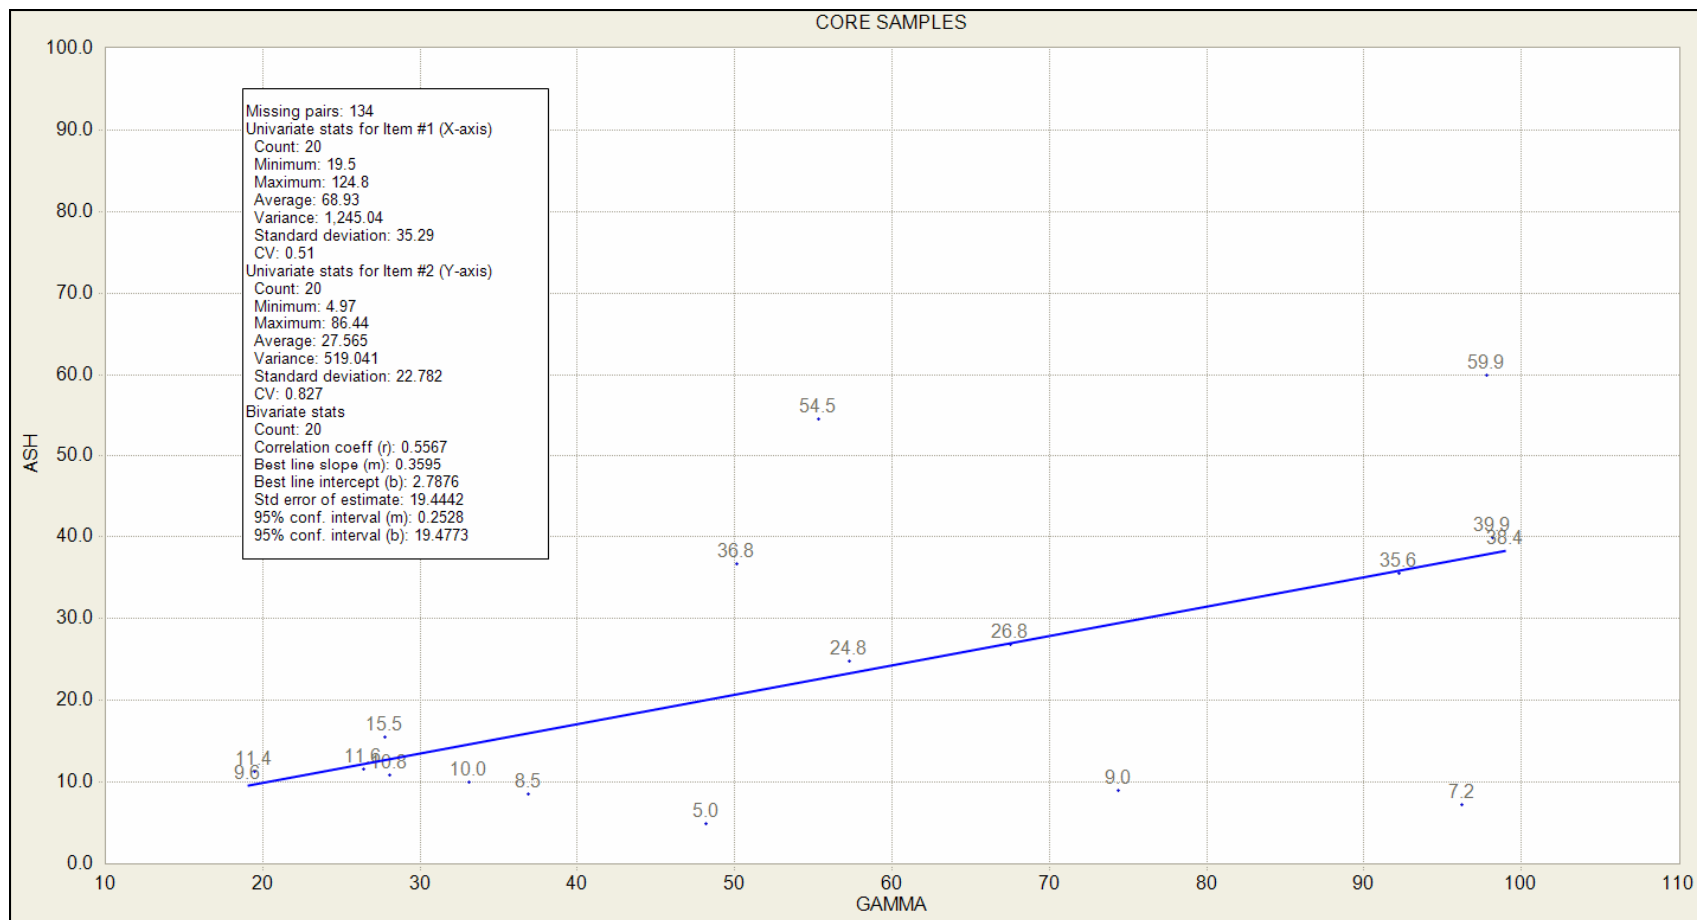
Graph 1: Scatterplot of gamma value vs ash content for CORE samples

Graphs 1-4 are scatterplots and statistics which illustrate the correlation between the gamma and ash values for core and rotary samples, as well as all samples together.

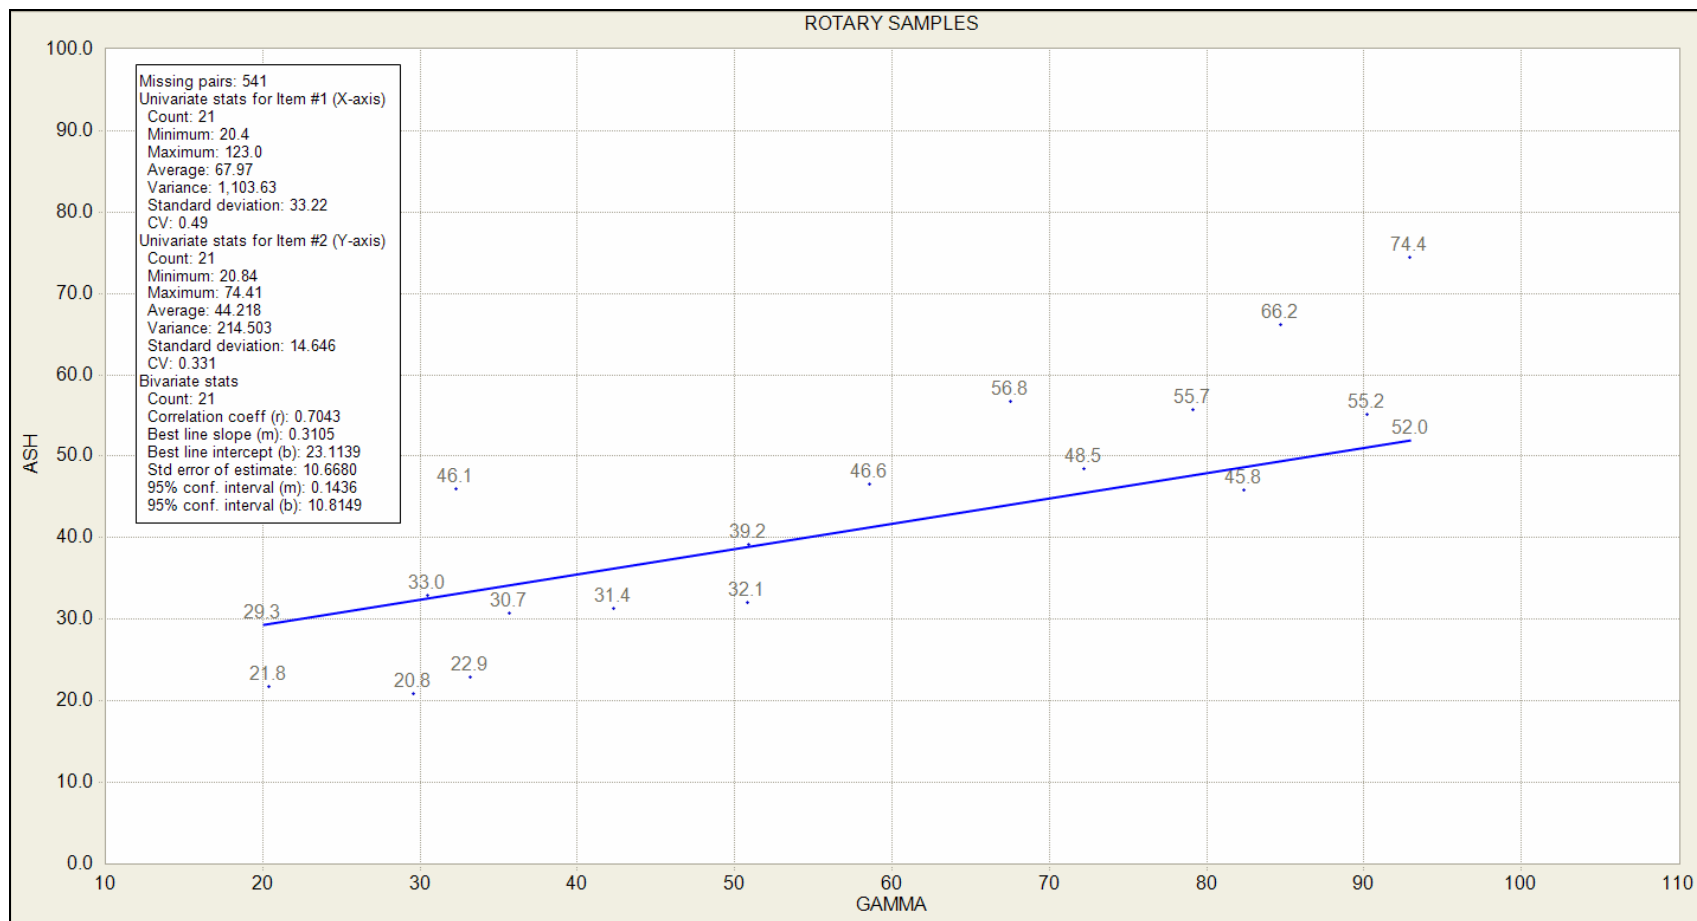
Graph 2: Scatterplot of gamma values vs ash content for ROTARY samples

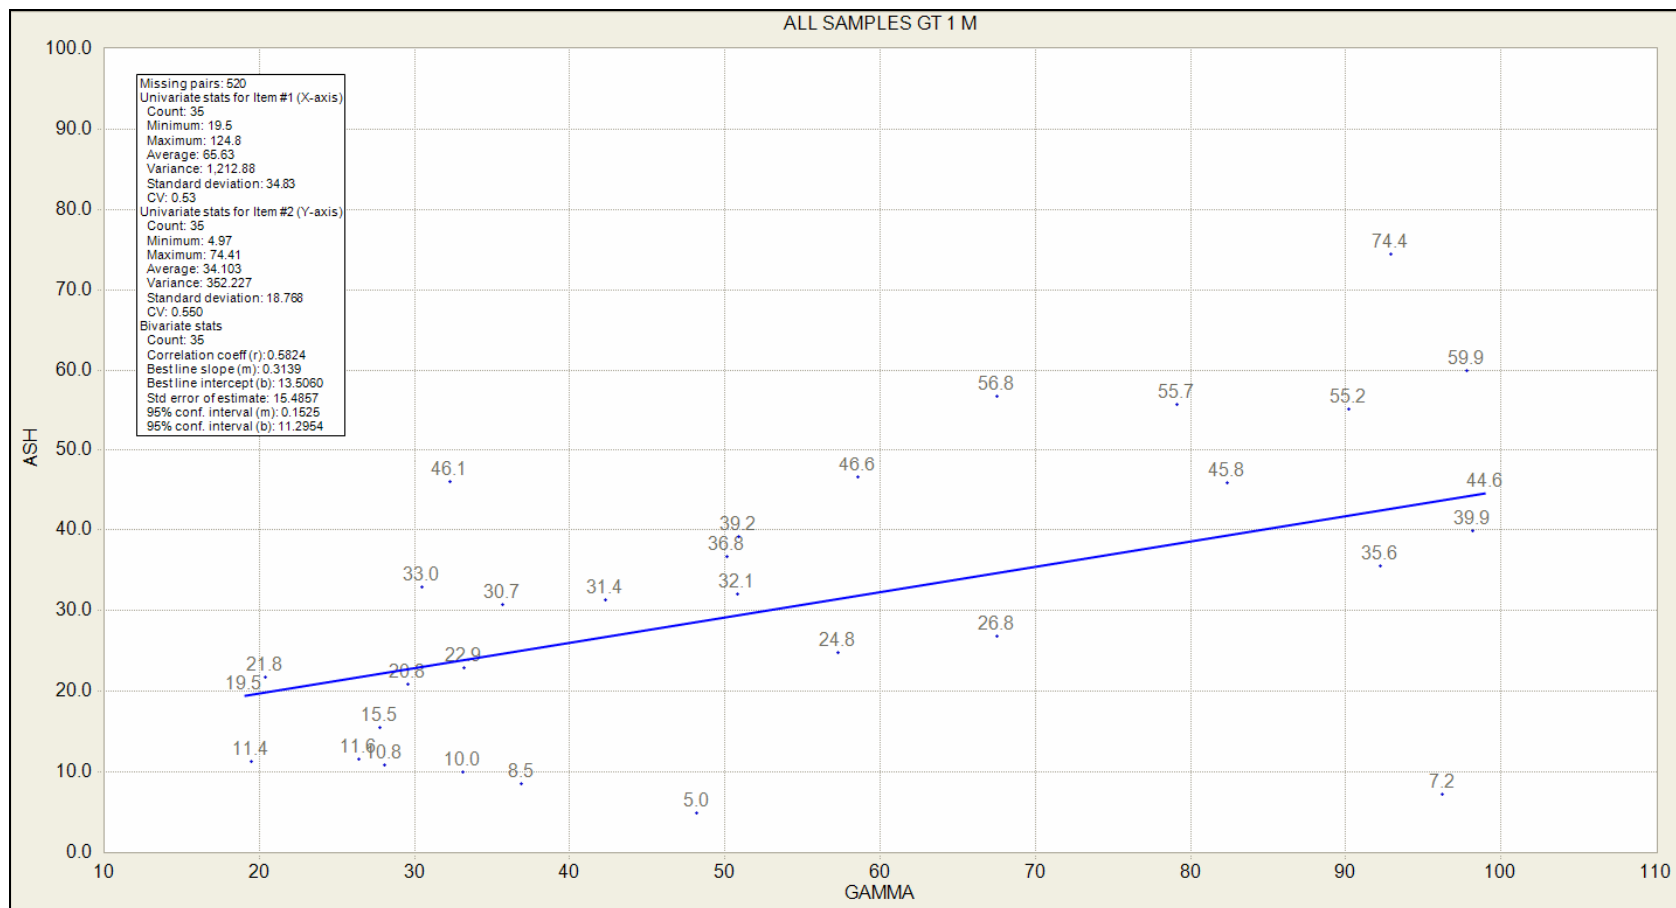
Graph 4: Scatterplot of gamma value vs ash content for all samples greater than 1 m intersected thickness.

From these observations, it would appear that the best correlation is where samples are considered together ( $R^2=0.54$ ). This led us to the calculation of a new item, know as GASH (Gamma Predicted Ash) value, which served as an estimate of the likely ash content from seams where no coal quality is available. This method requires some fine tuning, as the data shows that it tends to overestimate the ash content from lower gamma seams less than 35% ash, and underestimate the ash content for seams greater than 35% ash. See Graph 5.

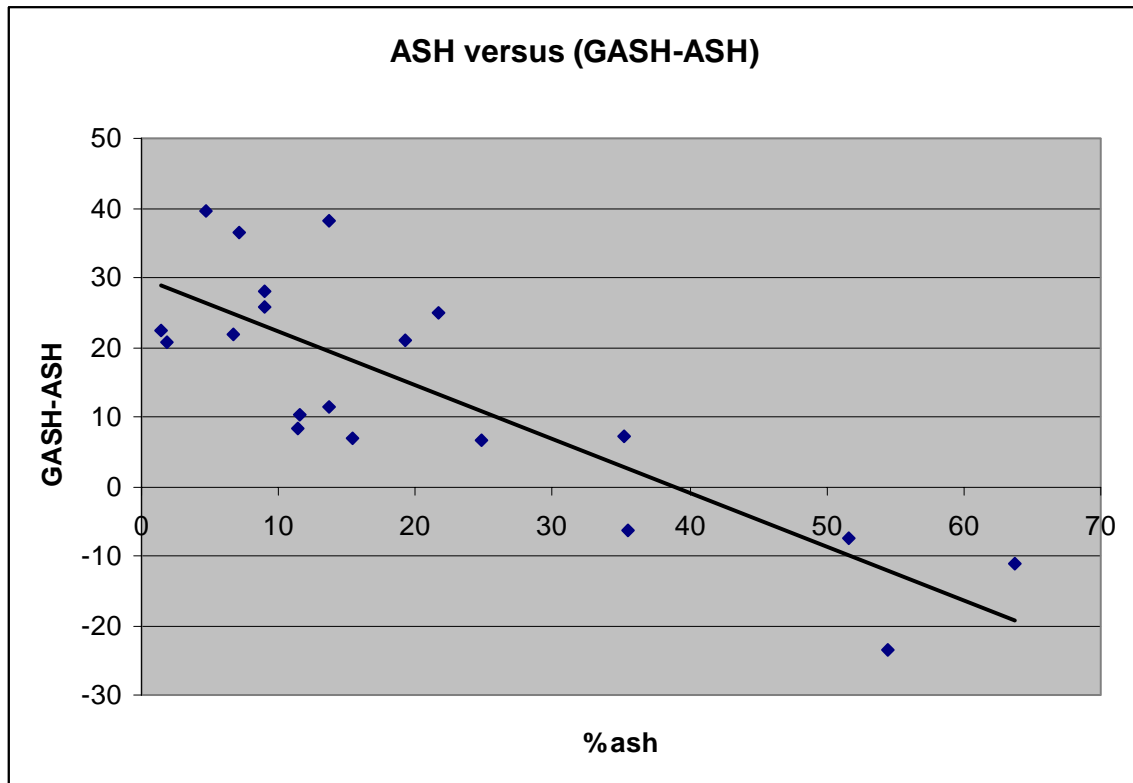
Graph 5: Cross plot showing difference between the gamma predicted (GASH) and actual ash as a function of ash content from composite data.
