STRATIGRAPHY OF THE PLACERS  
IN THE  
ATLIN PLACER MINING CAMP, B.C.

BRITISH COLUMBIA MINISTRY OF MINES  
AND PETROLEUM RESOURCES

1976

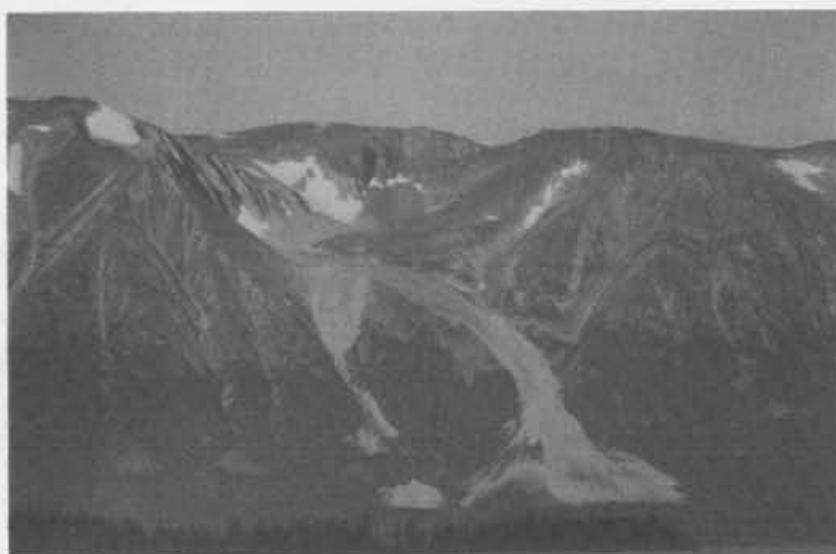
Figure 2

Telephoto (135 mm) of rock glacier on eastern flank of Atlin Mtn. Debris spalls from cliffs at upper left onto the glacier, which has an ice core.  
Photo: W. Proudlock, Aug. 25/76.

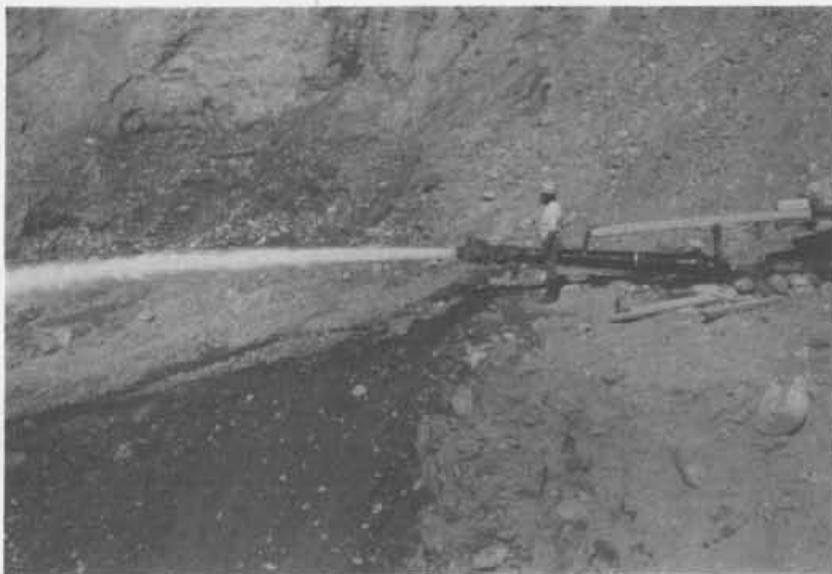
Figure 5

John Harvey operating monitor on his claim on McKee Ck. Looking at north bank. Force of water helps to break up the clays and free the gold from the gravels.  
Photo: P. Proudlock, Aug. 6/76.

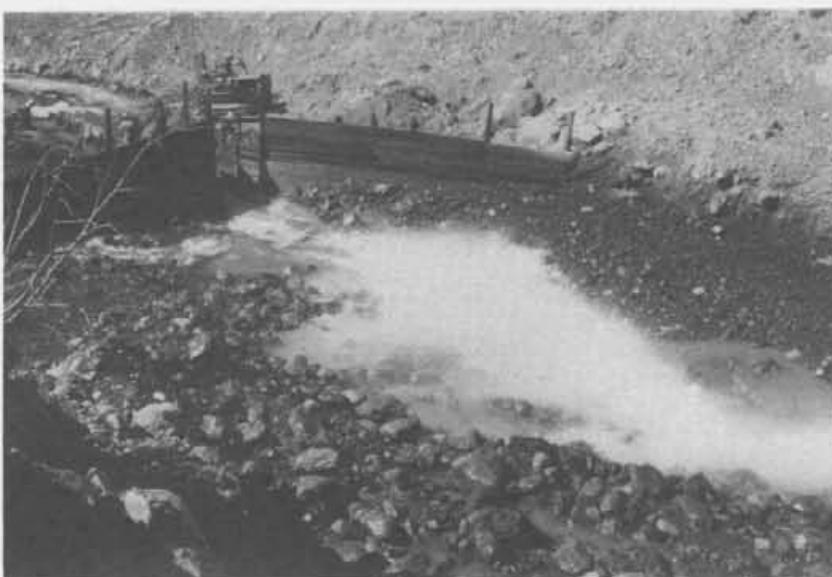
Figure 6

View of Harvey's monitor pit, with sluice box and wings at upper left. Gravels are pushed into the pit with a cat.  
Photo: P. Proudlock, Aug. 6/76.

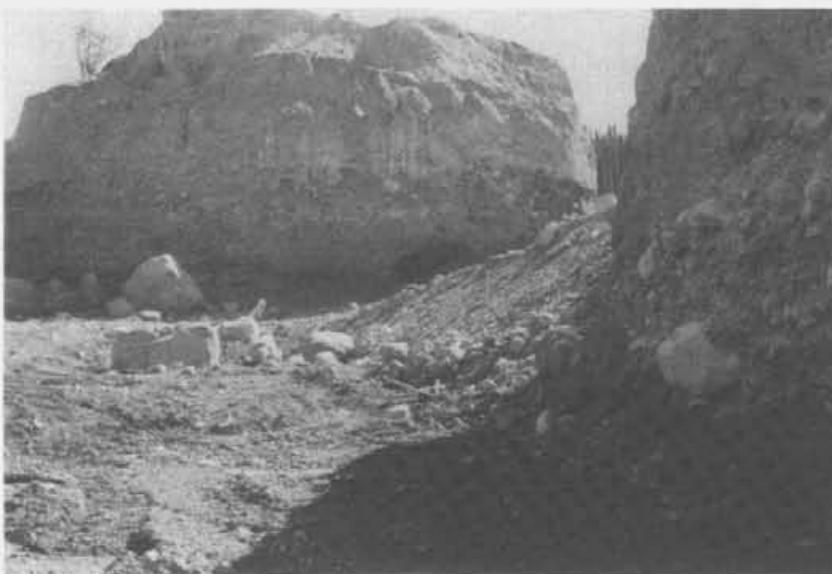
Figure 7

Looking upstream on McKee Ck.; cut bank shows good section. Gravels were stripped and then pushed by cat into the monitor pit, from where they are washed into the sluice box. About 2 to 4 feet of bedrock is also removed for sluicing.  
Photo: P. Proudlock, Aug. 6/76.

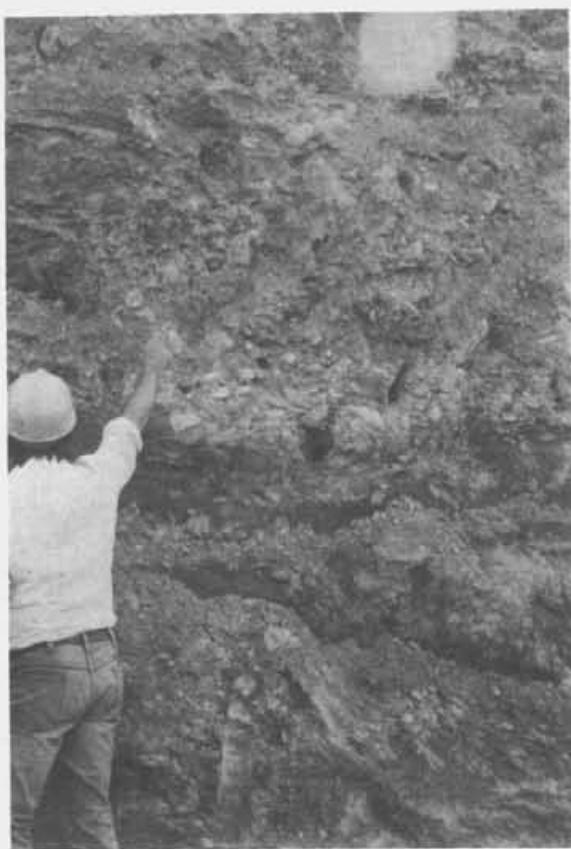
Figure 8

John Harvey pointing out auriferous channel gravels lying on top of weathered bedrock, and overlain by boulders and glaciofluvial material (or till?).

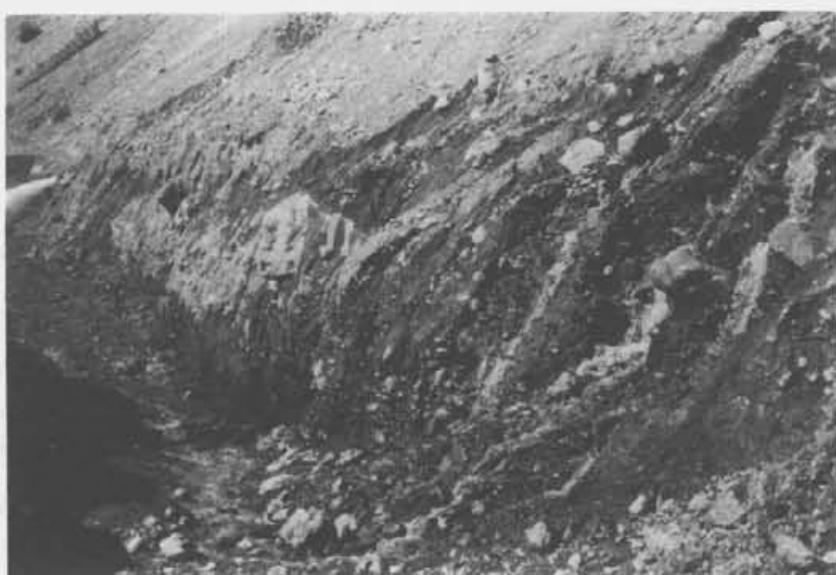
Figure 9

Pay channel gravels in uncut bank, on top of which monitor sits, further downstream. Note hammer as scale. About 3 feet of bedrock has been removed. Good gold is recovered from fractures.

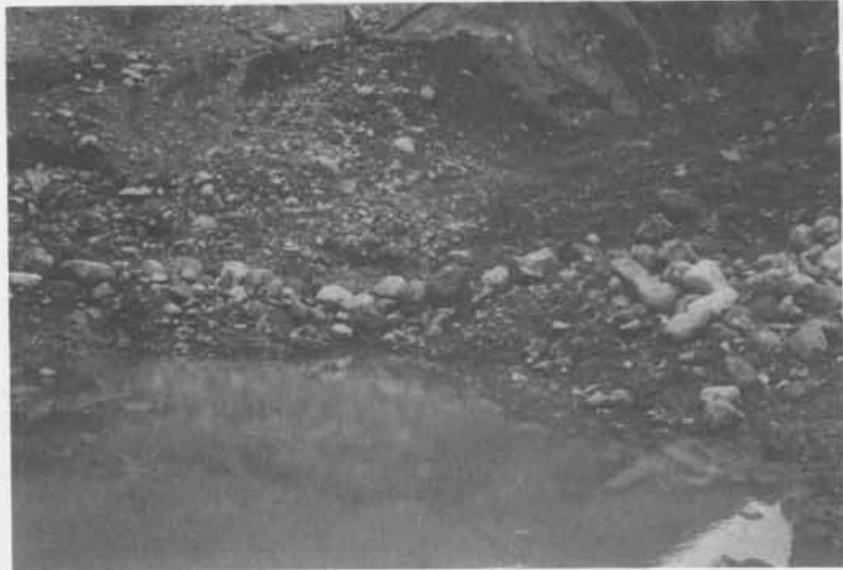
Figure 10

Monitor pit, empty for clean-up, but not scoured this time. Last clean-up of the season will see pit floor cleaned to bare bedrock.

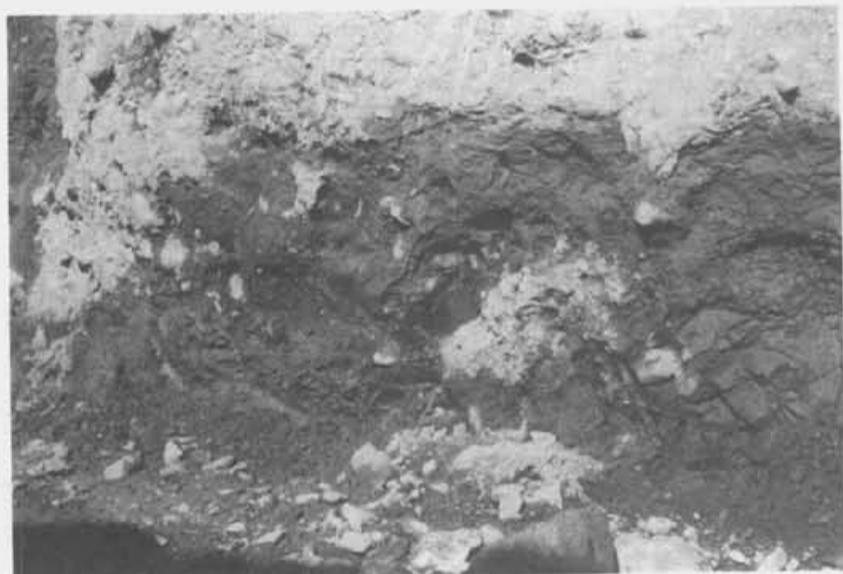
Figure 11

Detail of fracture in weathered bedrock which has filled with auriferous gravel. Manganese oxide gives black stain to pebbles.

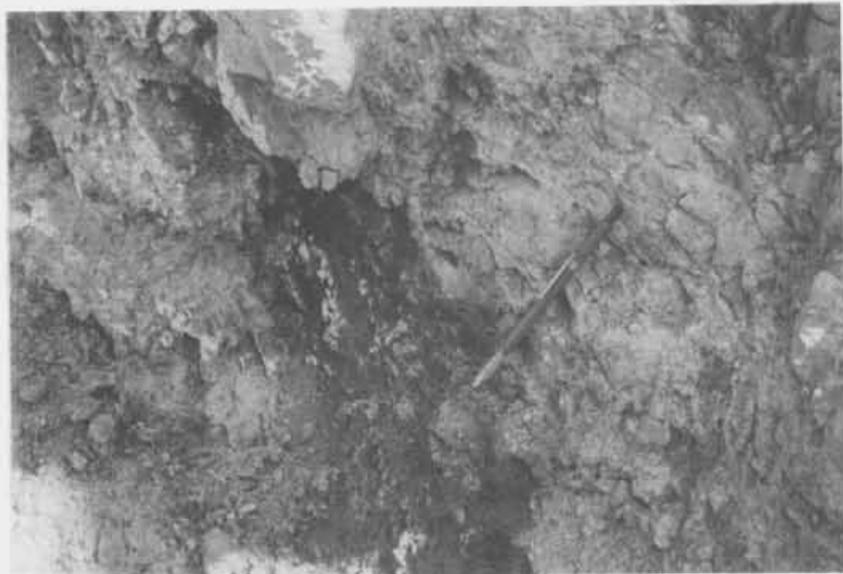
Figure 12

Pale green staining (looks bluish in photo) in bedrock fractures, thought to be garnierite or some other Ni mineral, but X-ray identified as kaolinite, quartz and mica.  
Photo: P. Proudlock,  
Aug. 6/76.

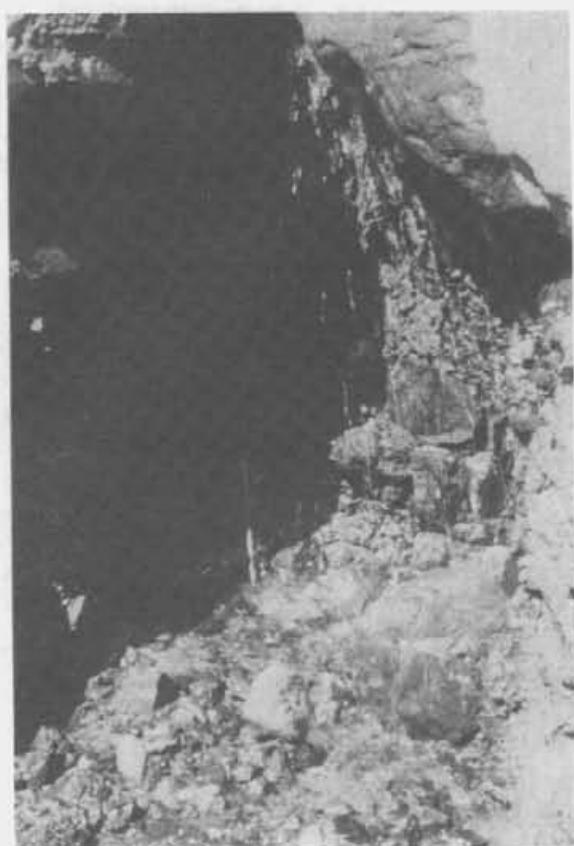
Figure 15, above.

North bank, upstream on McKee Ck., just above and across from Eldorado Ck. Here, more angular fragments and less chert are seen in channel fill, than downstream at the current mining site. Aug. 6/76.

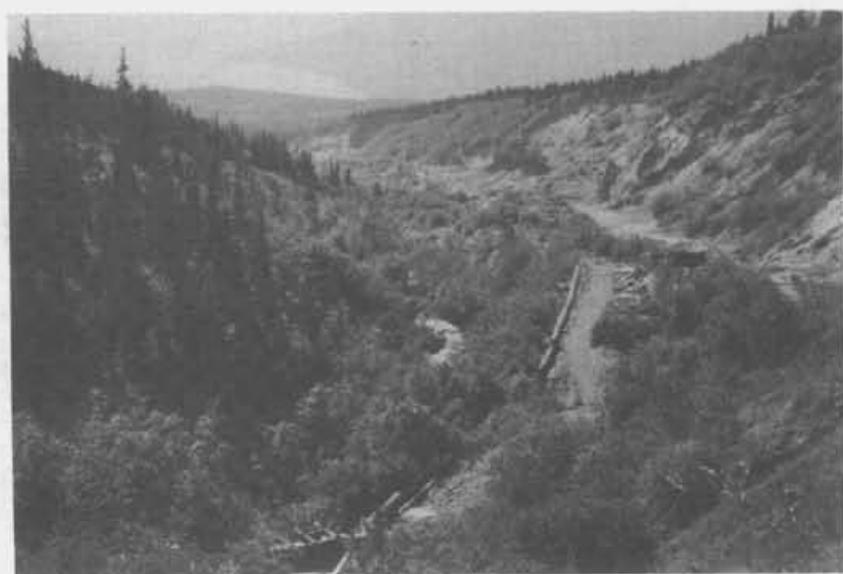
Figure 16

View looking west, down McKee Ck., from confluence with Eldorado Ck. Monitor pipe runs along north bank of creek. Old channel also lies to right of creek and is exposed in a number of places along the base of the cliffs.  
Photo: P. Proudlock, Aug. 6/76.

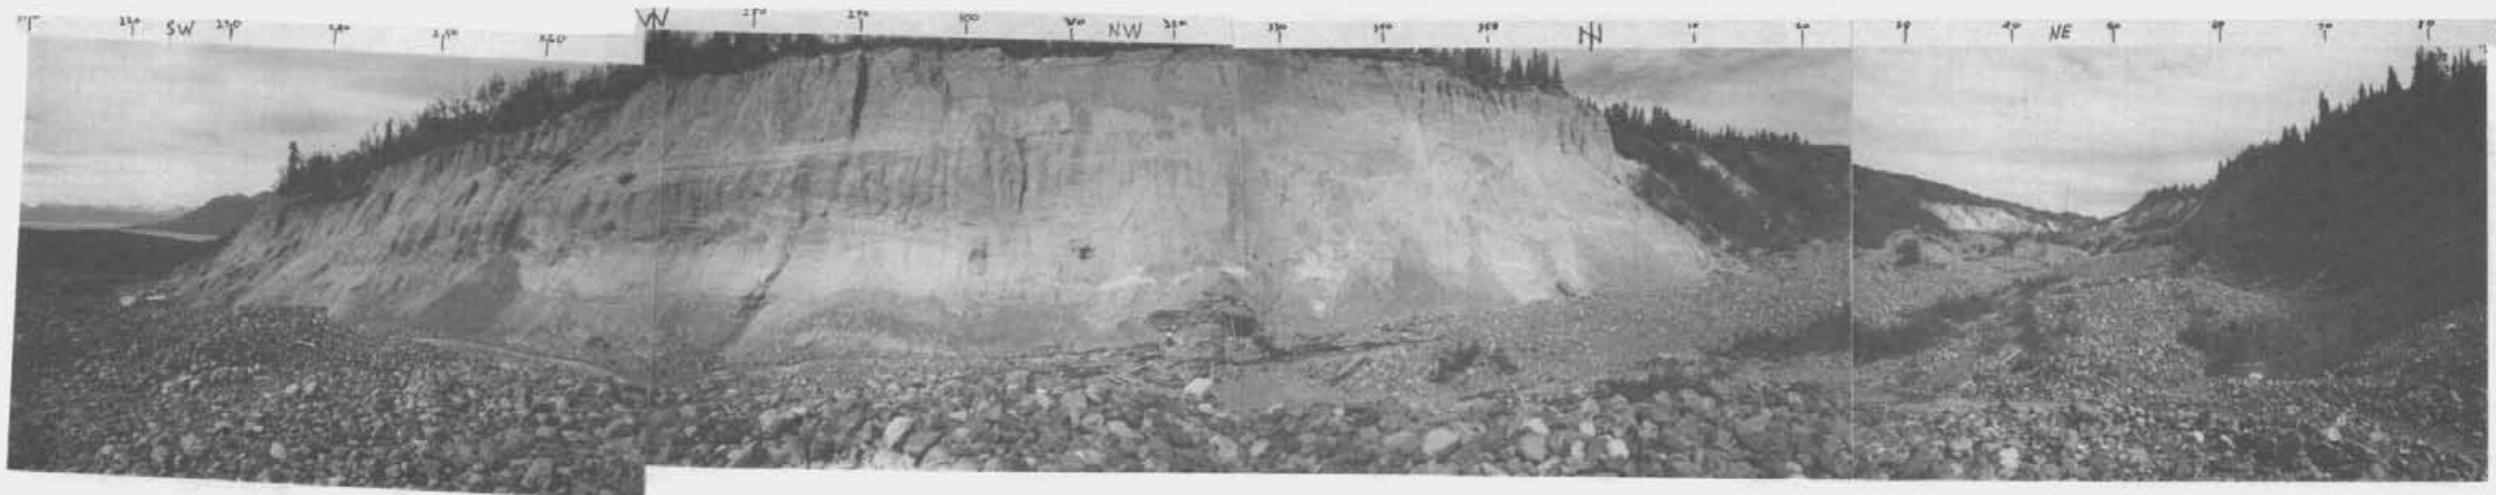
Panorama of McKee Ck., north bank, on Tony Vessnaver's claim. Wide angle (28 mm) shot, with overall angle of view about 240°. Till at top of cliff, with cross-bedded glaciofluvial sands and gravels below--these thin out downstream until at the road bridge, they, and underlying channel gravels are absent, indicating that glaciers travelled upstream, eroding the downstream deposits and then over-riding the glaciofluvial deposits. Channel gravels are present at the base of the cliff, capped by a boulder horizon.

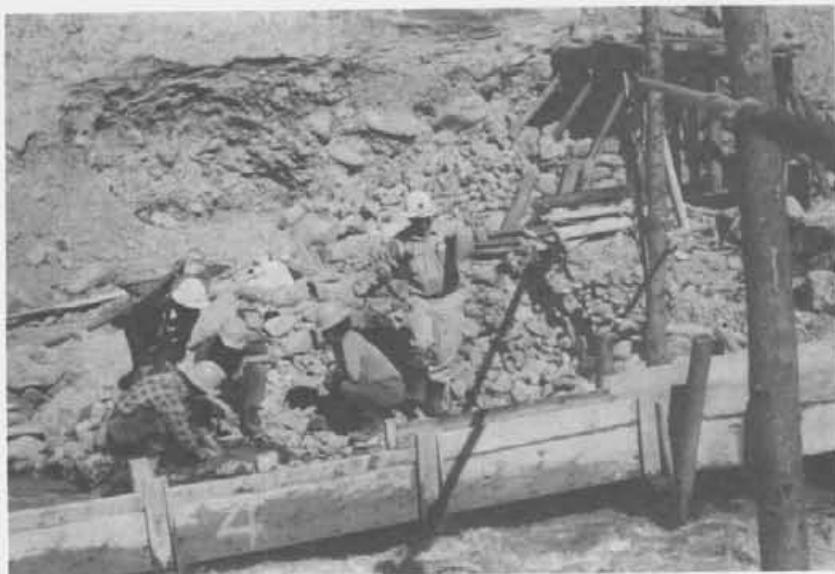
Figure 24

Sluice outside of Vesnaver's present adit, McKee Ck. The adit extends about 30'-40', and is fully timbered. Tony is panning; Bill Dudas, at right, is determining the stream sediment load. Others from left: Mrs. Dudas, W. Proudlock, and Tony's partner, Lorraine.

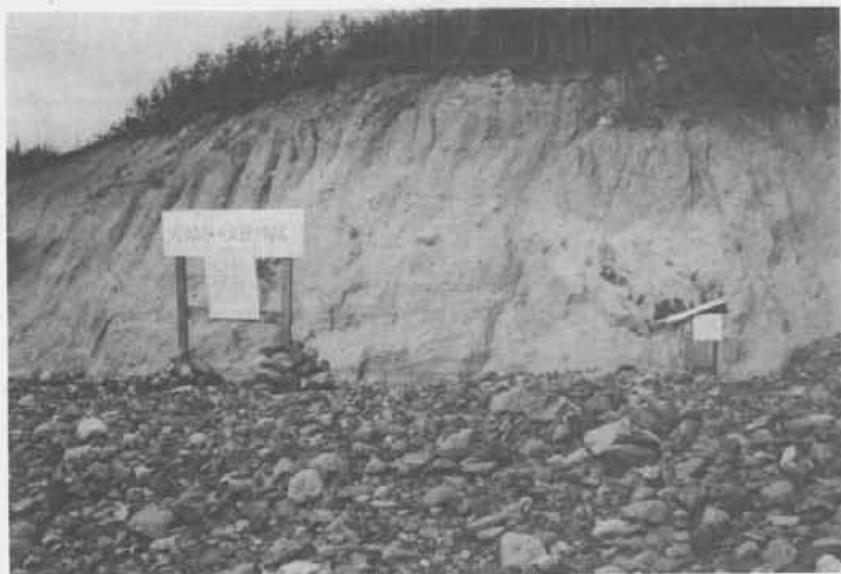
Figure 25

Entrance to Vesnaver's property, McKee Ck. Looking at north bank of creek, where a thick till overlies cross-bedded glaciofluvial gravels that are thinner than those upstream (see Fig. 21).

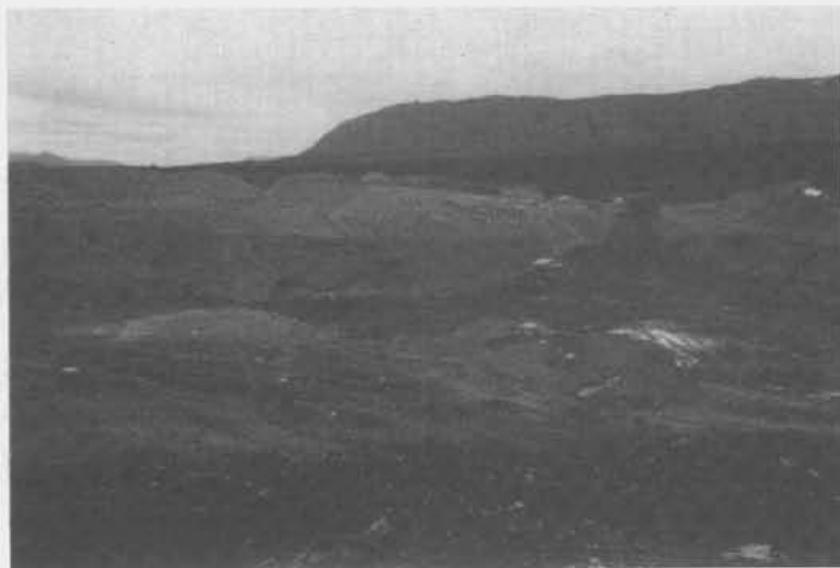
Figure 27

Overview of pit, wide angle (28 mm) shot, looking northwest. Old workings and auriferous gravel channel lie across center of pit floor.

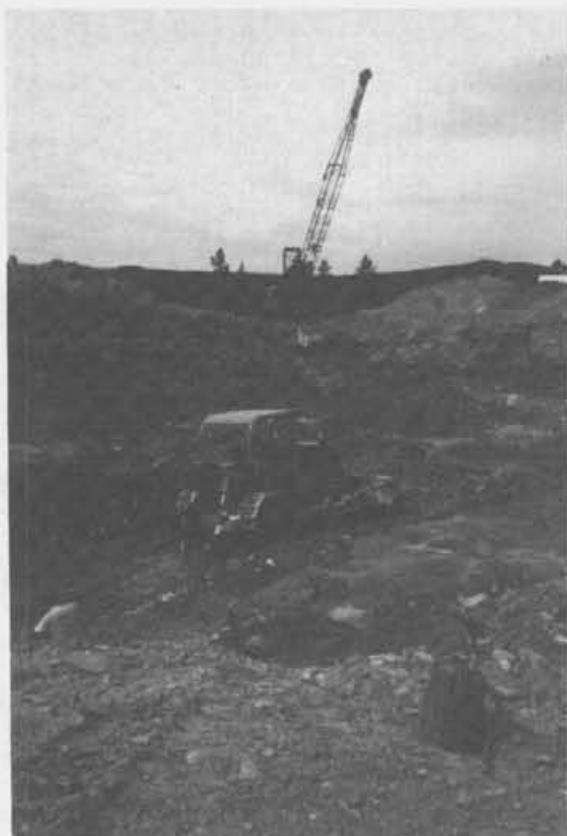
Figure 30, below.

Goldrun, Pine Creek, looking southwest. Old tunnel beside cat in west wall, bedrock knob behind at left. Gold is found in the red channel gravels, and also penetrates the bedrock along fractures to three feet or more.

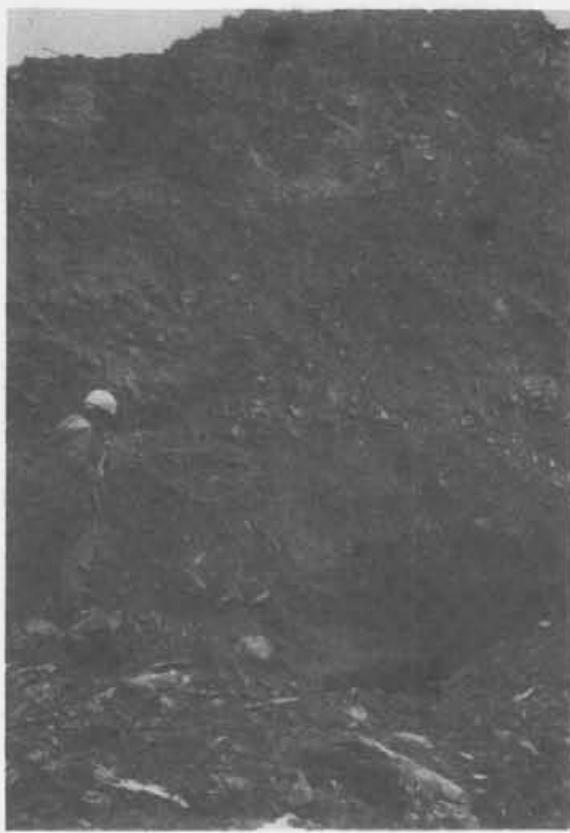
Figure 31

Goldrun, Pine Ck., looking at east end of pit, with old timbered workings exposed at base. The tunnels are six feet high and sit on bedrock. Timbers are still sound after more than 70 years.

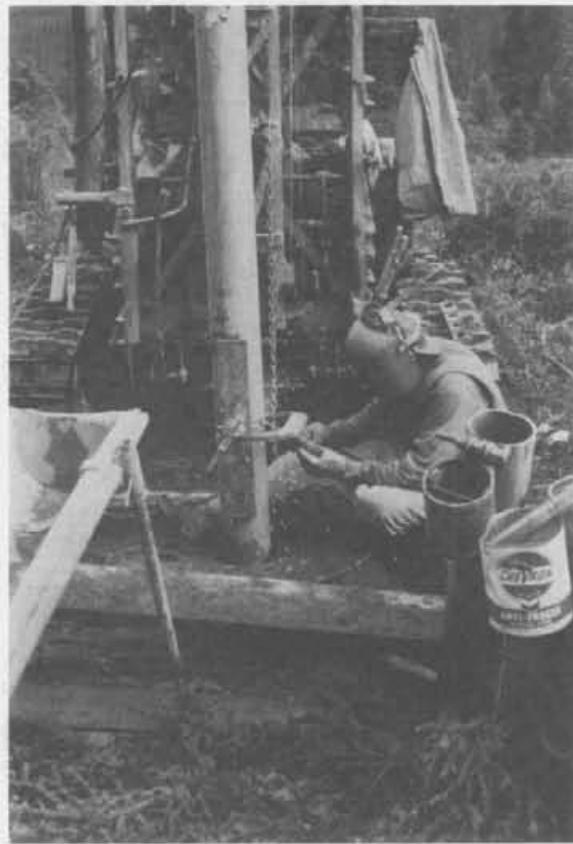
Figure 35

Goldrun, Pine Ck. Tory Mattson welding an additional length of casing, preparatory to further drilling, using a home-made clamp to obtain perfect alignment in the casing.

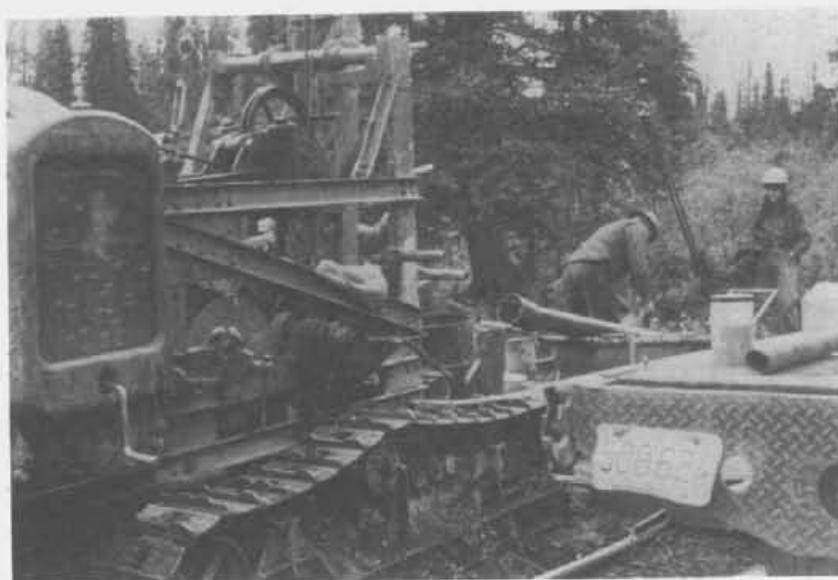
Figure 36

Goldrun, Pine Ck.; side view of drill, showing engine, cable reel and rocker. While Allan Mattson washes the gravel Tory continues to drill. W. Proudlock at right.

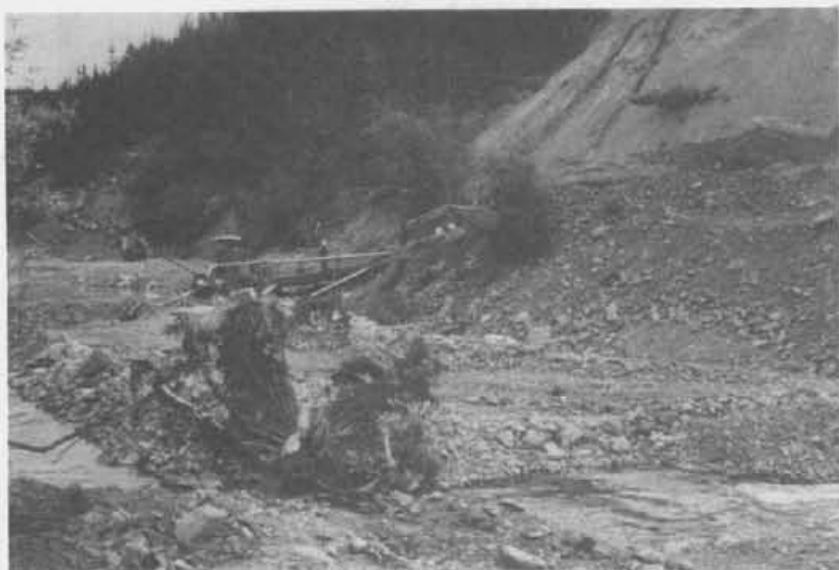
Figure 38

Enos Kyle's property on Spruce Ck., looking south. Cat and backhoe are working into weathered red bedrock on a "bench". Old workings are known in the far bank, and it is supposed that an old channel exists buried deep under the bank.

The lowest claim, at the confluence of Little Spruce Creek with Spruce Creek is owned by John Harvey. Although he was not working this claim, he reports that fairly good gold has been panned. Next upstream, the only major operation on Spruce, owned and run by Enos Kyle and Son (see figures 38-40). Gold was being recovered from channel gravels on bedrock above the present creek level. About eight feet of bedrock and gravel were sluiced. A D6(?) cat was used for stripping, scraping and ripping about three feet of fractured bedrock and for piling tailings. A tractor mounted backhoe was used to feed the sluice; water was pumped from the creek. The Kyles had dug a number

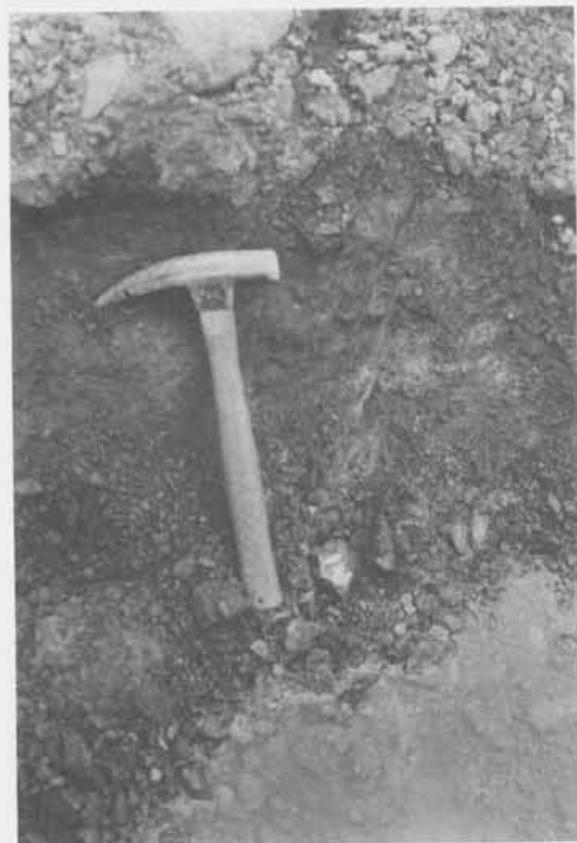
Figure 39

Section in test pit on west side of Spruce Ck., Enos Kyle's property. Two feet of fractured bedrock (?) overlie about two feet of a gold-bearing green clay (?), which in turn overlies the same bedrock. The bedrock here was exposed during early hydraulic mining.

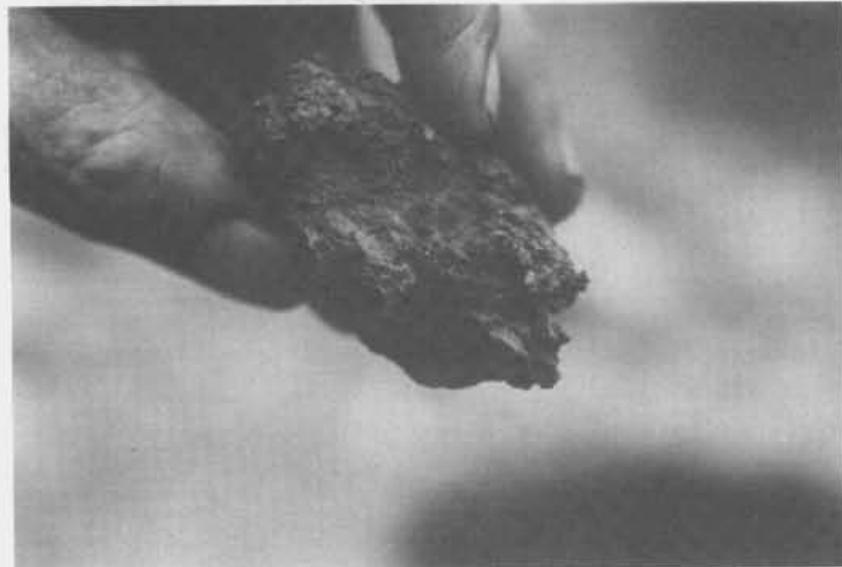
Figure 40

Detail of green material from test pit. X-ray identification gives composition as siderite, quartz, and possibly some clay. The material may be decomposed bedrock, alteration being due to a long trapped watertable.

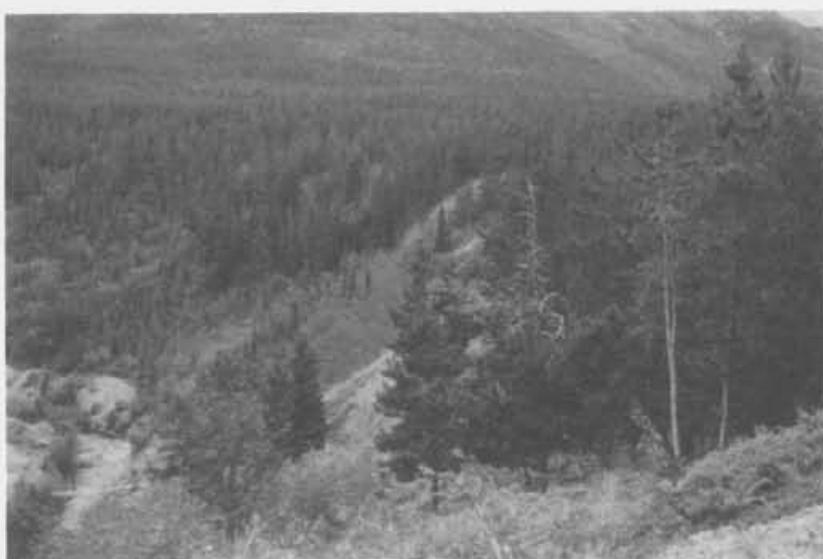
Figure 42

Above Enos Kyle's property on Spruce Ck., looking south-southeasterly across an old channel deep below till. Flow in channel would have been to the right (west, or northwest). The lower portion of the creek has been post-glacially cut into the old rim. Tony West's claim at lower left in photo.

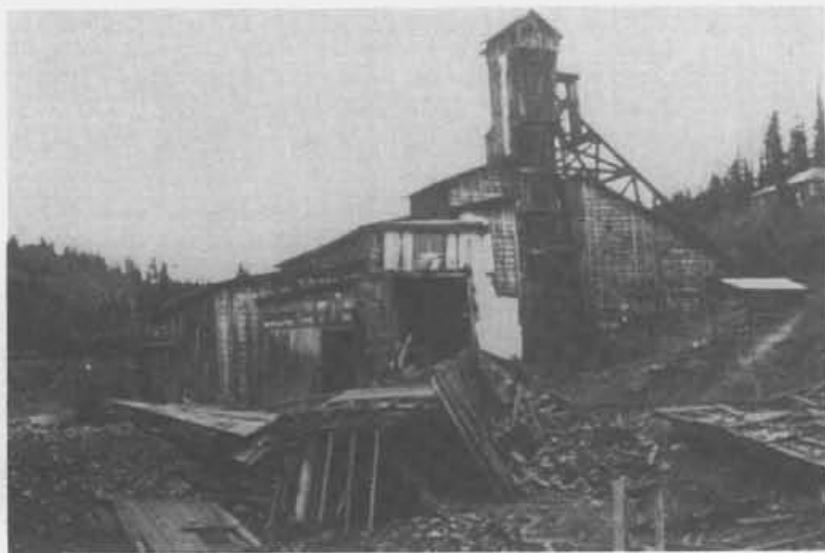
Figure 45

Headframe at Dominion, Spruce Ck.

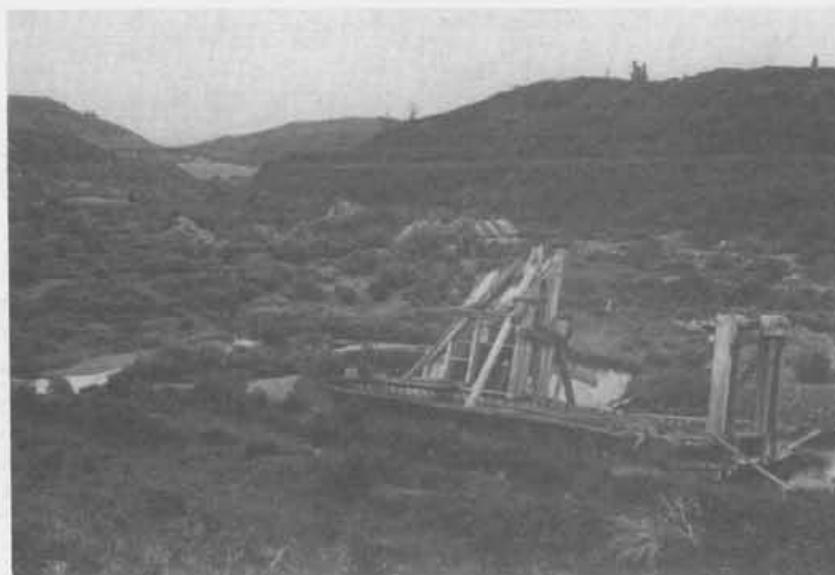
Figure 47  
Remains of old gold dredge near headwaters of Spruce Ck., Atlin area. Dredge was operated about one year then shut down, having produced little gold. Looking southeast.

The road up Spruce Creek was built to service claims worked some time ago. A large dredge once used recovered very little gold from Upper Spruce Creek. Figure 47 shows the remains of it. The valley from here to the headwaters becomes very wide and shallow, with eskers and terraces still largely un-eroded (figure 48). The road over the headwaters, down Slate Creek, across the O'Donnell River and over to Bull Creek is an almost impassable trail by 4X4.

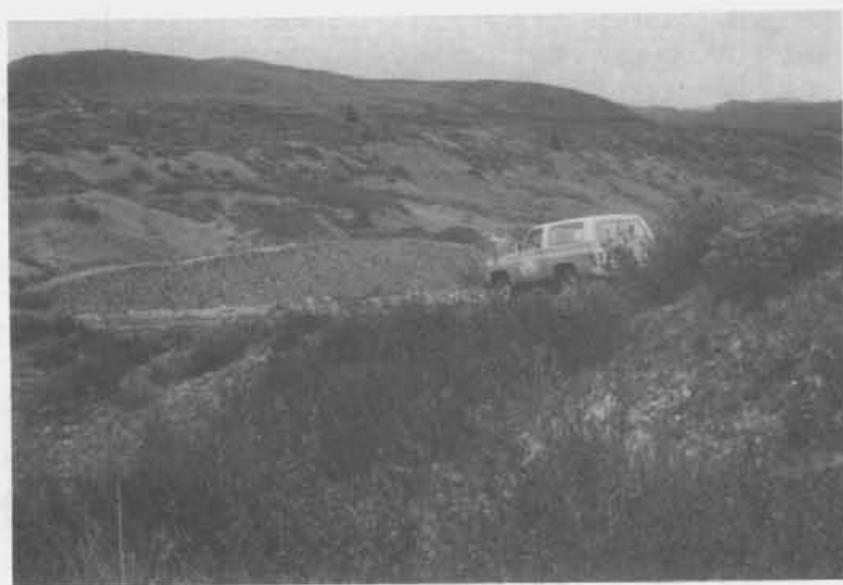
Figure 48  
"Road" running into Bull Ck. travels along top of a 20-30' high esker near Spruce and Slate Ck. headwaters. Looking east towards O'Donnell R. and Bull Ck. Photos: P. Proudlock, Aug. 10/76.

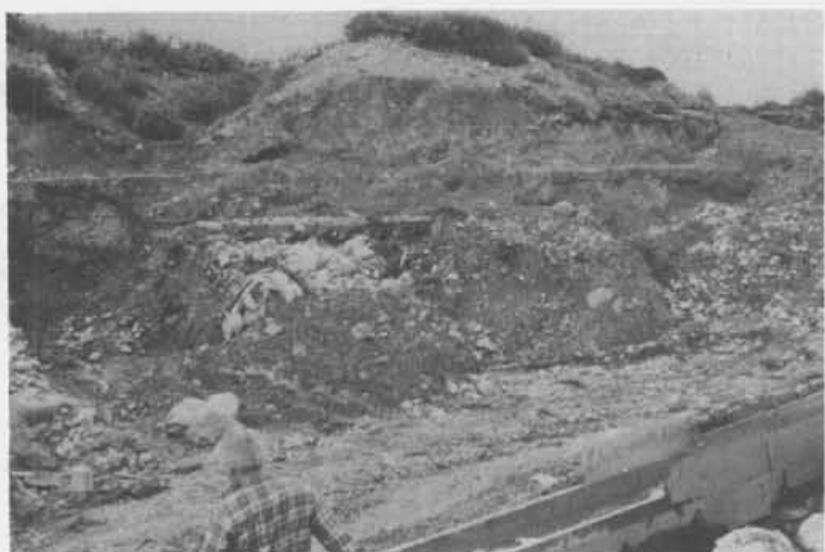
Figure 49

Bull Ck., Roy Smith's claim. Looking at north-west bank of excavation, showing section. Bull Ck. runs from right to left, behind photographer.

We were able to visit Roy Smith's claim on Bull Creek by helicopter (see figures 49-52). The present Bull Creek has been diverted by eskers, to a spot on the rim of the old channel, but still well within the walls of the old valley (figure 52). Roy Smith has been using a cat to open a pit in the old channel, and scrape the auriferous gravel into the sluice. The gold recovered at Bull Creek is a lot finer and also flatter than that of the main Atlin camp. The largest nugget so far recovered here is one fourth of an ounce. Two distinct layers of till are seen; a grey till overlies a yellow till which in turn overlies clean slightly stratified channel gravels. The bedrock is argillite, which grades from well fractured with good gold in fractures to a hard, poorly fractured, probably more metamorphosed rocks, with poor gold recovery. The present pit is west of the creek where channel gravels are two to four feet thick and thicken to the east where the pit will eventually be extended. The channel axis lies between the pit and Bull Creek, as Bull Creek now has bedrock rims higher than the pit where it passes the claim.

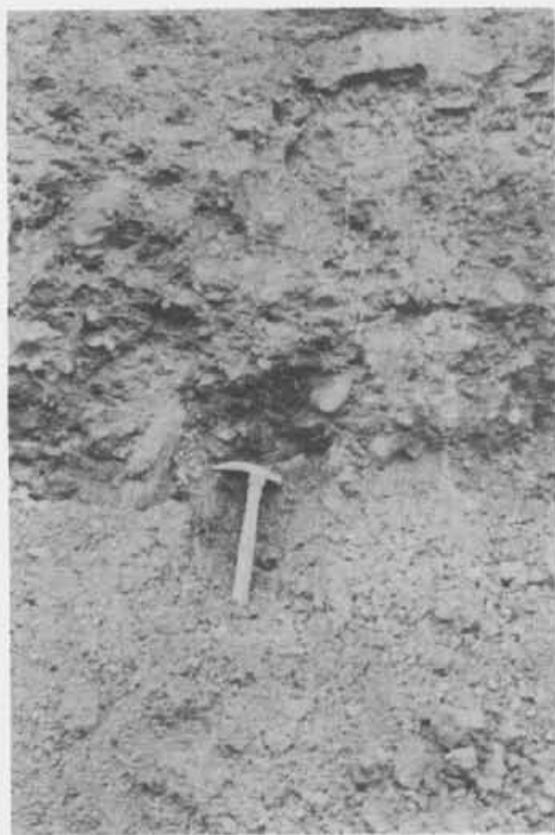
Figure 50

Bull Creek, Roy Smith's claim. Detail of section, showing auriferous channel gravels.

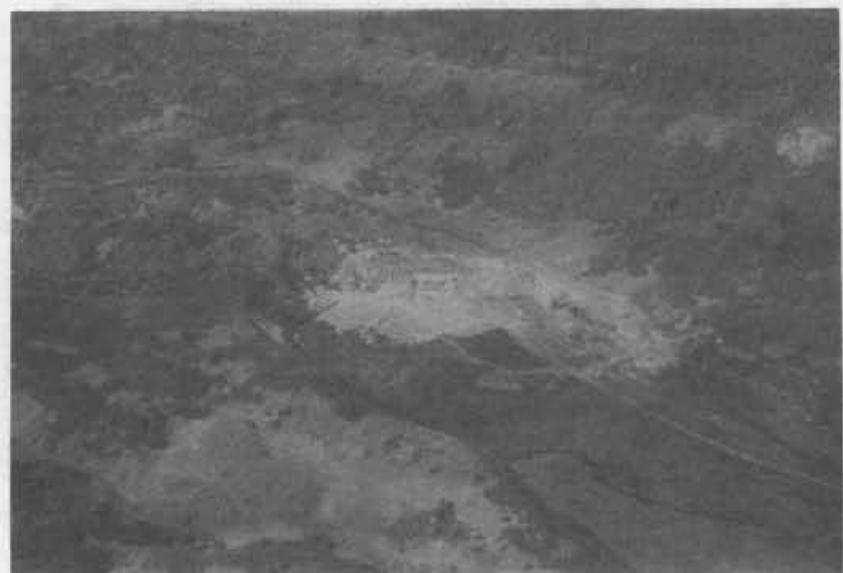
Figure 51

Aerial view of Roy Smith's operation on Bull Ck., looking west.

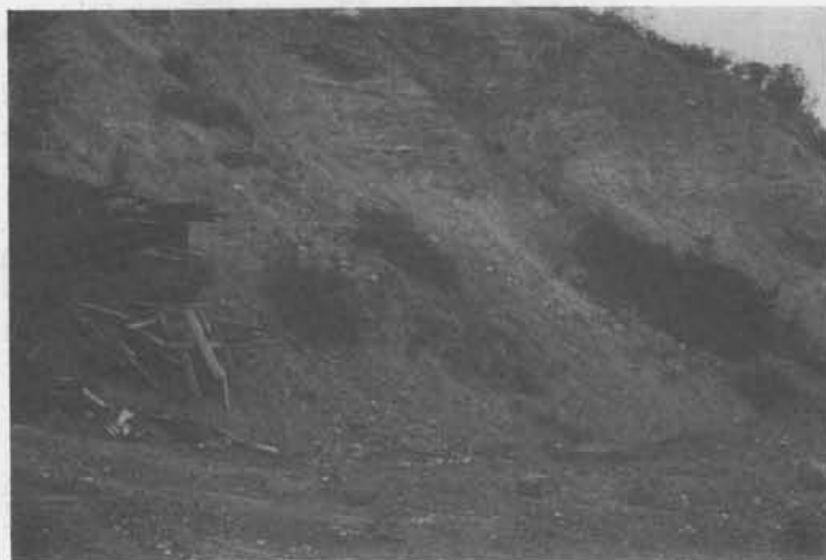
Figure 53

O'Donnell R., adit into north bank. Three adit levels were seen in the bank, which had also been hydraulicked at one time; old channel gravels are probably 15-20' thick.

No placer mining was done on the O'Donnel River in 1976. Some work had been done to the west of where the road comes down to the river (see figures 53-55). The bank had been dug into and sluiced. Tailings from the last and possibly previous operations have been allowed to spread out on the river terrace - an old head frame and water wheel have been half buried. In the north bank closer to the road there are a number of adits: three levels, one directly above the other. An old boarded over shaft was found near the river as well.

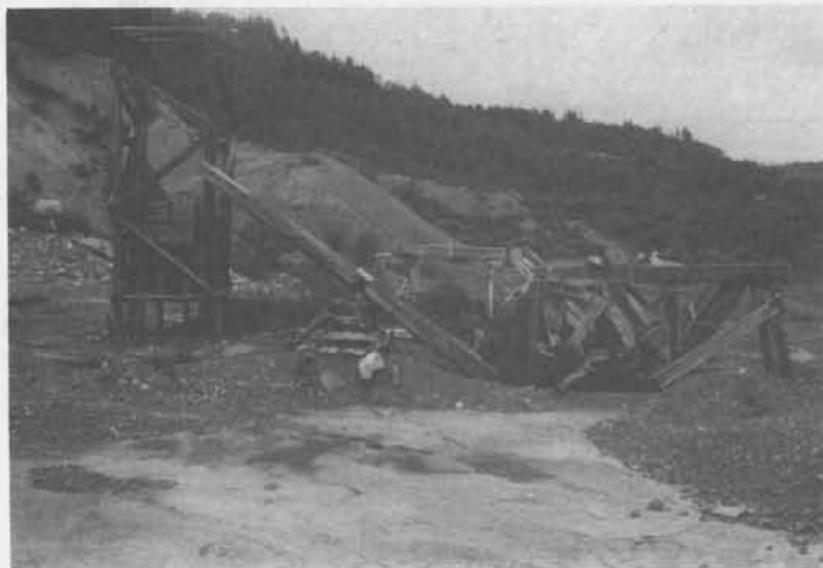
Figure 54

O'Donnell R., looking northwest to an old (?) shaft, situated 100-200 yards from bank, and a similar distance from the river.

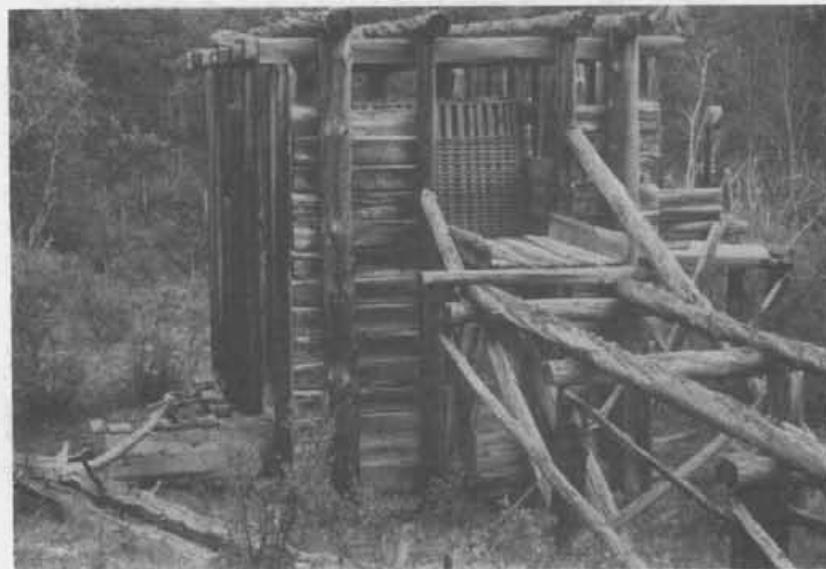
Figure 55

O'Donnell R.; old pipehead box above north bank, about half a mile west of the workings.

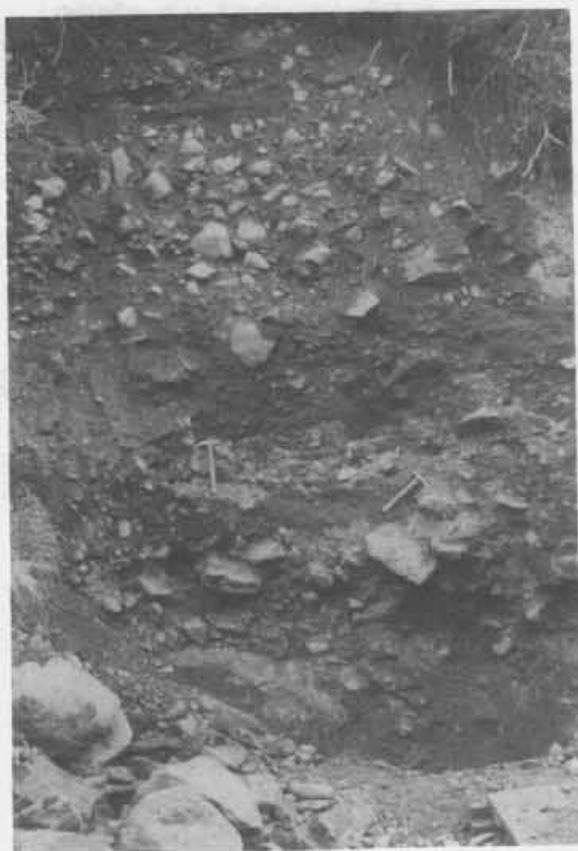
Figure 56

Bill Weigler's claim on Snake Creek, south of Surprise Lk. Hand pit in northeast bank shown. Good colour is obtained in the overlying gravels, plus in the fractured shale bedrock.

Snake Creek is a small mountain stream flowing roughly parallel to Otter Creek, but which flows into Pine Creek. Bill Weigler has a claim he has been working by hand (figures 56-59). No gold has been previously reported recovered from this creek, although some remnants of old mining equipment were seen. Bill has been digging into the east bank where a clayey till covers six to eight feet of channel gravels in three layers - all auriferous. The bedrock is a fractured slate, with gold in fractures. A small test pit in the west bank produced some gold.

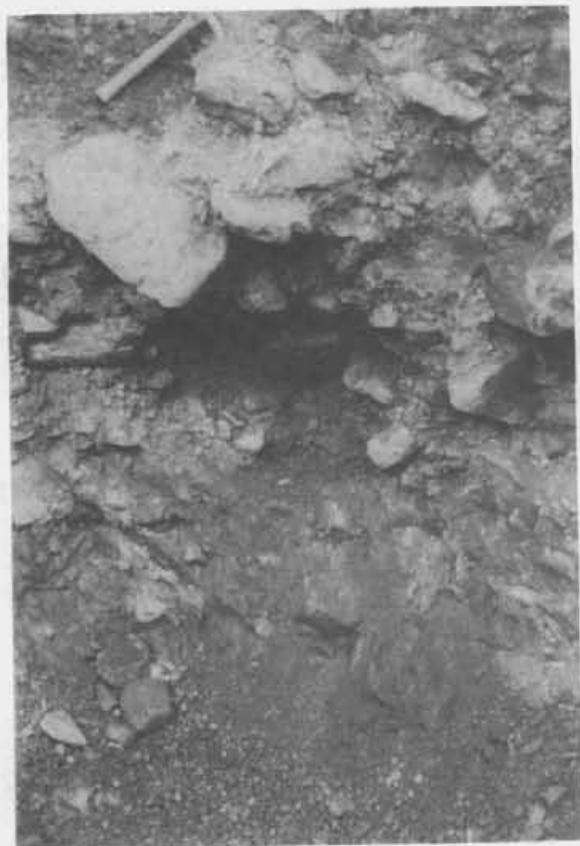
Figure 57

Detail of auriferous channel and bedrock contact in Weigler's northeast bank pit.

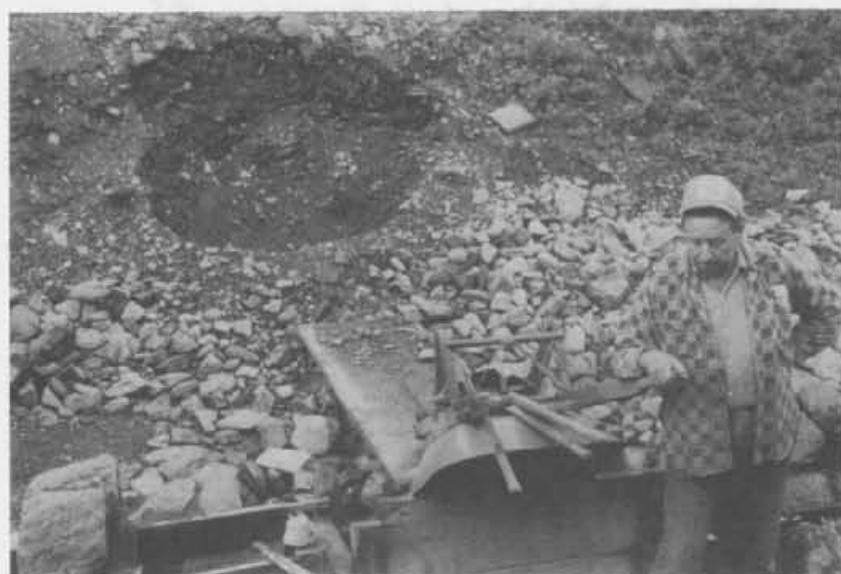
Figure 58

Bill Weigler on his Snake Ck. claim, showing hand pit in southwest bank of creek and the sluice box.

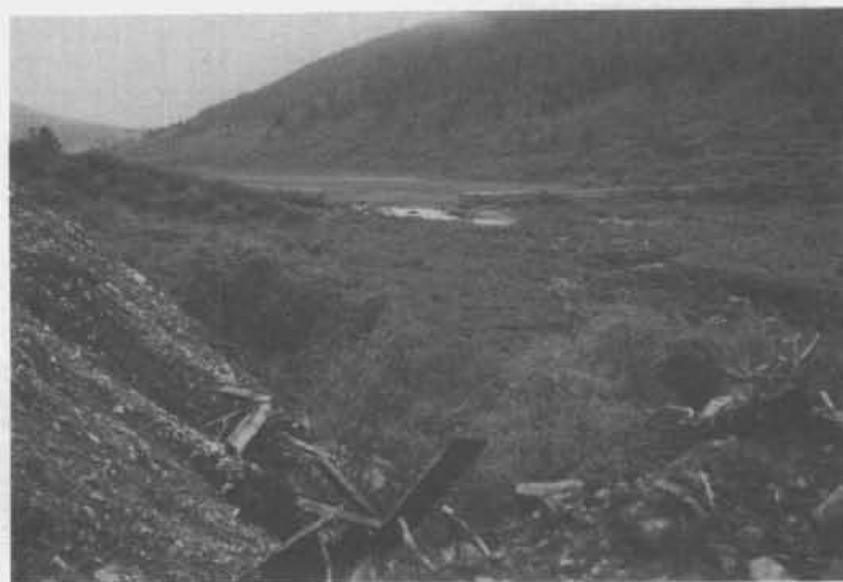
Figure 60

Otter Ck., east of Atlin. Broken earth dam on upper creek once supplied hydraulicking on lower creek. Water was also diverted to this man-made lake from Snake, Wright, Casino and Union Cks. Surrounding area is fairly well glaciated. Aug. 12/76.

supplied water for extensive hydraulic mining on lower Otter Creek has now been washed out in the middle. Since there was often a shortage of water, a long aqueduct was constructed from Union and Casino Creeks across Wright Creek to Otter Creek. Remnants may still be seen in many places. Water may also have been brought from Snake Creek. Lower on Otter Creek where the extensive hydraulic mining was, high cliffs of gravel have been left. A thick cover of till and cross bedded and stratified glaciofluvial gravels cover clayey channel deposits. Bedrock is greenstone. Our panning produced no colour on the west side of the creek, though enough good gold must have been present to warrant the extensive hydraulicing which produced a large fan delta of tailings well out into Surprise Lake. Recent sluicing had been done, perhaps in 1975, on an old channel between Otter and Wright Creeks (see figure 63). Piles of tailings are present; also a large sluice and monitor. A pipe line is installed to Otter Creek and some equipment is still on the site. We were unable to view a decent section due to extensive workings and some slumping covering possible exposures.

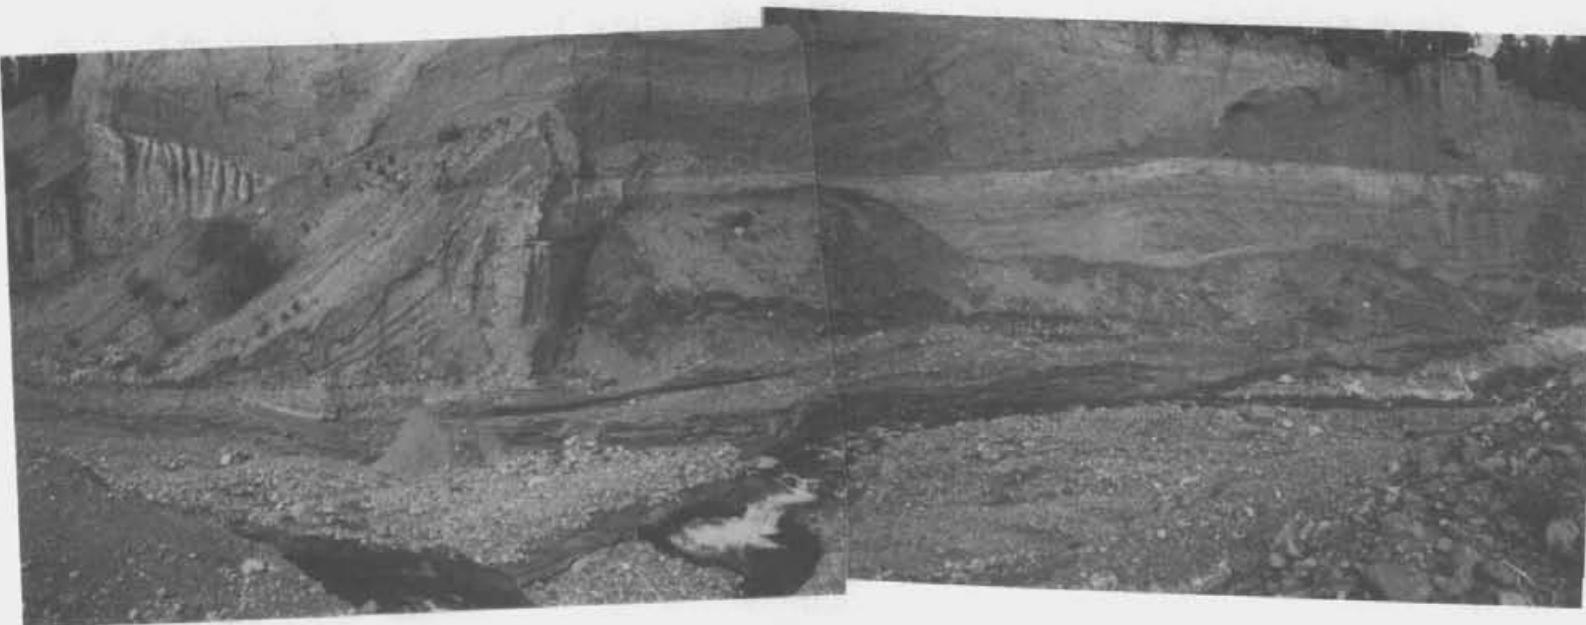
Figure 61

Lower part of Otter Ck., eastern hydraulicked bank. Greenstone bedrock is exposed with very clayey auriferous (?) channel deposits overlying; these were protected by the stratified and cross-bedded glacio-fluvial sands and gravels, which in turn are blanketed by till (and perhaps later glacial outwash). Our panning produced no colour.

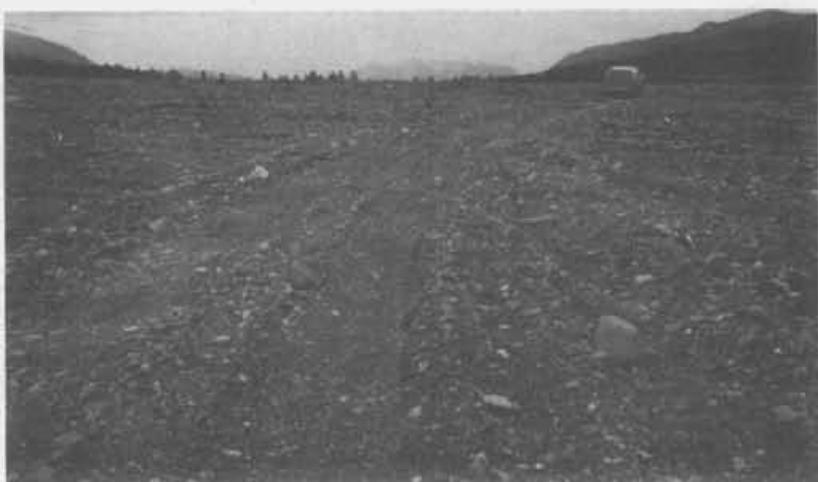
Figure 62

Otter Ck. delta into the western end of Surprise Lake, looking east. Present delta is made up entirely of hydraulicked tailings.
