STRATIGRAPHY OF THE PLACERS  
IN THE  
ATLIN PLACER MINING CAMP, B.C.

BRITISH COLUMBIA MINISTRY OF MINES  
AND PETROLEUM RESOURCES

1976

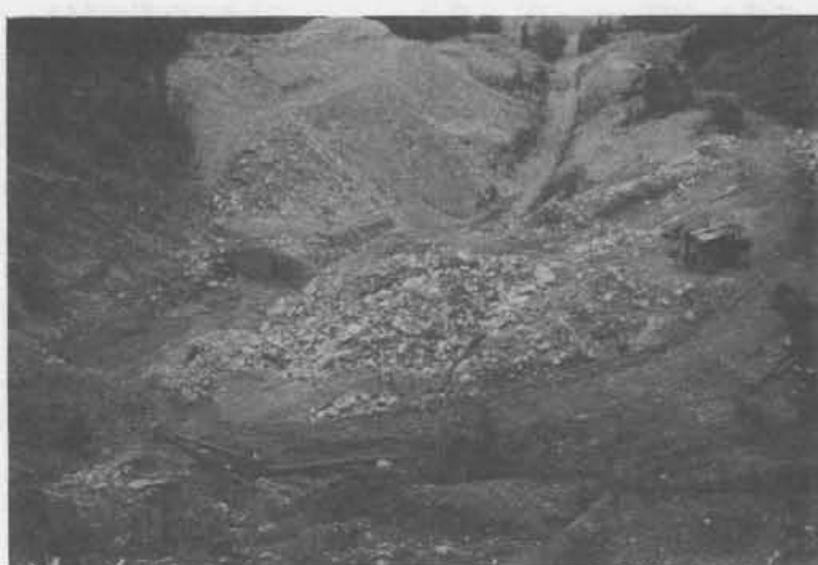
Figure 63

Old Otter Ck. channel excavated midway between two present stream beds. Operation here, as recent as one year old, was mechanical, using a monitor pit and cat; the monitor had been washing part of the cliff.

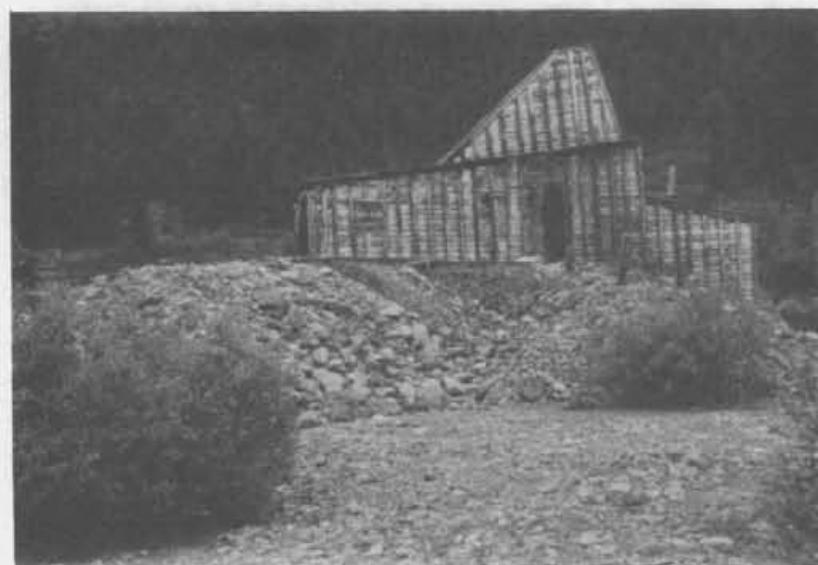
Figure 64

Old shaft, sunk during '30's, on Wright Ck. at point where creek widens. There was ice in the shaft, approximately forty feet down.

Lower Wright Creek does not appear to have been extensively mined. An old shaft, sunk in the 1930's at a widening in the creek valley probably was not successful in recovering much gold as little tailings are present. Higher up, the valley is "V" shaped and not well glaciated. Some minor cat work and sluicing had been done a few years ago (figures 64 & 65).

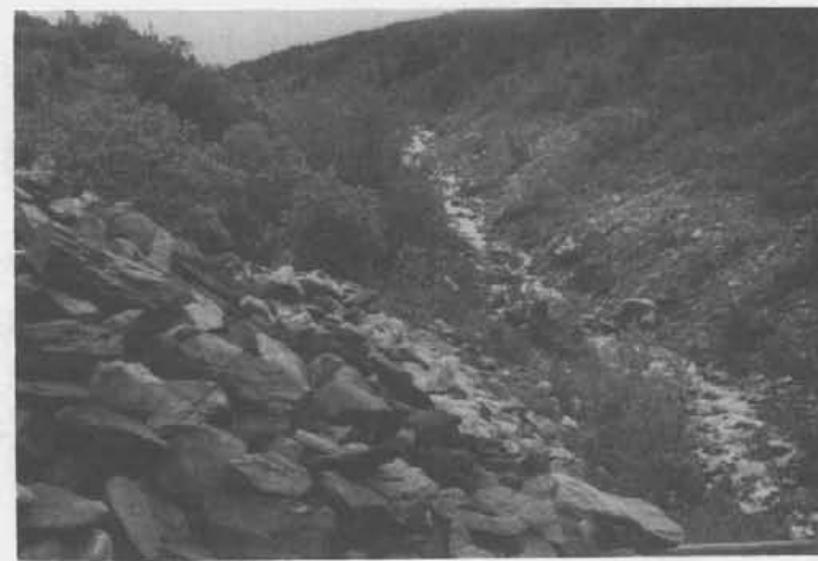
Figure 65

Looking up from forks on Wright Ck.; dragline piles on left. Valley is distinctly V-shaped, not nearly as well glaciated as Otter Ck. valley.

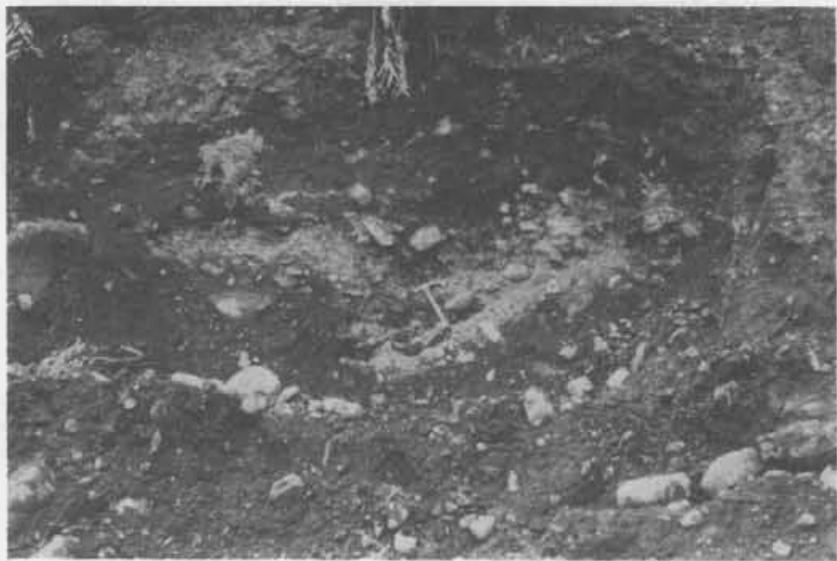
Figure 66

Norm Bentley's claim on lower Birch Ck. The old channel lies in the west bank, about ten feet up above the present creek channel. This test pit exposes four feet plus of unconsolidated gravel that hardens towards the bottom of the pit, and bedrock. Good gold is found in the gravel and in fractured bedrock.

workings and adits into the east bank of the creek are present. Norm is now working a small channel well in the west bank using a combination backhoe-loader and sluice. He contracts out any heavy stripping. He has uncovered this small channel in a number of places along the creek and has recovered good gold. Since only one side of the channel has been exposed it is not known how wide it is, and since exposure is along a steep creek bank the depth of till cover is not known. Bedrock is a rusty, fractured greenstone which has gold in the fractures; it slopes into the bank indicating that the channel is more extensive than so far exposed.

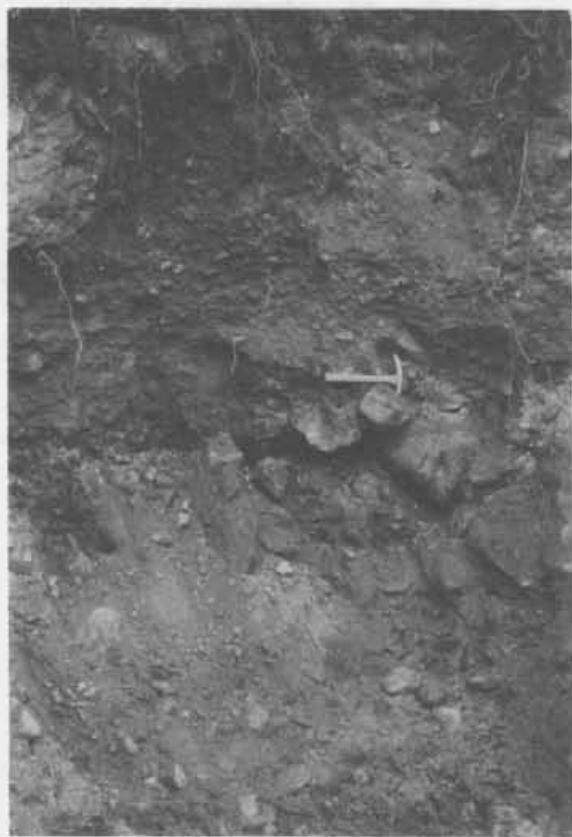
Figure 67

Detail of Norm Bentley's west bank test pit on Birch Creek.

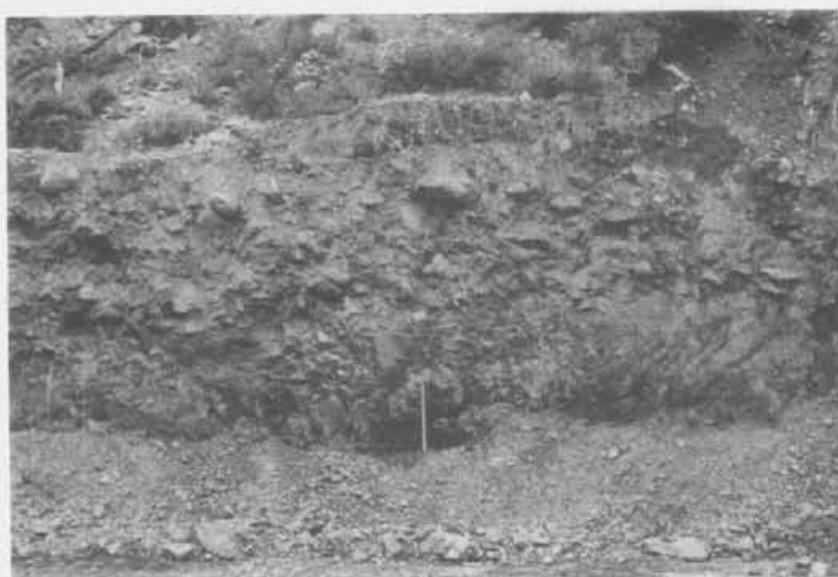
Figure 68

Norm Bentley, lower Birch Creek. Same west bank as in Figs. 66, 67, after new road was dozed in, and bank was stripped to expose channel gravels. Hammer handle is about  $2\frac{1}{2}$  feet long. Aug. 22/76.

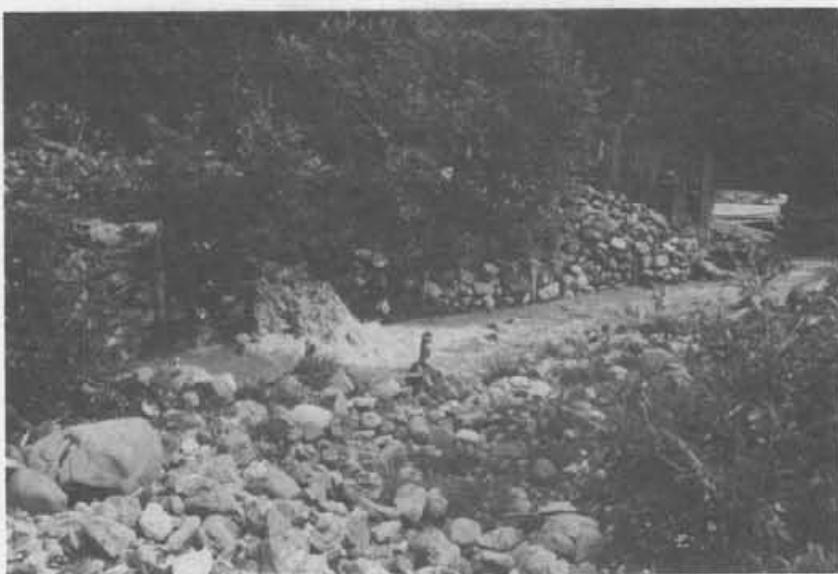
Figure 69

Norm Bentley, lower Birch Ck. Old workings on east bank; hand piled boulders from drifts.

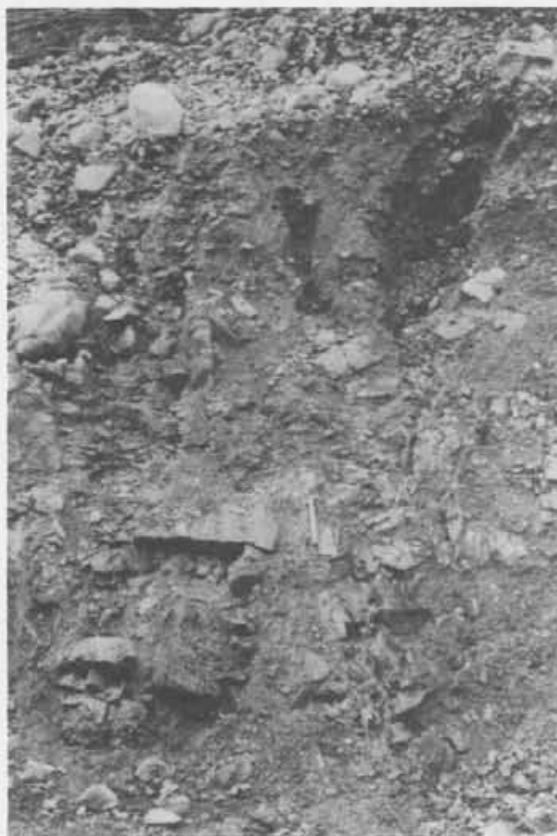
Figure 71

Joe Holtzer's claim, situated upstream from Norm Bentley, Birch Ck. Wall of pit on east side of creek, up on rim of old channel, showing argillites conformably over limestone, dipping steeply into bank.

Above Bentley's is Joe Holtzer's claim, operated by himself and his wife, with one man sometimes hired (see figures 71-75). Although the heavy stripping is contracted, Joe does most of his own work with a small loader equipped with a ripper. Bedrock is faulted and broken marble/limestone and argillite. Faulting, which is near vertical and trending parallel to the creek, predates placer deposition as no gold was recovered from gouge. The channel gravels here are largely centrally located in the creek bottom, although gold recovery has been sporadic with the best gold recovered against the east bank. Joe mentioned that the gold that comes from the limestone is very clean - "It looks like it's just been minted". Joe has also been recovering a lot of mercury with the gold, as have others on the creek. This may be from early placer operations where it was used in the sluice for recovering fine gold, although there is the possibility that cinnabar is present.

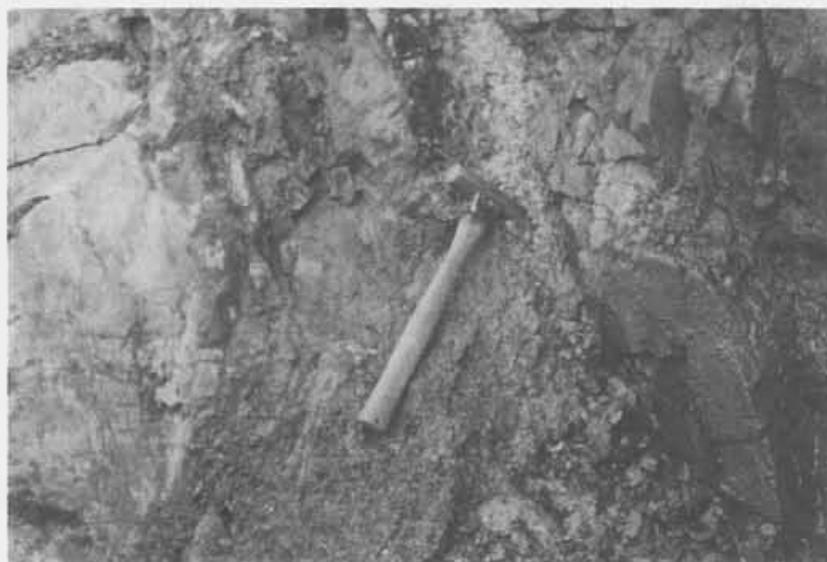
Figure 72

Joe Holtzer, Birch Ck.  
Detail of gouge in a  
fault ( $135^{\circ}/80^{\circ}$ NE). Some  
quartz rodding noted.

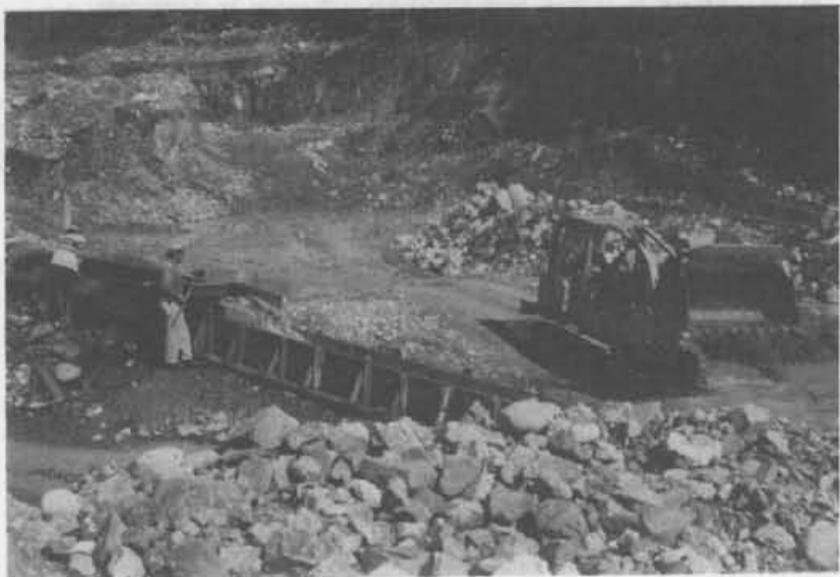
Figure 73

Joe Holtzer, Birch Ck.  
View looking north. Joe  
Holtzer operating loader,  
Orst Curniski in yellow  
slickers by sluice, and  
a friend of Joe's in the  
sweater. Pit into marble  
and argillite bedrock  
behind.

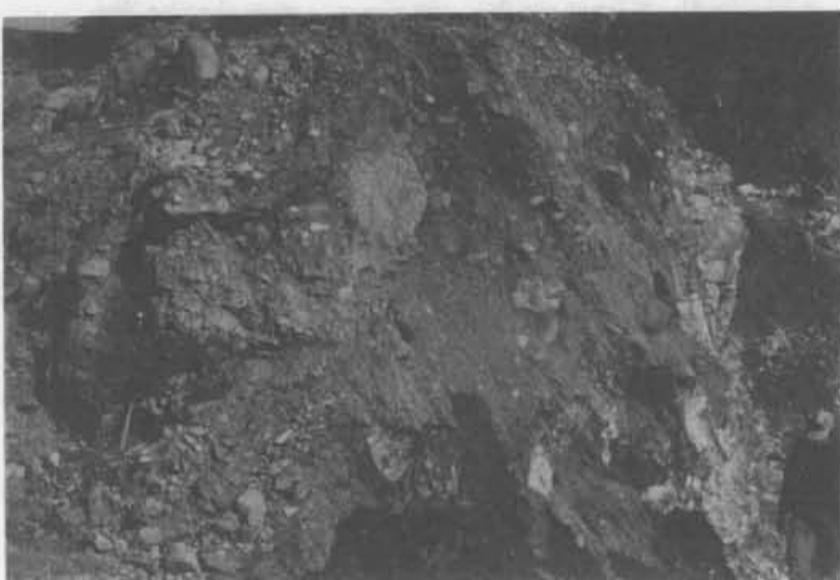
Figure 74

Closer view of hillock to  
left of pit in Fig. 73.  
Till overlies the channel  
gravel, which rest on top  
of argillites and lime-  
stone. The best gold  
comes from gravels  
nearest the bedrock, plus  
the bedrock itself.

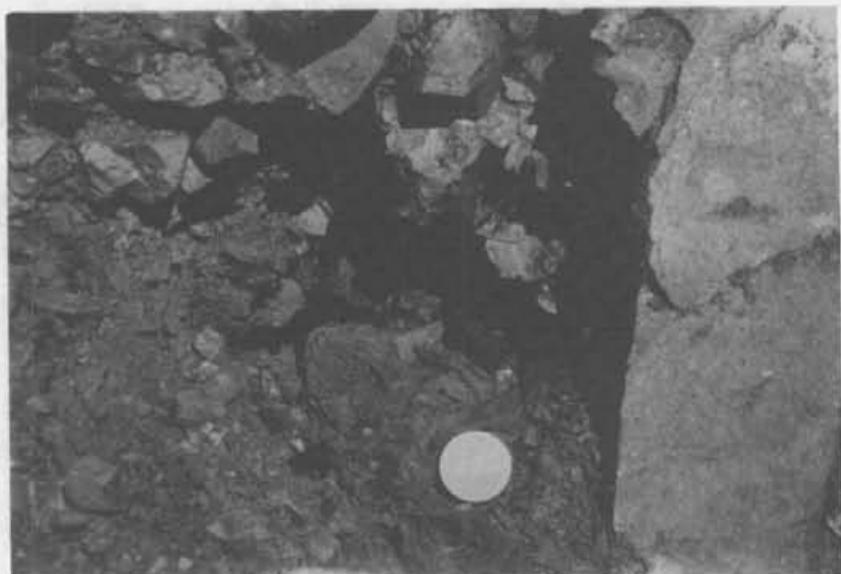
Figure 75

Detail of  $H_2O$  solution  
cavity in marble near  
base of hillock, Joe  
Holtzer's claim. Marble  
impurities leave brittle  
black web throughout  
cavity. Argillite is  
faulted.

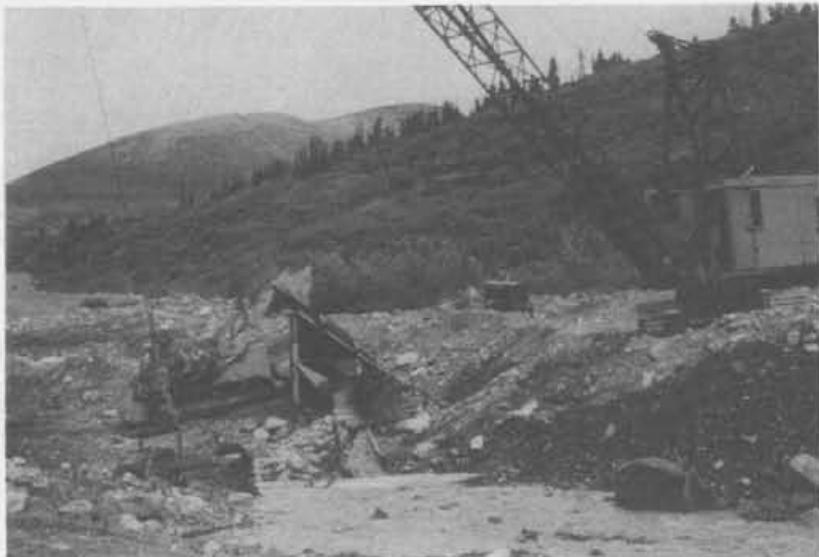
Figure 76

North view of Irvin Haines property, upstream from Joe Holtzer, Birch Ck. Loader works from west bank of creek, feeding into a spring-mounted grizzly over the sluice. Here, the dragline is clearing and piling the tailings from the mouth of the sluice. Stripping and bank cutting are done by the cat.

Irvine Haines operation, next up the creek (see figures 76-78) is a larger one, running a dragline and cat loader. He has been removing a wide strip along the west bank. Till, varying from four to ten feet thick caps six feet of channel gravels with discontinuous layers of clay which rest on very fractured, rusty bedrock. Pyrite is fairly abundant. Bedrock has been ripped six to eight feet with good gold values recovered.

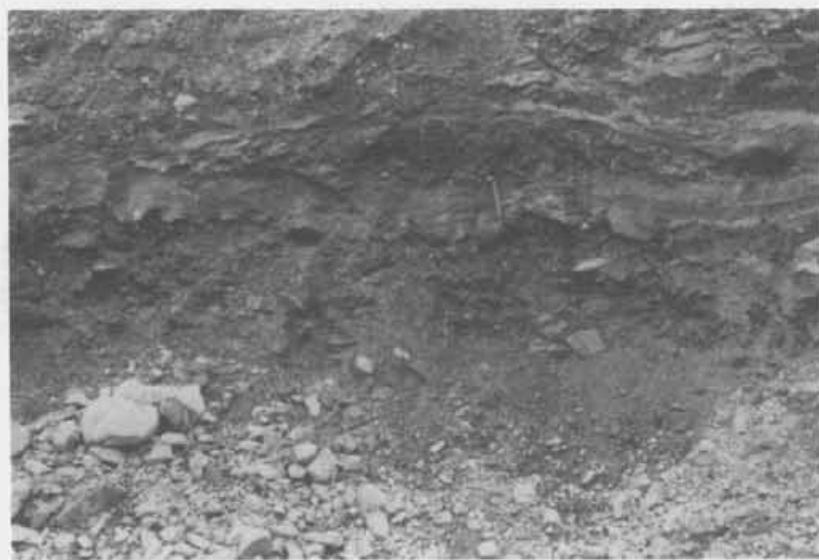
Figure 77

Section of west bank of Birch Ck., slightly downstream from Irvin Haines dragline and sluice. Auriferous channel gravels rest on a fractured bedrock. A glacial clay layer with a gravel lens is seen above the channel.

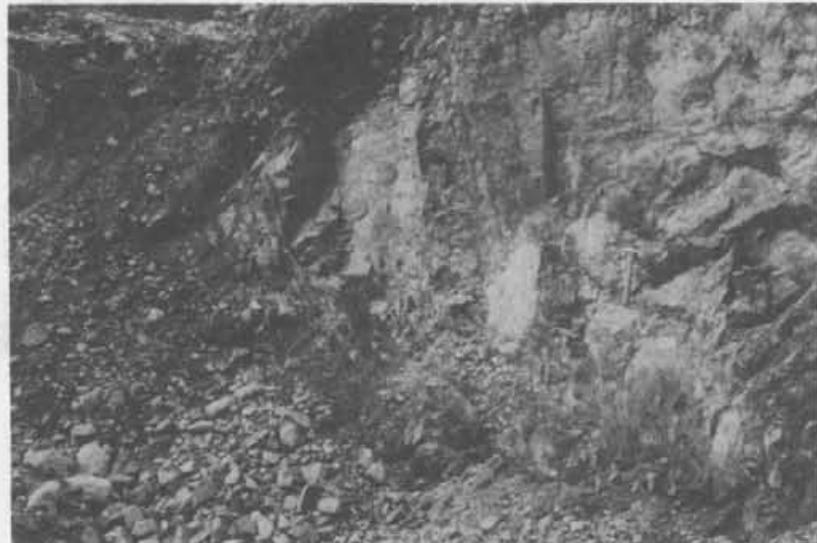
Figure 78

Irvin Haines' property, Birch Ck.; view of west pit wall. Channel gravels and about six feet of bedrock have been stripped and sluiced. The bedrock is pyrite-rich and very fractured, with good gold well into the fractures.

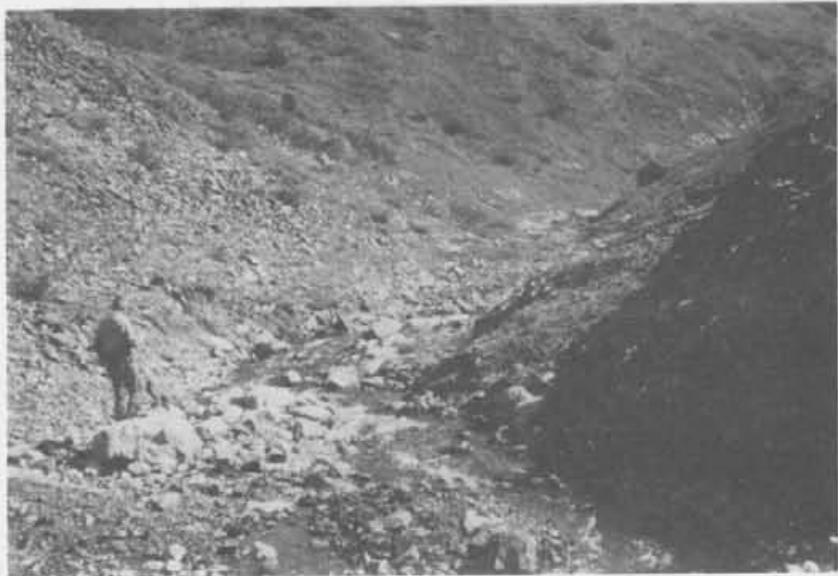
Figure 79

John Dobrovitz walking along south bank of upper Birch Ck. Creek has very little gravel; heavy cirque glaciation is in evidence. No gold but plenty of pyrite is being recovered from the fractured and weathered surface of argillites and green-stone. He has been hand sluicing from small test pits along the creek.

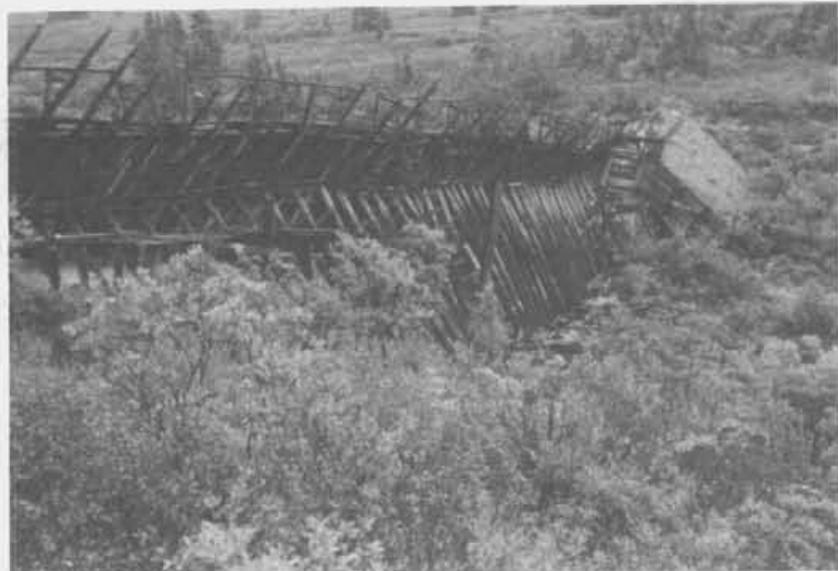
Figure 80

Large wooden dam near top of Boulder Ck. View of downstream side, looking northeast. Dam was built to provide water for early hydraulic mining.

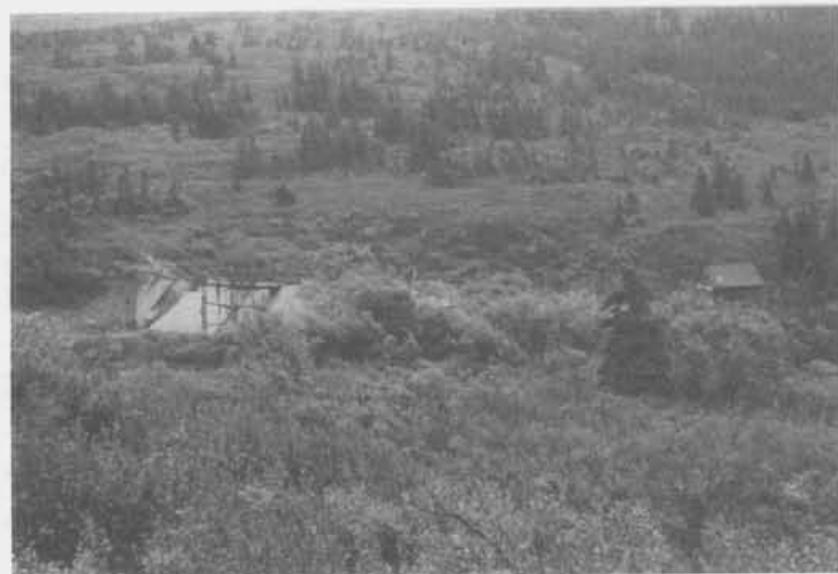
Figure 81

Looking southeast at upstream side of wooden dam on Boulder Ck.

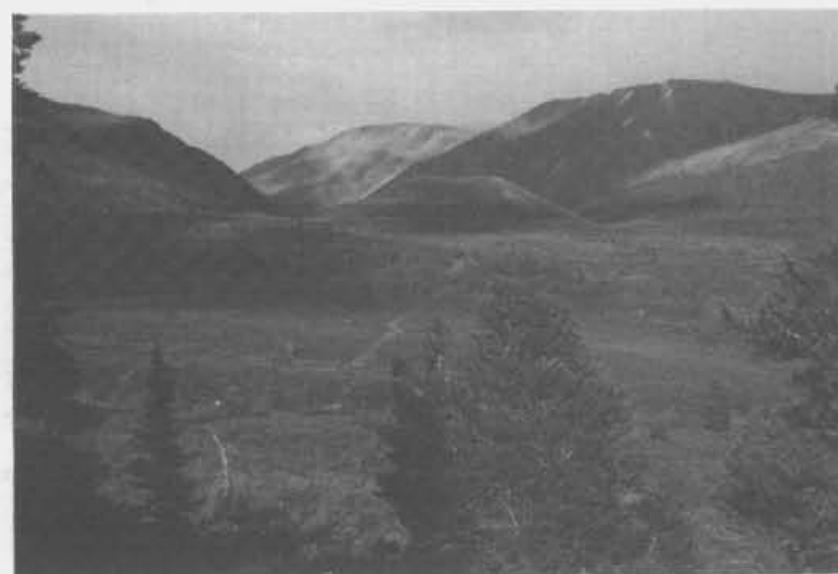
Figure 82

Looking northeast across Ruby Ck. at a small cinder cone in Cracker Ck. Pass, opposite Ruby Mtn. Assymmetry is due to prevailing westerly winds at time of eruption

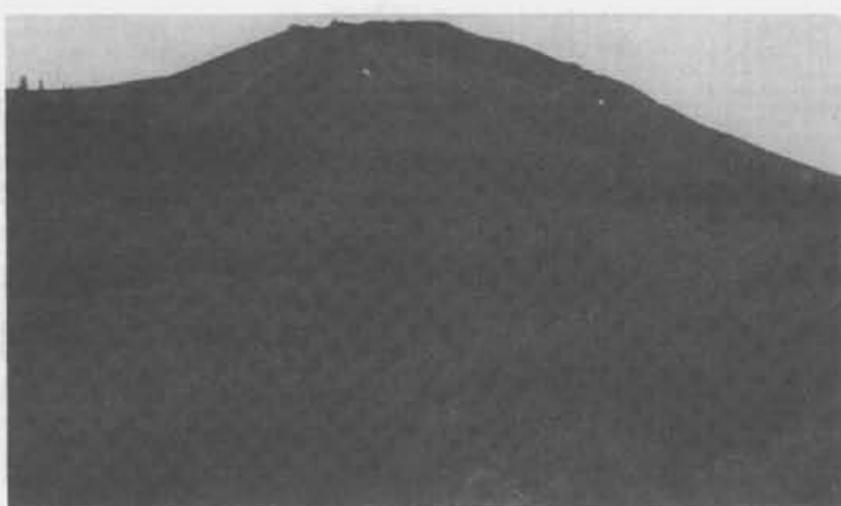
Figure 83

Ruby Mountain, a volcano east of Atlin, north of Surprise Lake and west of Ruby Ck. Looking west up a large slide from the southeast side of the peak, one of the sources of the brown scoria which blankets Ruby Ck. and the nearby columnar basalt flows.

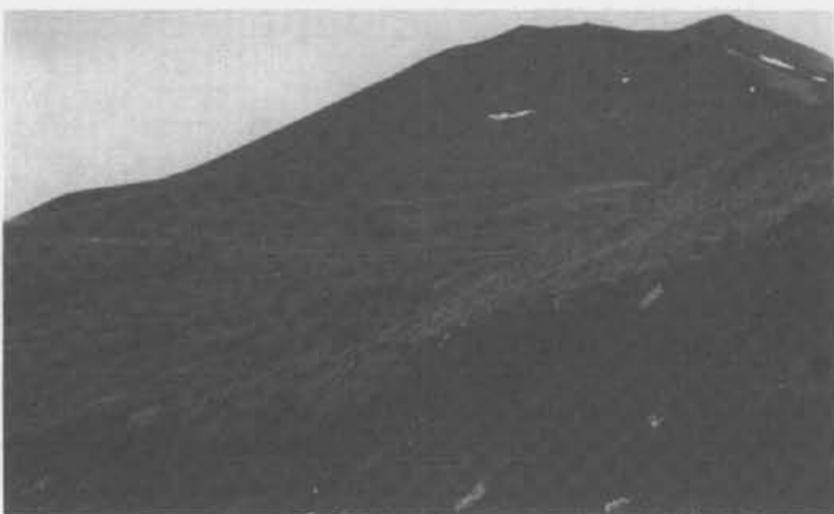
Figure 84

Ruby Mountain, near the Adanac molybdenum property. View looking south across a slide on the northeasterly side of the peak. Levies on the side of the slide are distinct. Scoria here is mostly jet black, and red.

Panorama of Adanac molybdenum property; angle of view about  $130^{\circ}$ , taken from road into property. Black "paving" on roads is scoria from slide on Ruby Mtn. (fig. 84). Mt. Leonard is situated directly above mill in photo.

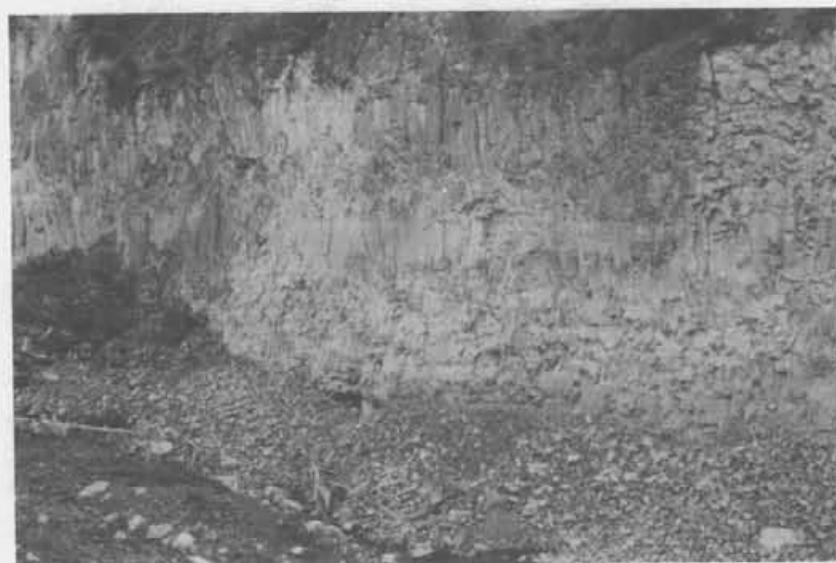
Figure 86

Columnar basalt in Ruby Ck., forming east bank. Origin of level line unknown; columns are seen to be continuous across the line. The base of the flow is near the center of the photo, at the column-talus line, where it overlies till(?).

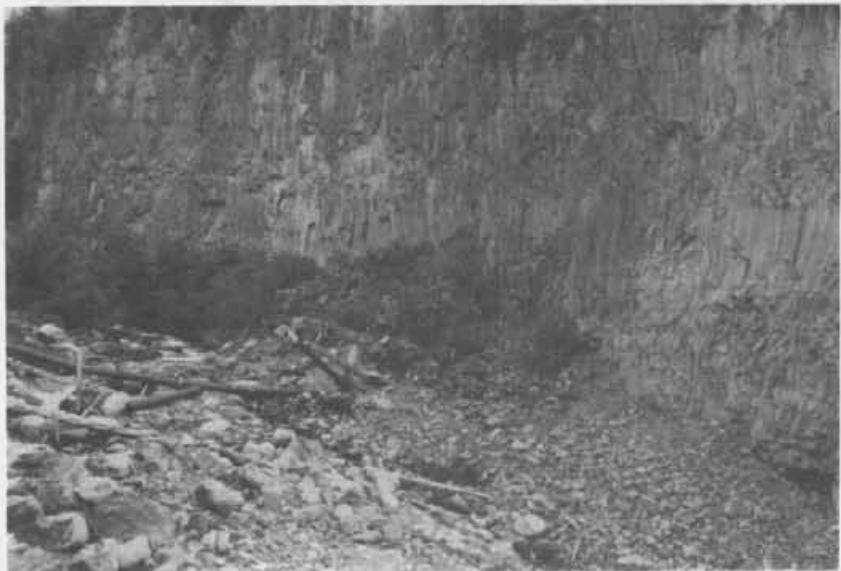
Figure 87

Columnar basalt cliffs, on Ruby Ck., and the monitor for working the gold-bearing channel gravels plus till which reportedly lie beneath the flow. Base of flow visible at bottom right of photo.

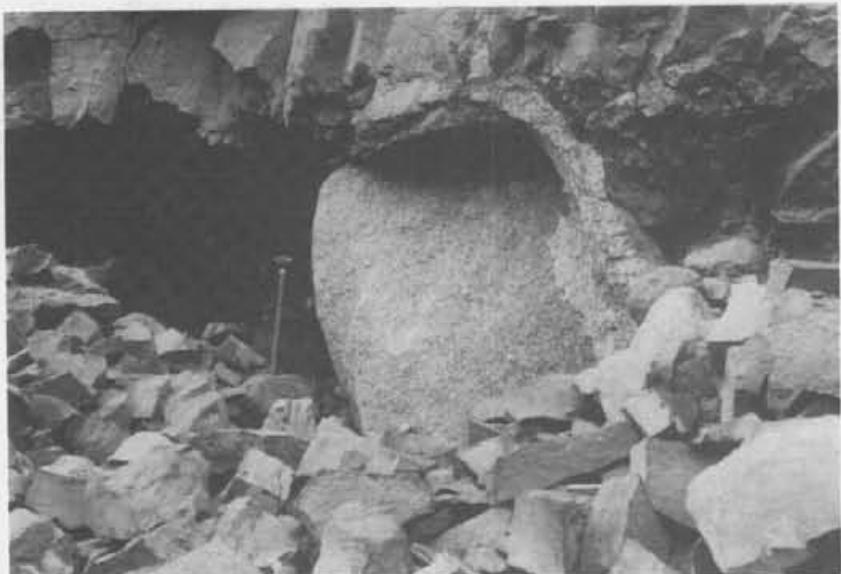
Figure 88

Detail of base of flow. Large granodiorite(?) boulder at right from either a boulder till(?) or channel gravel. Some gold was panned from cavity at left. Exfoliation on top of boulder is due to weakening caused by the heat of the flow. Talus in foreground is fallen basalt columns.

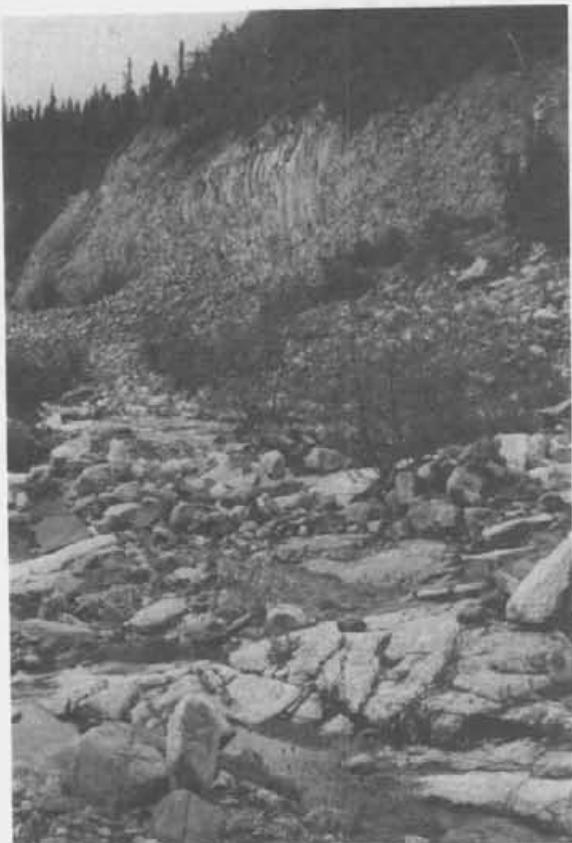
Figure 89

Looking north up Ruby Ck. from just below workings. The stream flows over intrusive bedrock, with gravels and till(?) at its margins, covered with columnar basalt. The boulder in Fig. 88 is possibly a scoured chunk of this bedrock, deposited in auriferous channel gravels and not necessarily a till, as other sources note.

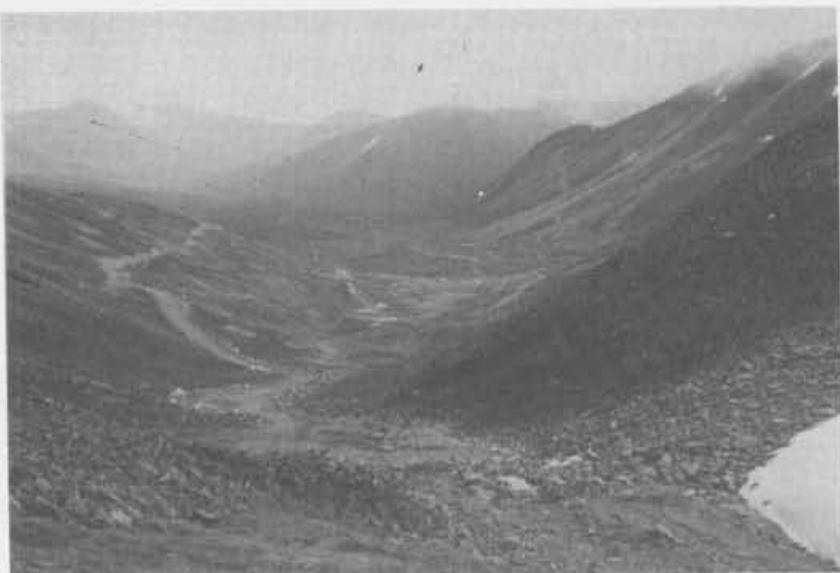
Figure 90

Adanac molybdenum property, east of Atlin on Ruby Ck. Looking N70°E down the pass over the claim group. Test mill for bulk moly samples in the distance, with camp beyond that.

The Adanac molybdenum property is located on upper Ruby Creek between Ruby Mountain and Mount Leonard. Access to the property is by a good road up the west side of Ruby Creek. Low grade molybdenum is disseminated as a porphyry in a granitic intrusive. About three stages (?) of intrusive are present ranging from fine to coarse grained. The rock is pinkish to orangeish coloured and is probably a monzonite to quartz monzonite. Very little molybdenum mineralization can be found in place. Some was found below Ruby Lake and also just above South Ruby Creek across from the test mill. A pyrite halo probably exists, though from the cirque only bright pyrite gossan zones are seen above the property. A camp and a good sized test mill, still in fairly good condition are situated on the property at about 4,500-5,000 feet on South Ruby Creek. The visit to the property was to record it by photos for the Ministry - these are included as figures 90-94.

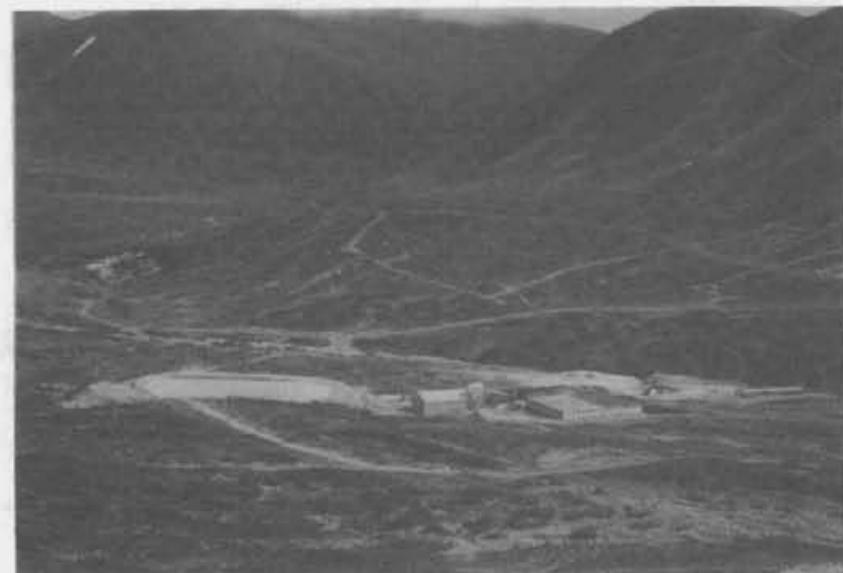
Figure 93

Adanac molybdenum, Ruby Ck. Test mill in lower center, camp at left; looking east. Ruby Ck. flows from right to left, then curves around mountain back to right.

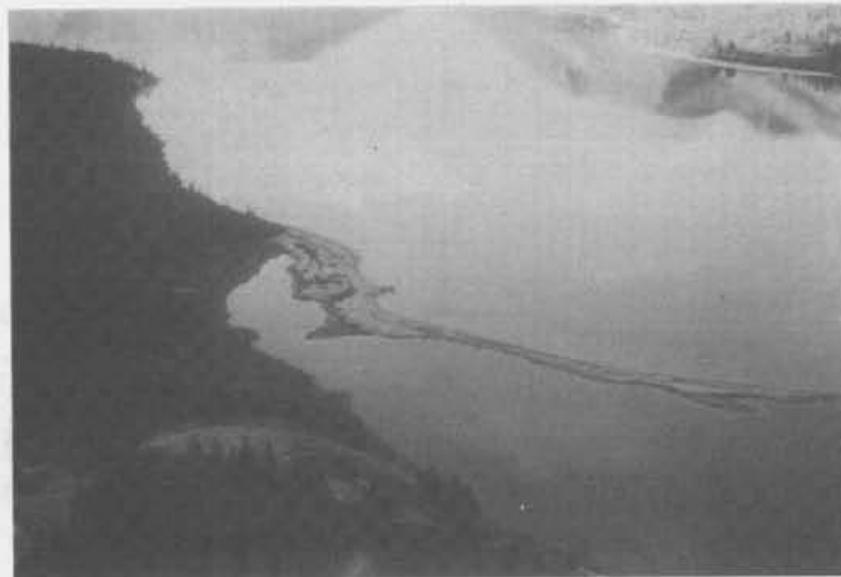
Recessional moraine at northeast end of Surprise Lk. View from helicopter looking south.

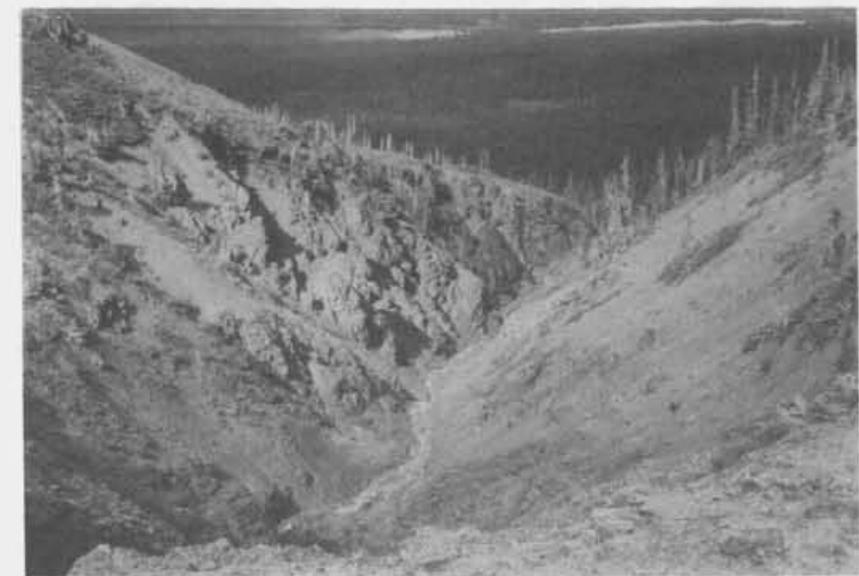
Figure 98, above.  
Johns Manville property east of Line Lk., along the Gladys River chain of lakes. View looking down south creek to the show situated in photo center. Abundant pyrite, some arsenopyrite, and possibly chalcopyrite, bornite, and chalcocite.

Figure 99  
Panorama of the southerly of two creeks, flowing from a high cirque, taken from its north bank, Johns Manville property east of Line Lk. Angle of view about 80°. Cirque is to upper left. Fig. 98 was taken looking down to right.

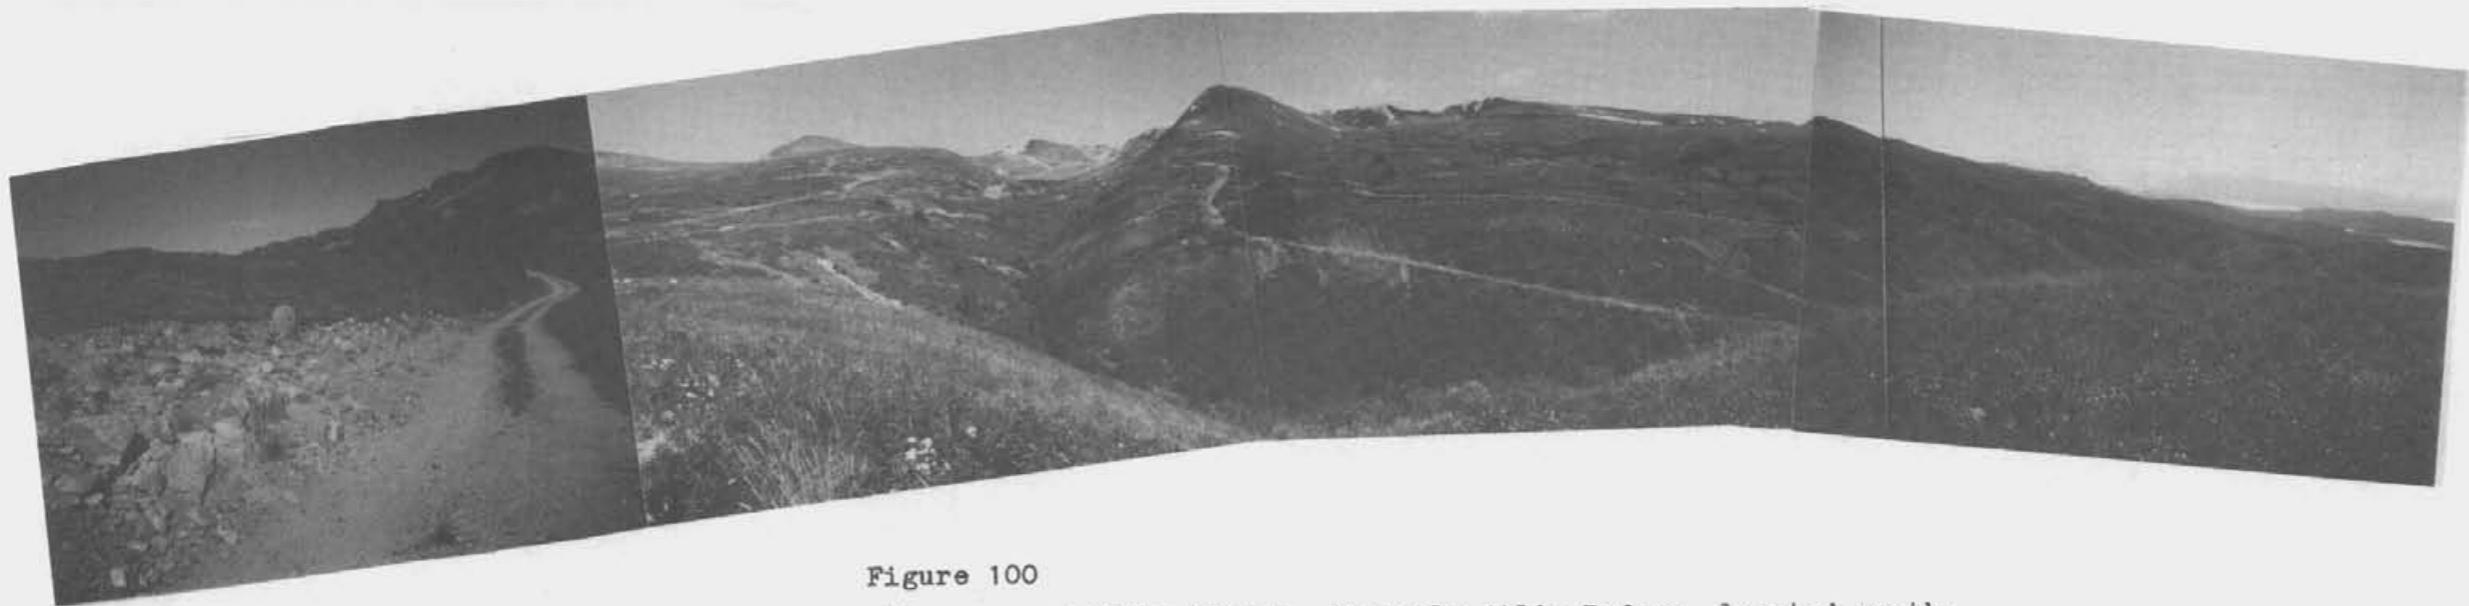
Figure 100

Panorama of Atlin Silver, formerly Atlin Rufner, located north-east of Atlin on the west flank of Mt. Leonard. Angle of view about 240°.

We visited Atlin Silver, up Fourth of July Creek (see figures 100-106), and were given a tour of the new mill by manager, Gene Larabie and met president, Claud Dancy. The mill, with a capacity of 100 tons of ore per day was scheduled to go into full production the following week at 50 tons per day. A few test runs had been put through the mill to locate and fix any 'bugs'. Run of the mill ore was 18 ounces per ton silver with assays up to 50 ounces per ton. The zinc concentrate made is 40% to 50% zinc with 2% lead and 20-30 ounces per ton silver; the lead concentrate is 50% lead with 150-170 ounces per ton silver, but has 12% to 15% iron as well.

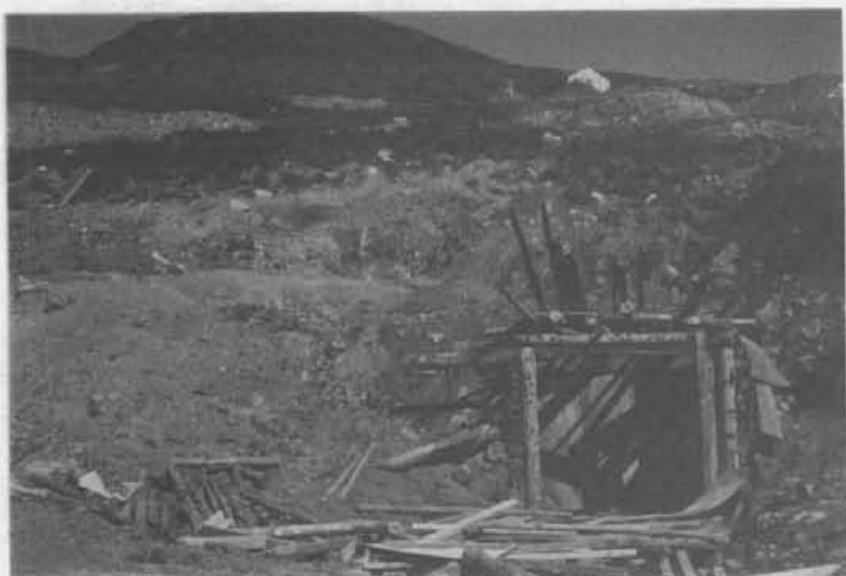
Figure 101

Atlin Silver, lower of upper two adits visited.

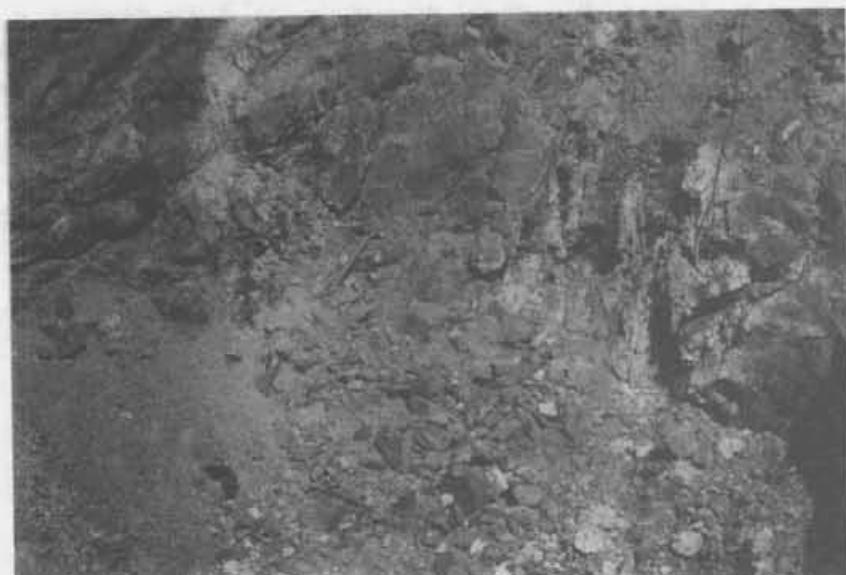
Figure 102

Atlin Silver, northeast of Atlin. Granitic wall rock and lamphyre dyke with galena-quartz stringers and some sphalerite in the upper of the two adits.

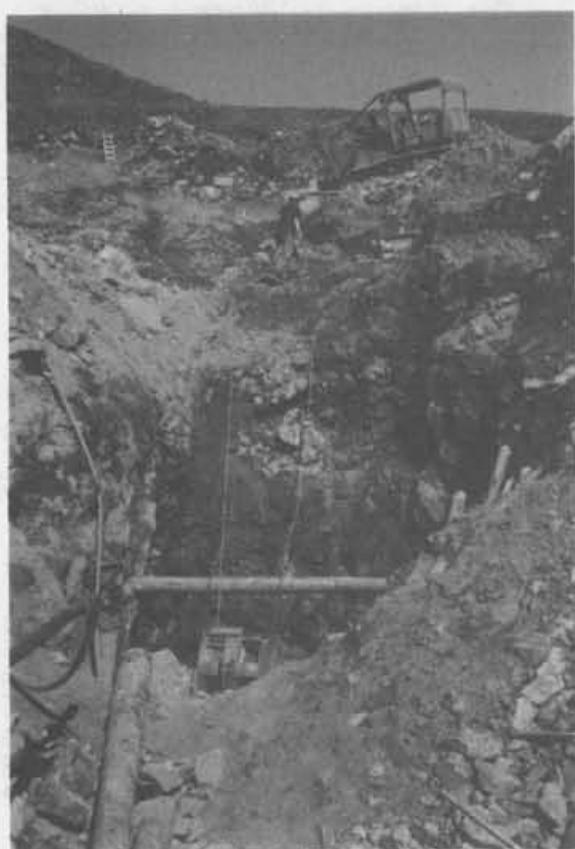
Figure 103

Atlin Silver, northeast of Atlin. Trenching and draw-point at caved, upper adit portal in a high grade vein.

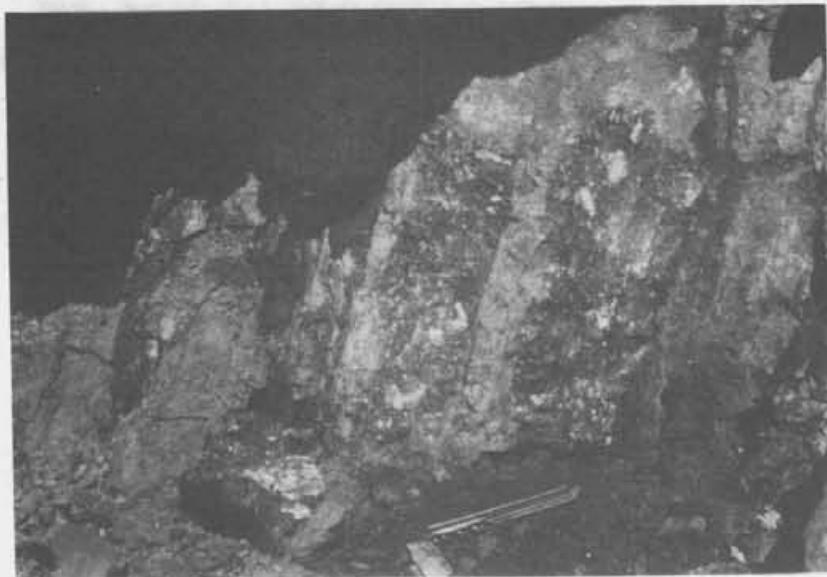
Figure 104

Chunk of high grade ore in vein at upper adit, Atlin Silver. Stringers of galena, separated by quartz crystal layers with which black sphalerite occurs.

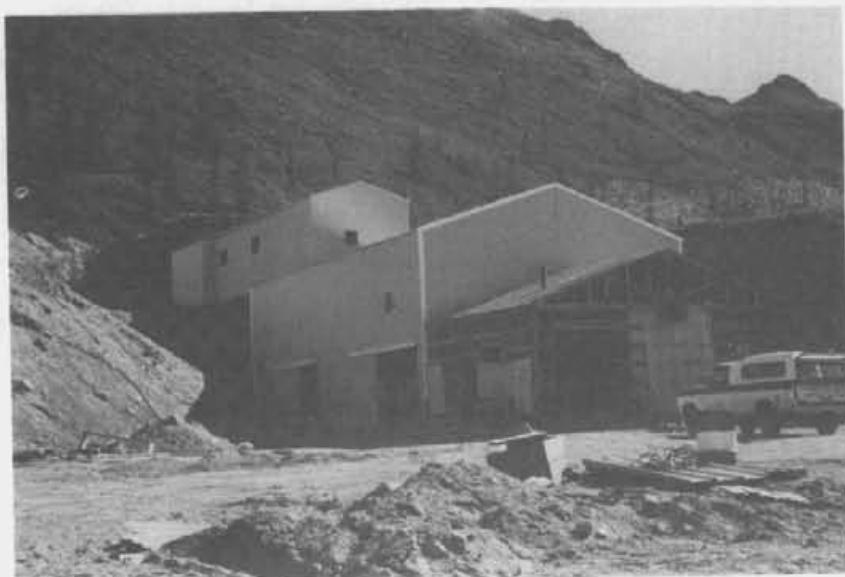
Figure 105

Atlin Silver mill, to run eventually at 500 t.p.d. with a capacity of 1000 t.p.d. Consists of two crushing stages, one grinding stage, plus flotation cells. Two concentrates are produced, lead and zinc, with most of the silver coming out in the lead concentrate.

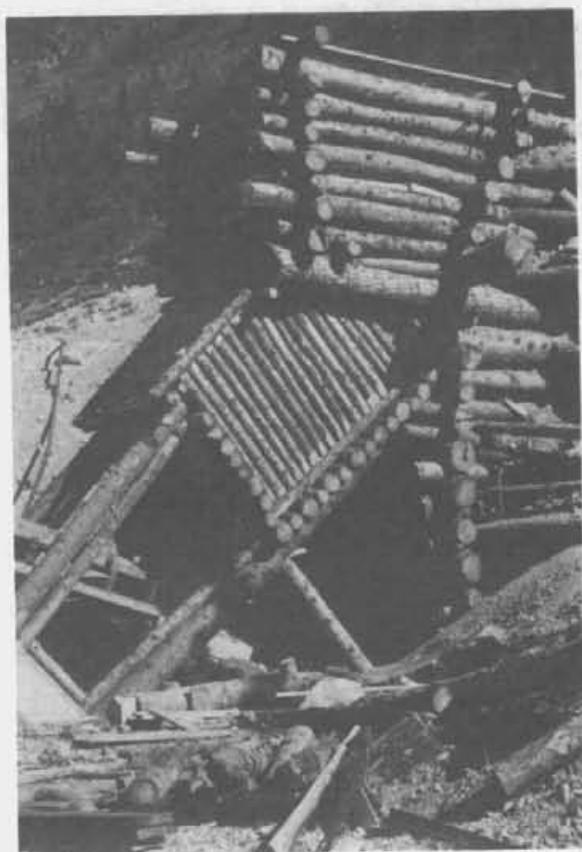
Figure 106

Atlin Silver coarse ore bin on the hill above the mill. A pan feeder at the bottom leads to a jaw crusher.

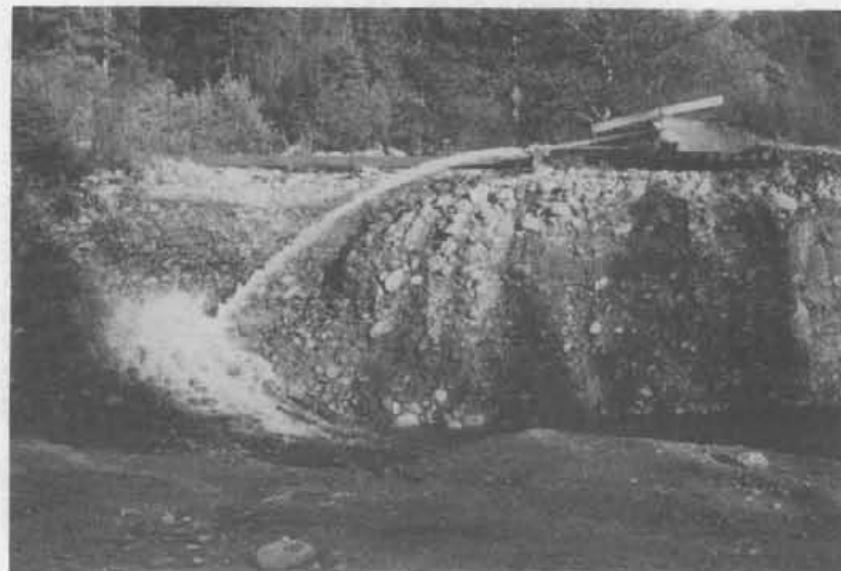
Figure 107

Centerville, B.C., north of Cassiar and a few hundred miles east of Atlin: George Zimmick's placer operation. One of two monitors is seen here on top of old channel gravels, 8-10 feet thick, which rest on fractured shale bedrock.

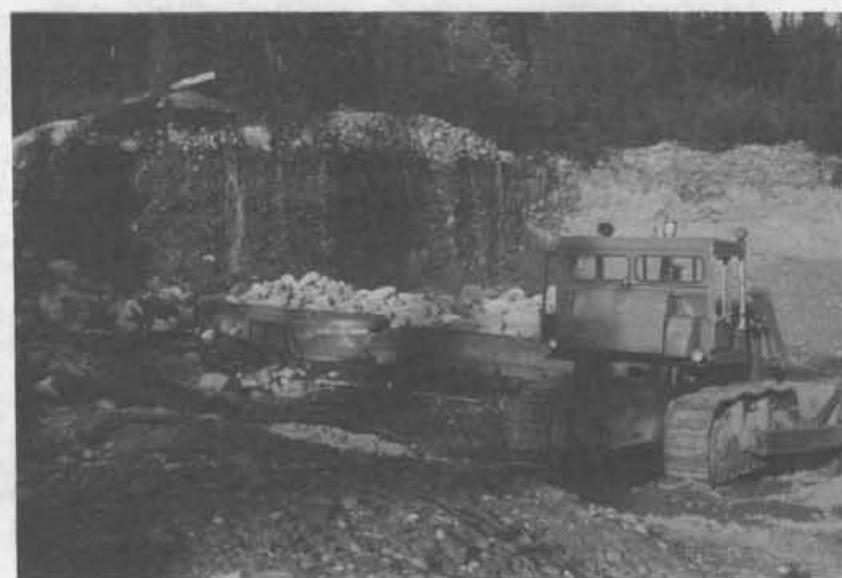
Figure 108

Centerville, B.C., sluice and cat; bedrock is seen in foreground.
