## QUATERNARY STUDIES IN THE PEACE RIVER DISTRICT, 1990: STRATIGRAPHY, MASS MOVEMENTS AND GLACIATION LIMITS (94P)

By P.T. Bobrowsky and C.P. Smith

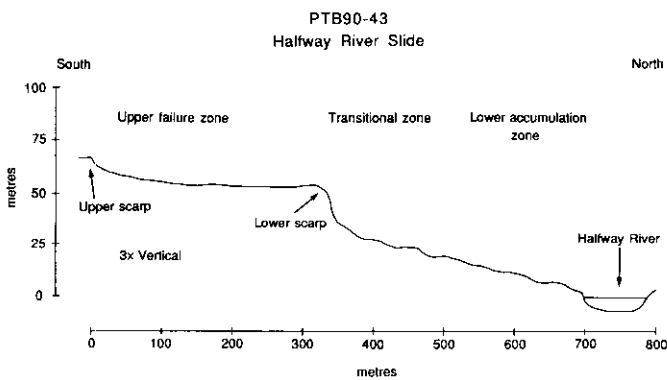
Figure 3-8-4. Longitudinal cross-section of locality PTB90-43 (Halfway River slide); failure occurred at 1500 hours on August 20, 1989. Mass movement is schematically divided into three parts: upper failure zone, transitional zone and lower accumulation zone.

At approximately 1500 hours, on August 20, 1989, some 5.5 kilometres north of Highway 29, Pleistocene terrace sediments on the south side of the Halfway River catastrophically failed (Figure 3-8-2, Plate 3-8-1). The resultant debris flow of about 1.88 million cubic metres temporarily dammed the river for up to 6 hours, at which point overtopping of the dam was followed by breaching. The area of the river dammed by sediment measures approximately 100 by 440 metres. During the period of damming, the course of the Halfway was diverted northward across the vegetated floodplain and point bar on the opposite side of the river. The event can be considered a Type I landslide dam of Costa and Schuster (1988). The affected area of the flow is described in relation to three zones: an upper failure zone; a middle transitional zone; and a lower accumulation zone (Figure 3-8-4).

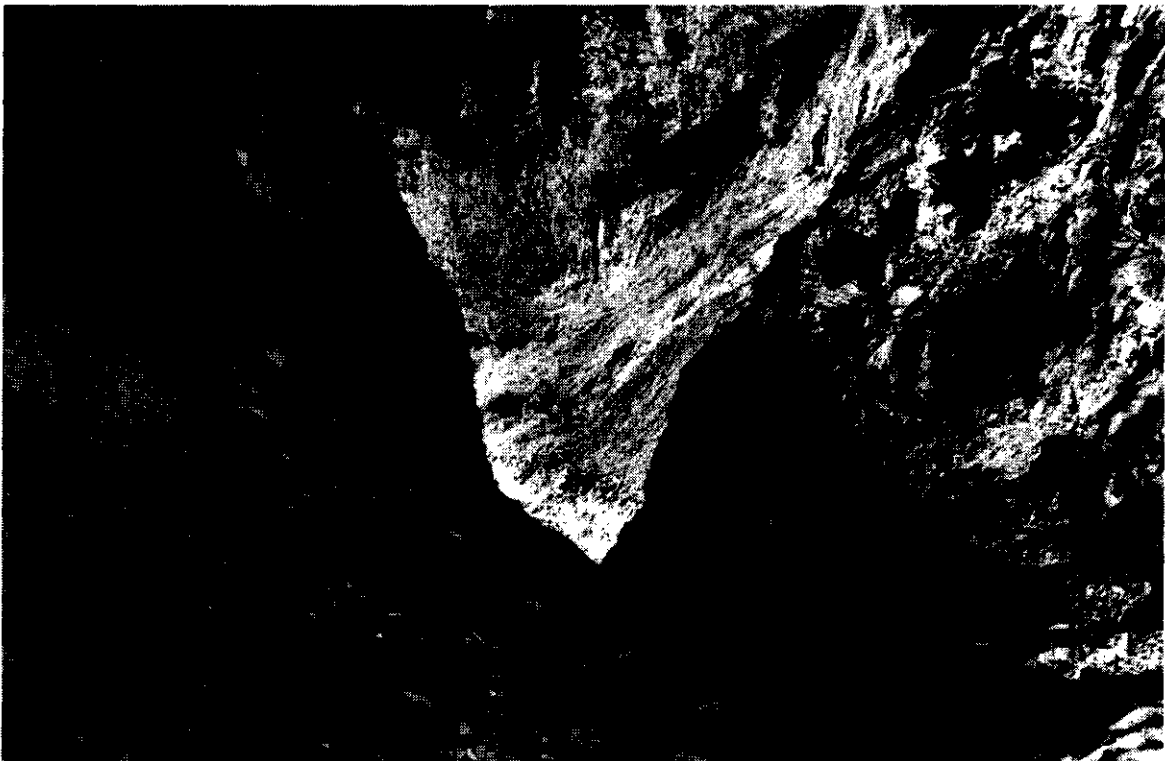
Plate 3-8-5. View down slope from end of elevated conduit gully toward nick point and amphitheatre feature.

The geomorphology of the site consists of a gully 3 metres deep (A) which borders an open field on an upper terrace adjacent to a main tributary valley (C) (Figure 3-3-7; Plate 3-8-5). The elevated gully (A) serves as a water conduit to a small amphitheatre-like erosional feature (B) which "represents the adjustment of the landscape to recurrent intervals of erosion by running water and slope failure" (Eisbacher and Clague, 1984:15). The elevated gully intersects the amphitheatre at a nick point 2 metres above the highest point of the sloped surface (Figure 3-8-8). The amphitheatre has a horizontal length of 55 metres and a height of 27.2 metres in relation to the main tributary valley (Figure 3-8-8).

Much of the original sediment is derived from the bank walls of the conduit gully directly above the nick point (Plate 3-8-5). During the course of our work in the days preceding the mud flow event, our mapping of the section had severely lessened the sediment strength and integrity of

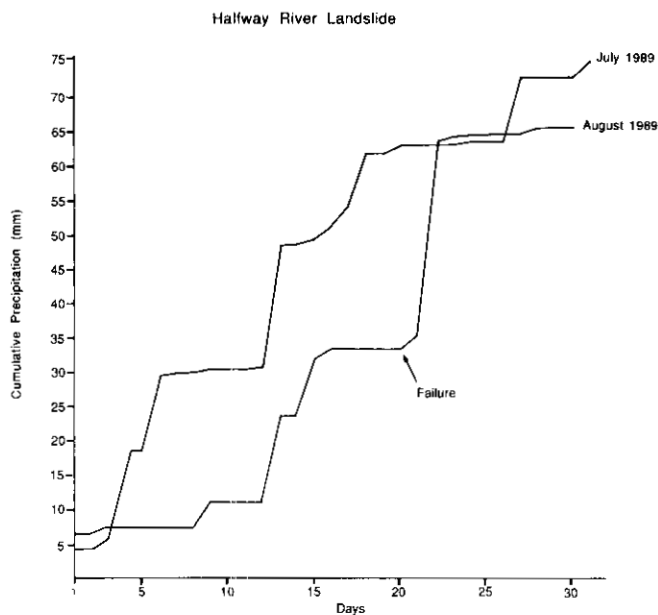
Figure 3-8-6. Precipitation record for the period preceding the Halfway River slide in northeastern B.C.

Throughout the Holocene, including today, the Peace River District has proven to be the centre of a variety of mass movement phenomena. Many of these events were and continue to be either threatening or costly. The large mass movement on the Halfway River which temporarily dammed the flow of water could have been disastrous under different circumstances. Rainfall historically proves to be a prime impetus for triggering slope failures (cf. Church and Miles, 1987; Evans and Clague, 1989). Long-term water-accumulation appears to be a good explanation for the Halfway River slide. Precipitation for August, 1989 (Halfway River slide) was 64.9 millimetres which is over twice the 22.9 millimetre total for May, 1973 (Attachie slide). Neither month-end precipitation total reflects heavy rain.

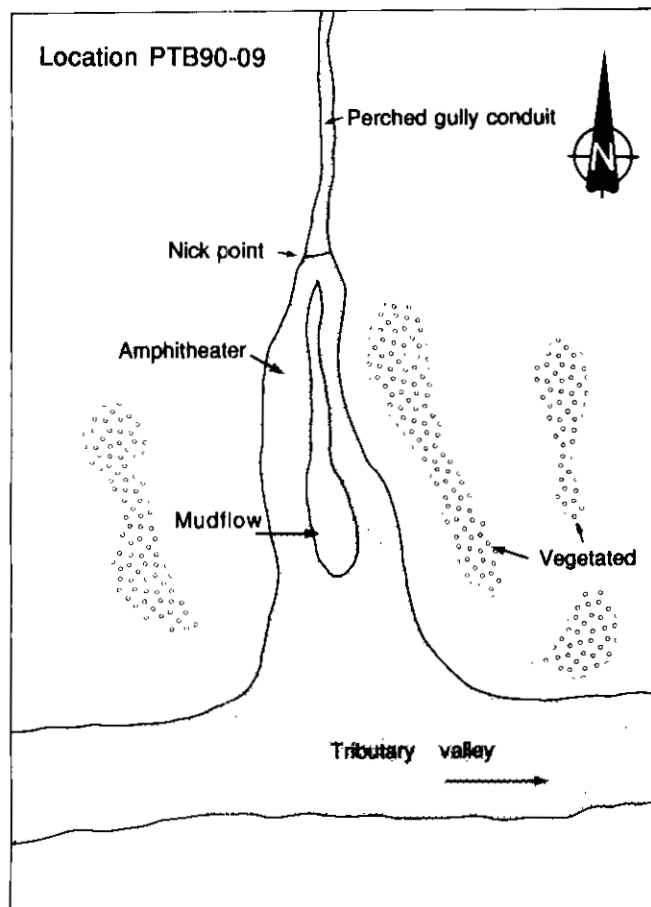
Figure 3-8-7. Conceptual plan view of locality PTB90-09 described in detail by Bobrowsky *et al.* (1991). Note location of (a) elevated conduit gully, (b) amphitheater and (c) main tributary.

On the evening of July 4, 1991, during a local rainstorm depositing 3.8 millimetres of precipitation, a small mud flow was deposited in a gully of a tributary valley containing a well-exposed stratigraphic section (Section PTB90-09 described in Bobrowsky *et al.*, 1991; Figure 3-8-7). The precipitation record for the area indicates that rainfall for that day, as well as for the preceding weeks, was essentially average for the time of year. Meteorological conditions often cited as generating debris flows can be discounted; instead, sediment disturbance by us during mapping is a more likely antecedent cause of this event which was finally triggered by the local rainstorm.

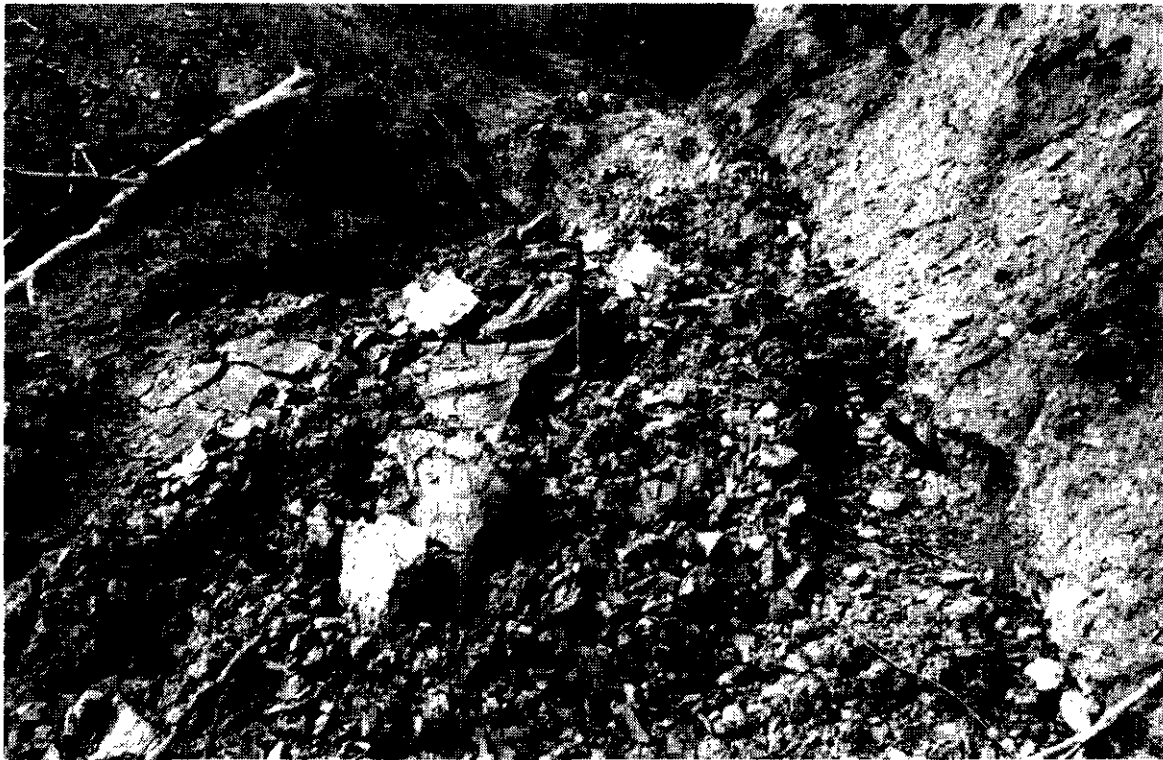
Plate 3-8-6. View up slope of mud-flow nose. Pick for scale is 65 centimetres long. Note angular nature and size of debris blocks. Note also marginal undercutting of slope on right side of photo (arrow).

A mud-flow scar and deposit occur within the amphitheatre feature. The plug-nose of the deposit is up to 1.5 metres thick and 4.5 metres wide (Plate 3-8-6). The outer edge of the plug is not well defined as the deposit actually continues down-slope to a lower sediment dump of lighter and finer grained material, but an approximate limit is 55 metres from the edge of the nick point. Debris in the plug consists of small to medium-sized angular blocks of hardened mud, a few fragments of which are over 1 metre in maximum dimension. These blocks represent sheared and fragmented pieces of the adjoining chute-channel walls. Their emergence at the surface of the flow is probably a result of intergranular dispersive forces, buoyancy of larger fragments and forward push of debris from behind (*cf.* Eisbacher and Clague, 1984). The up-slope end of the plug gradually grades into a tail feature which extends almost up to the amphitheatre edge at the base of the nick point (Plate 3-8-7). This proximal sediment accumulation consists mainly of large pebble to cobble-sized clasts. Most of the clasts are remnants of the flow which lagged behind as the channel-flow forces diminished. Additional washing by rain further winnowed the fine sediments from this pebble-cobble lag. Lateral margins of the chute are defined by a levee, which represents the zone of laminar flow and sediment spill-over (Plate 3-8-8). The debris levees range in thickness from less than 5 centimetres to 70 centimetres. From crest to crest, the chute width averages 3.1 metres, whereas the depth ranges from 0.30 to 1.60 metres, averaging about 1.2 metres.

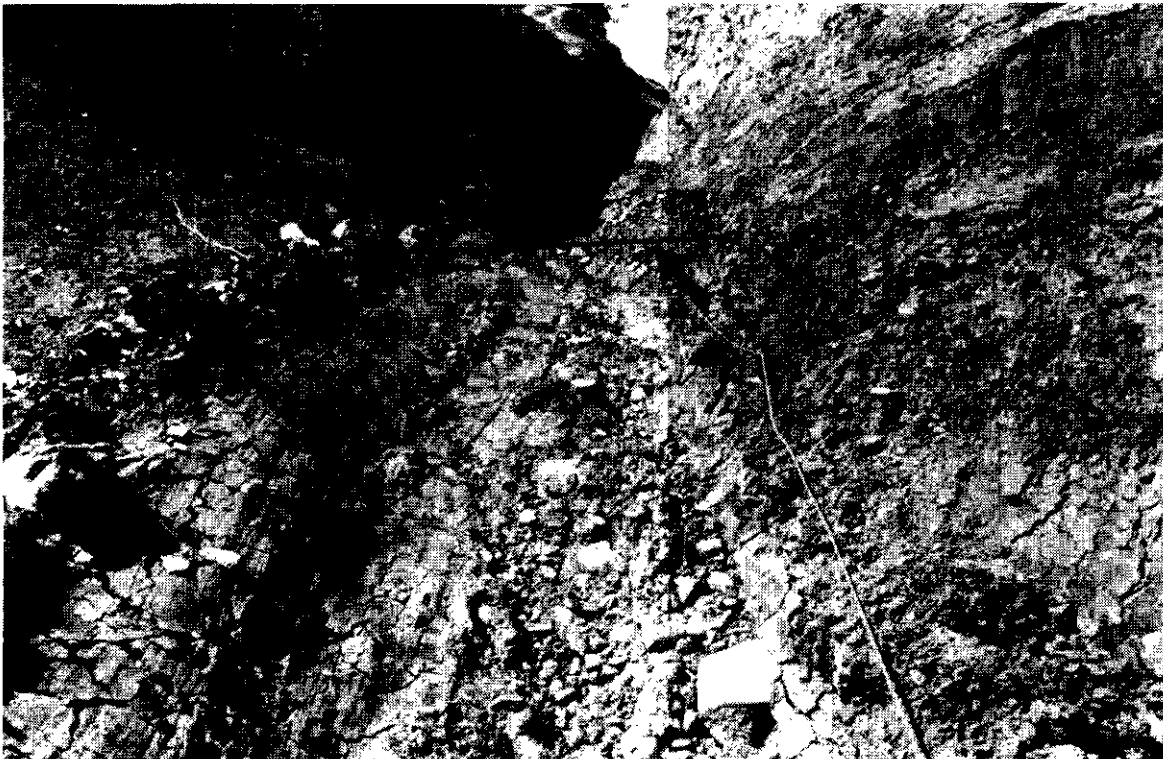
Plate 3-8-7. View up slope of mud-flow channel scar. Arrow points to horizontal scale which is 3.1 metres in length. Note relation of marginal levee, slickensided surface and central washed-pebble lag deposit.

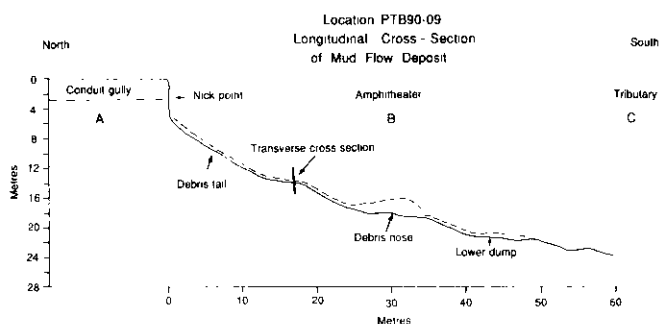
Figure 3-8-8. Longitudinal cross-section of PTB90-09 and mud flow deposited in the afternoon of July 4, 1991.
