Fontas Road Aggregate Prospect: Kilometre 48, NTS 94H, Northeastern British Columbia

Aggregate Prospecting Report 2009-1

FONTAS ROAD AGGREGATE PROSPECT: KILOMETRE 48, NTS 94H, NORTHEASTERN BRITISH COLUMBIA

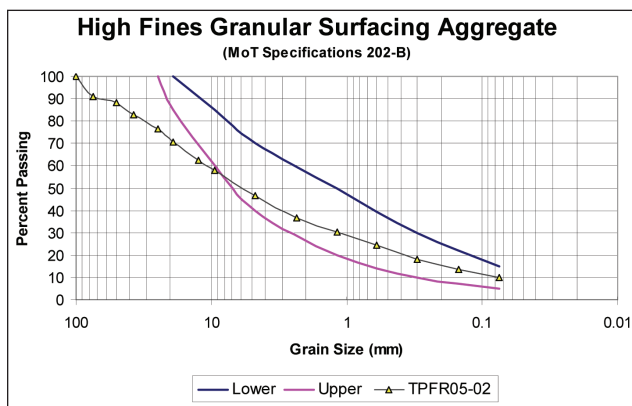
Figure 4. The upper and lower curves define the grain size distribution acceptable by MoT for high fines granular surfacing aggregate .

In order for the material to be used as High Fines Granular Surfacing Aggregate (Figure 4), screening or crushing of clasts greater than 20 mm is required. Although crushing may decrease the clasts size, the additional fines generated will require processing in order to maintain the appropriate gradation specifications. The material may be suitable for 25 and 50 mm Well Graded Base Course Aggregate if both the larger size fraction (>20 mm and >50 mm size fraction for the 25 mm and 50 mm specifications, respectively) and the fines can be reduced (Figure 5). The material is not appropriate for Intermediate Graded Base Coarse Aggregate

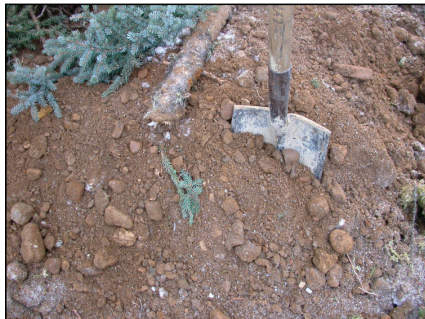
TEST PIT No. TPFR05-01

Depth (m)		Material Type		Estimated Gradation (%)			Oversize	Max	Water Table	Sample	Comments
Top	Bottom	Description	MUSCS	Fines	Sand	Gravel	(%)	(cm)	(m)		
0	1.5	GRAVEL and SAND	GM	10	40	30	20	10	NA		Poorly sorted, good gravel with sandy matrix; massive; well rounded to sub-angular; mainly local clasts.
1.5	2.6	SAND and GRAVEL	SM	20	50	30	0	6			Sand with some gravel; coarsens up; gradational upper contact; sharp lower contact.
2.6	4.2	SAND, clayey	SC	30	70	0					Laminated, silty-clay to silty-sand and fine sand; no clasts.

Gravel from top 1.5 m.

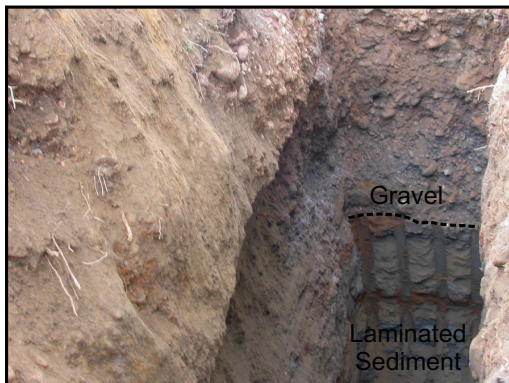
TEST PIT NO. TPFR05-02

Depth (m)		Material Type		Estimated Gradation (%)			Oversize	Max	Water Table	Sample	Comments
Top	Bottom	Description	MUSCS	Fines	Sand	Gravel	(%)	(cm)	(m)		
0	2.1	GRAVEL, sandy	GM	10	35	40	15	15	NA	TPFR05-02	Good gravel with medium to coarse sand matrix; well-rounded clasts; some fine sand and silt; oxidized in places.
2.1	4.8	SAND, clayey	SC	30	70	0					No clasts; well laminated fine silty sand; oxidized in places.

Gravel over laminated silty, clayey fine sand. The contact is shown by the black line.

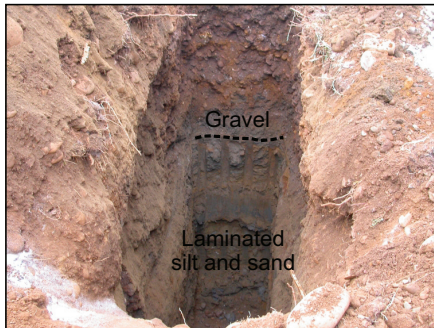
Gravel from upper 2.2 m. ►

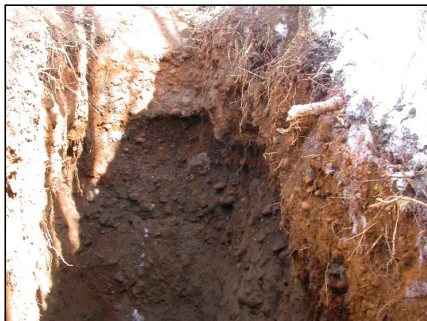
Gravel from upper 2.3 m.

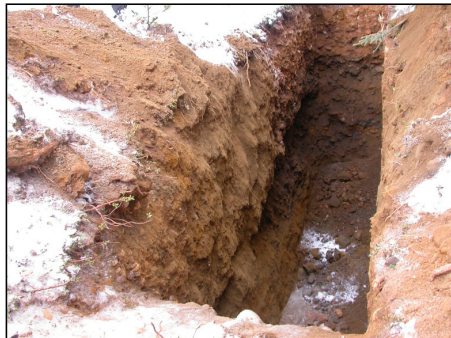
Gravel in upper 2.4 metres. The view is to the south into the ridge.

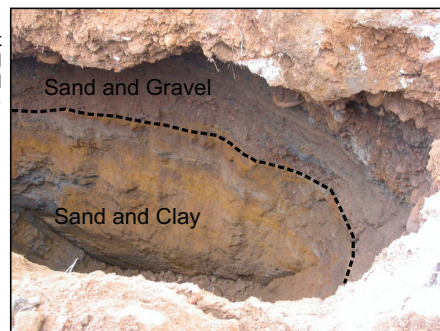
◀ Gravel over laminated silty fine sand and clay,

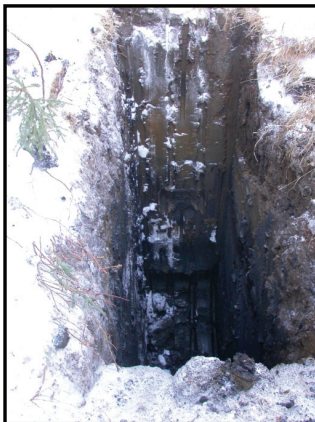
This test pit contained organic-rich clay in the upper portion and massive silty clay below. The pit contained no granular material.
