GEOLOGICAL INVESTIGATION OF THE
UNDERGROUND WORKINGS:
SUKUNKA COLLIERY

PREPARED FOR: B P EXPLORATION CANADA LIMITED

BY: G R JORDAN CONSULTING SERVICES LTD.

DECEMBER 1977

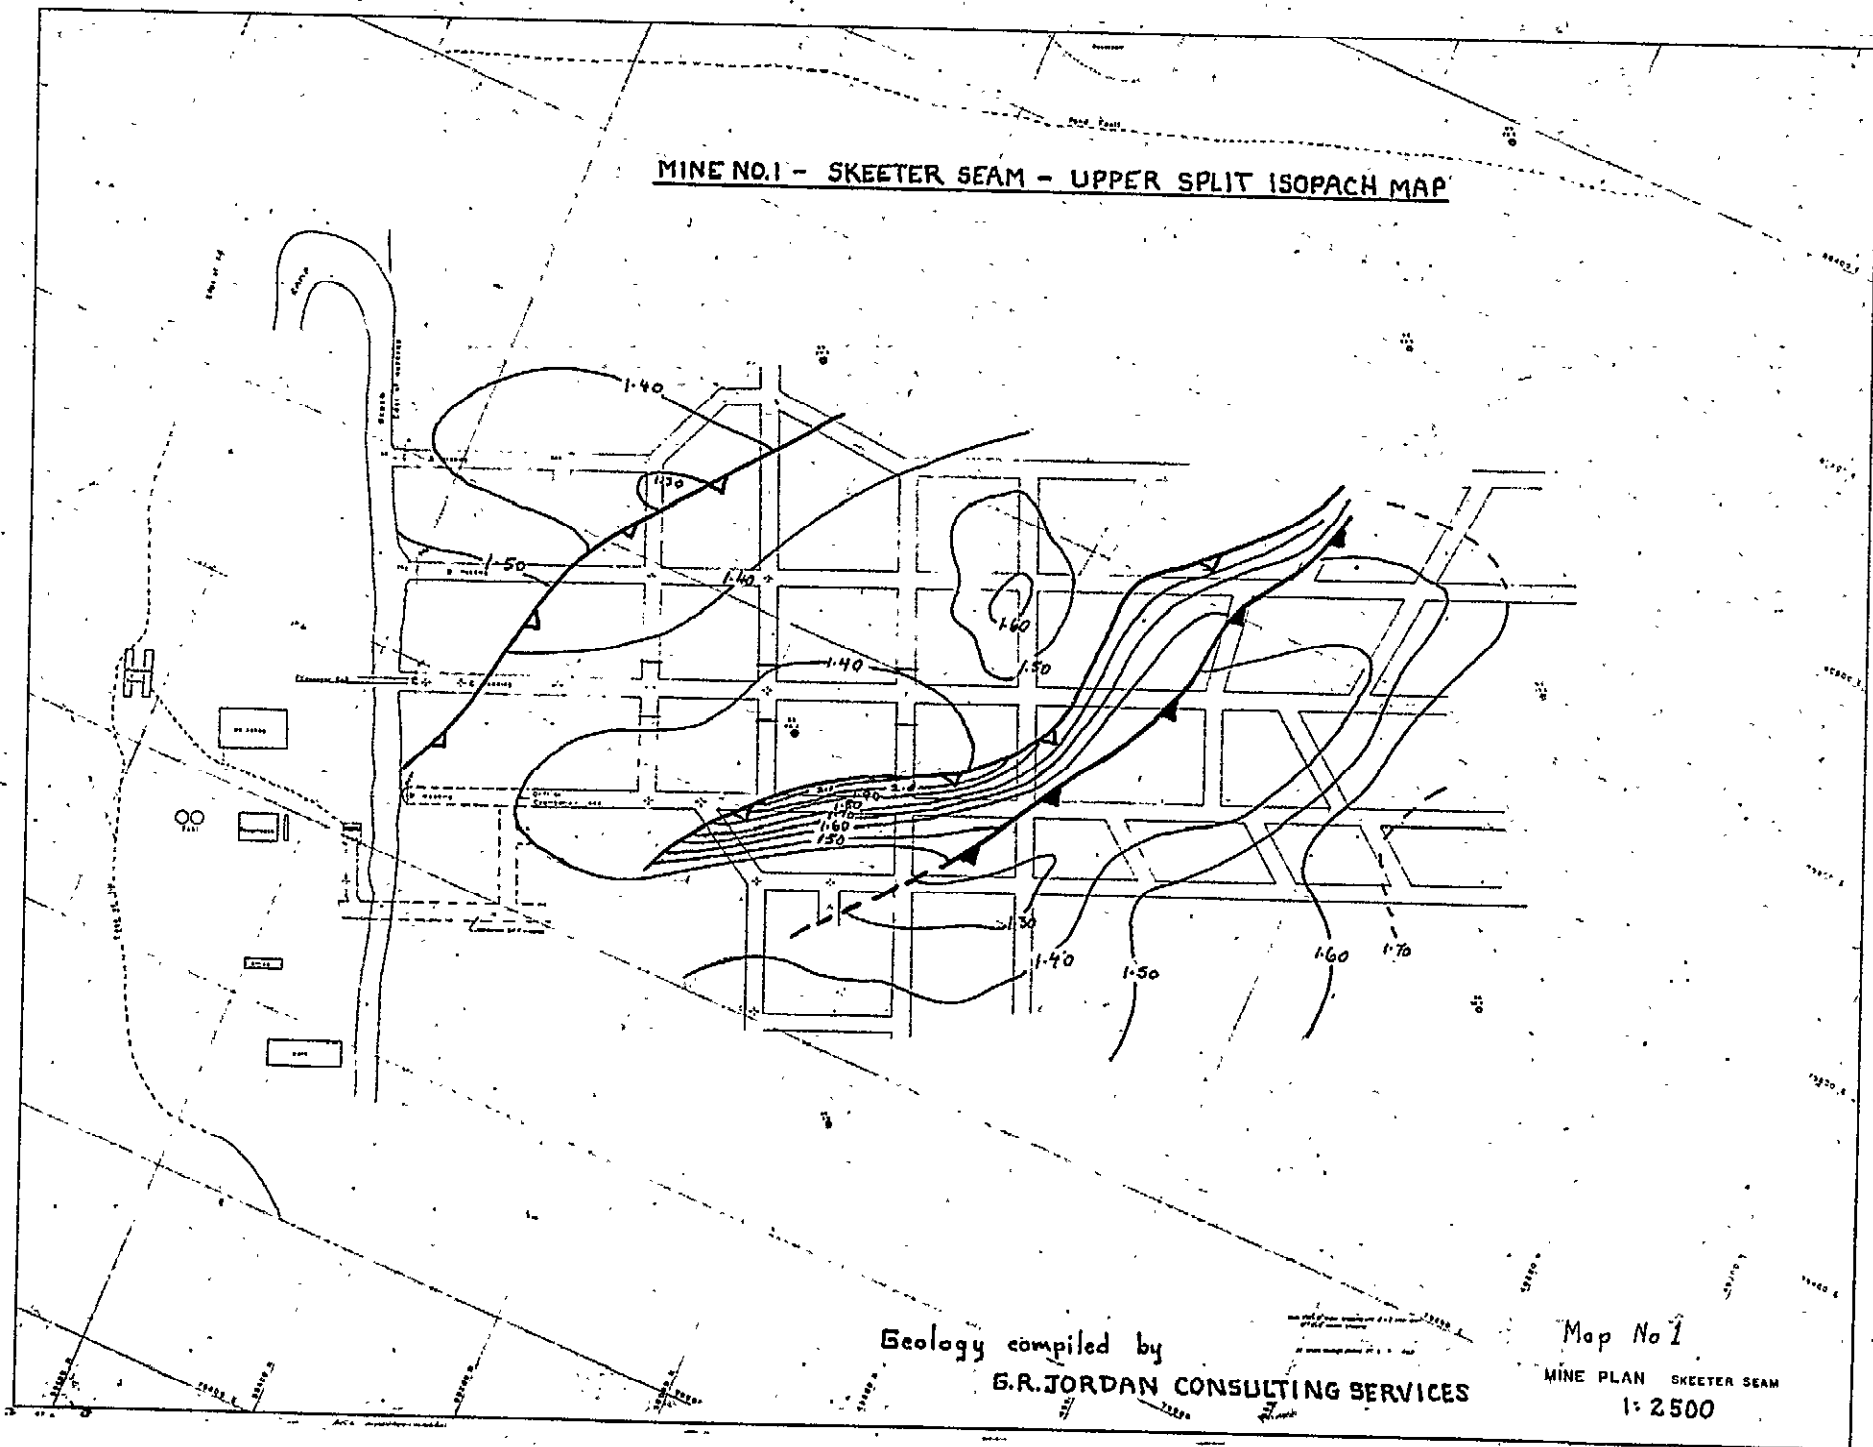
Map No 1
MINE PLAN SKEETER SEAM
1" = 2500'

The upper coal parting is characterised by a zone of bright coal bands near the top and by a very persistent and easily identifiable bed of dull hard coal towards the base. The contacts of the coal with the roof and the rock band are sharp with no gradation to mudstone. Thin bands of hard dull coal are usually located at the contacts, although these bands were often found to be intensely sheared by tectonic movement at the coal-rock interfaces.

MINE NO. 1 - SKEETER SEAM - UPPER SPLIT ISOPACH MAP

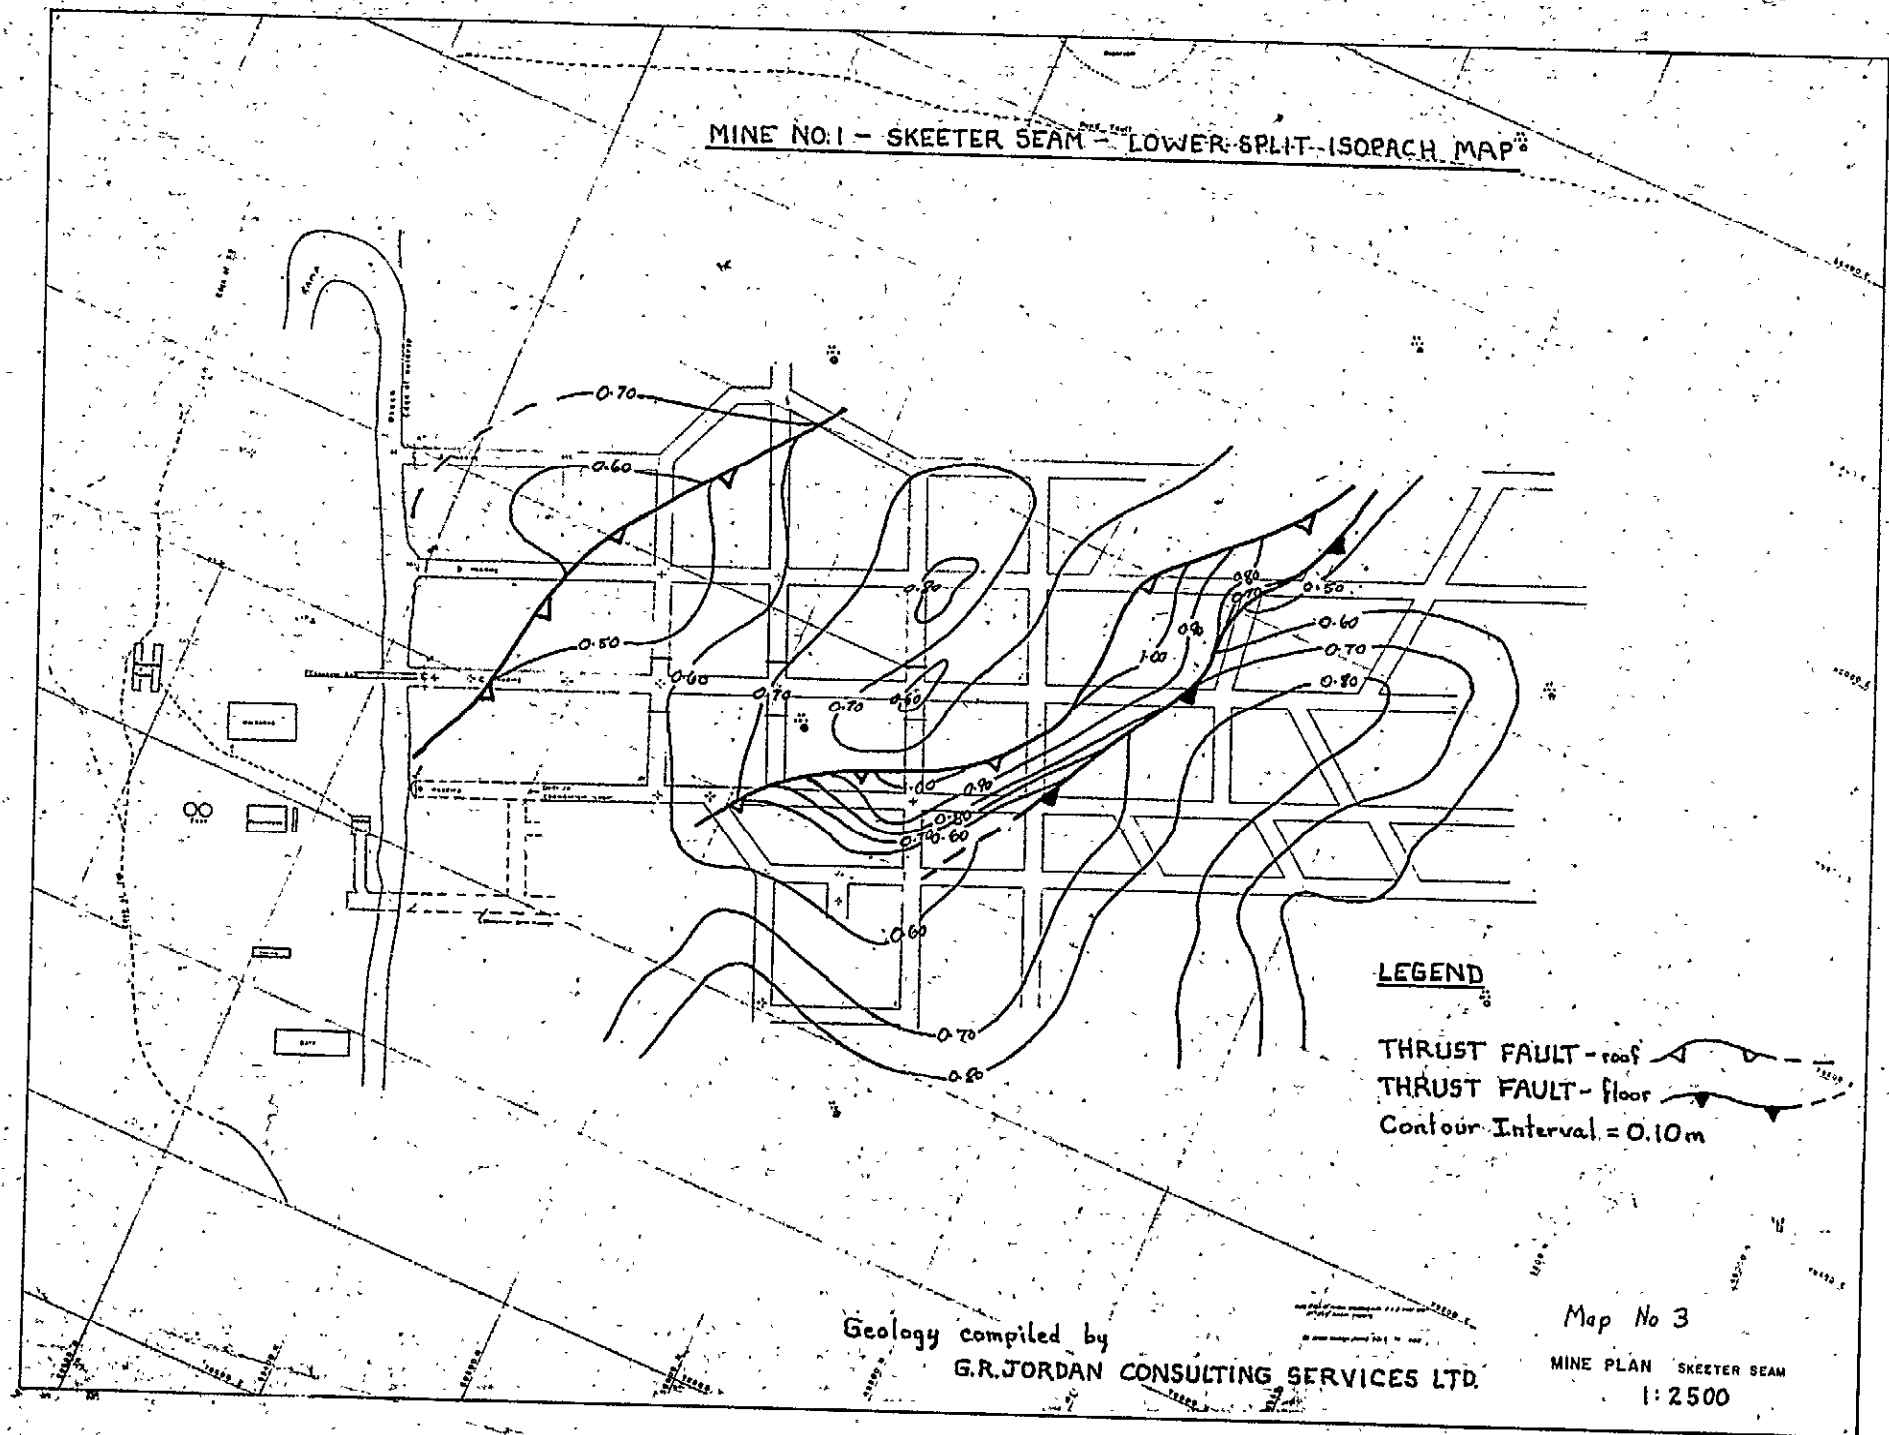
MINE NO.1 - SKEETER SEAM - LOWER SPLIT ISOPACH MAP

The lower coal split is characterized by dull banded coal in the top half becoming dull and bright banded coal in the lower half. The lower dull and bright coal is usually intensely sheared and soft. the pattern described above is found in all seam sections measured throughout the mine workings. The contacts between the rock band the seam floor are sharp with no gradation to mudstone. Map No. 3 is an isopach map of the lower split and, like the upper split, shows that there is little normal variation of split thickness from the portal to the face except for a tectonically disturbed zone where a system of thrust faults trends across the mine workings.

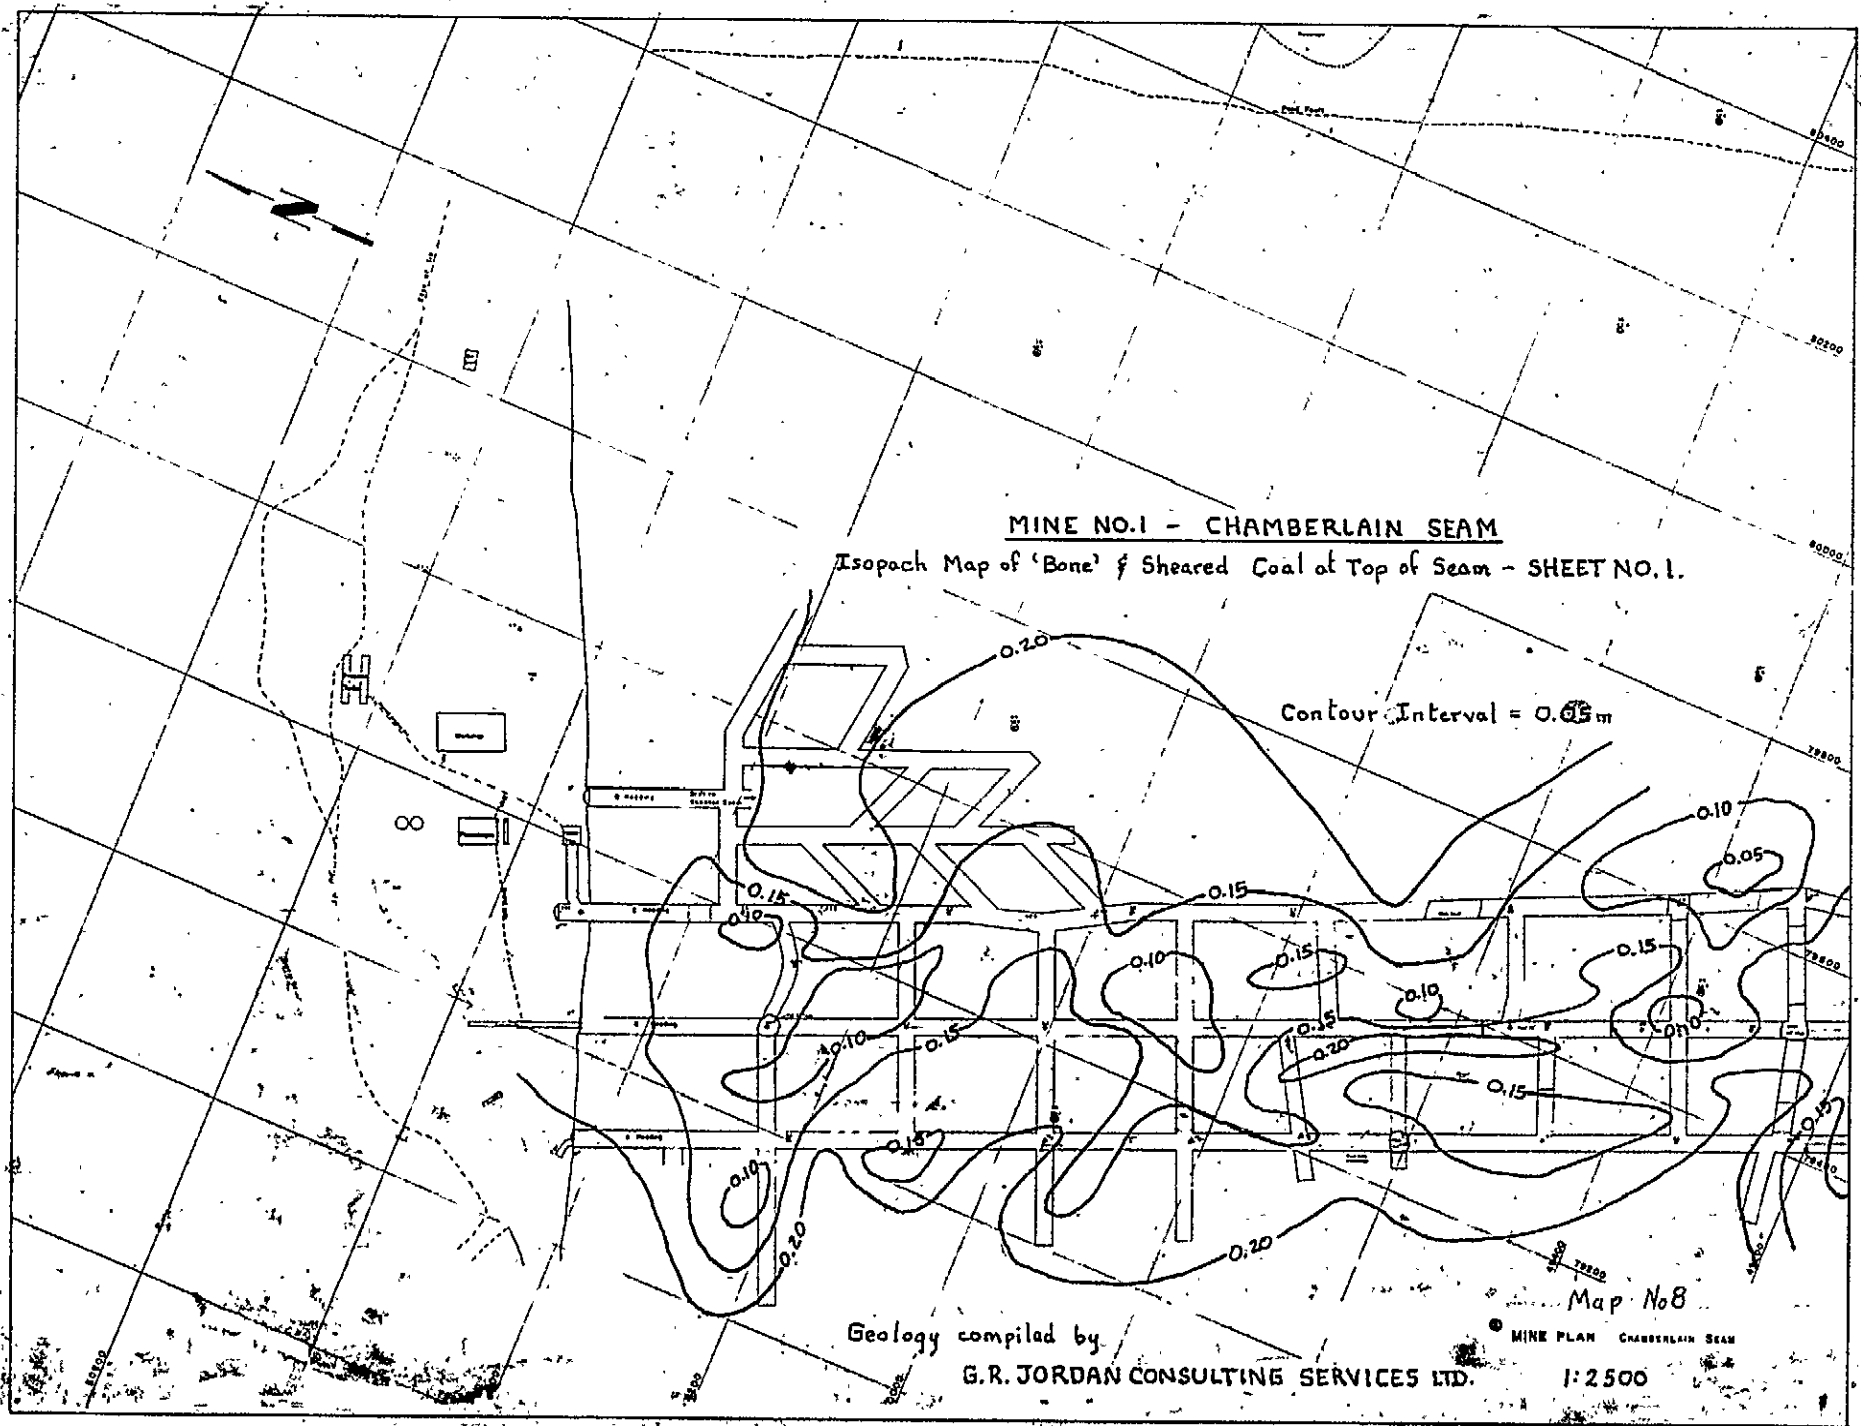
MINE PLAN CHAMBERLAIN SEAM

Map No. 7 shows the location of seam sections measured in the Chamberlain seam workings of Mine No. 1. The graphic sections prepared from these measurements are included within Appendix "A". In the more recent workings of the Chamberlain seam, laminite was again the only immediate seam roof lithology observed.

During an inspection of the Chamberlain seam workings it was observed that a large amount of the seam roof had failed and scaled off as bedding plane slabs or flakes. The same phenomenon was observed during the earliest workings of the Chamberlain seam at Mine No. 1 prior to the installation of heating equipment. At that time the rapid rate of deterioration of the seam roof caused considerable concern.

Subsequent to the installation of heating equipment it was found that roof deterioration was greatly retarded. It was concluded that the freezing of moisture in the roof was forcing the beds to separate and fail in a manner similar to frost heaving. In the new workings of Mine No. 1 flooding of the mine followed by removal of the mine water and freezing probably has resulted in the extreme amount of immediate seam roof deterioration.

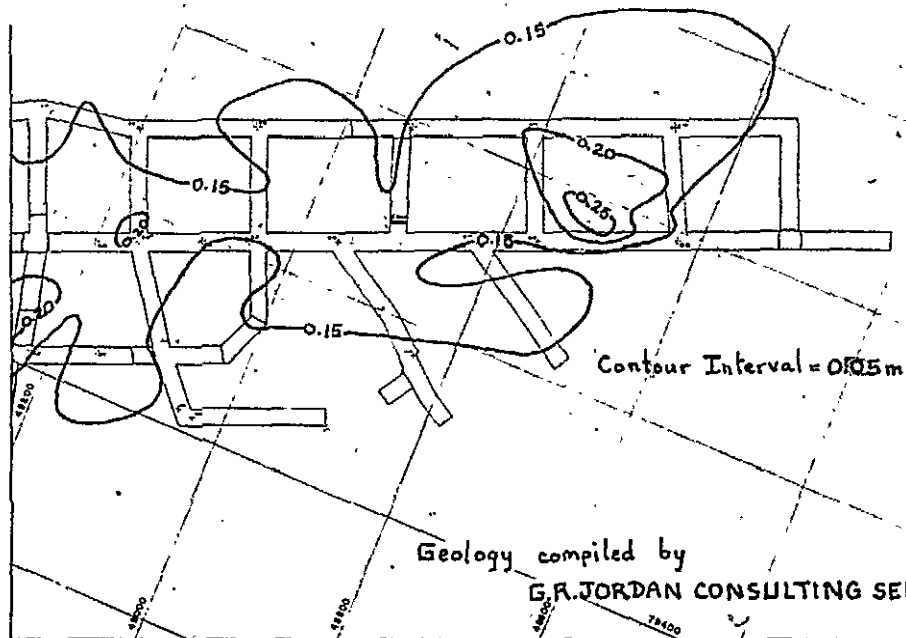
SCALE - 1:2500 Map No 8

Isopach Map of 'Bone' & Sheared Coal at Top of Seam - SHEET NO.2.

Patterns of roof joints can be readily observed in the "Window Mine" area. Time limitations have not allowed a detailed investigation of these structures to be made. However, the principal joint directions are shown on Map No. 8 at several locations within the mine workings.

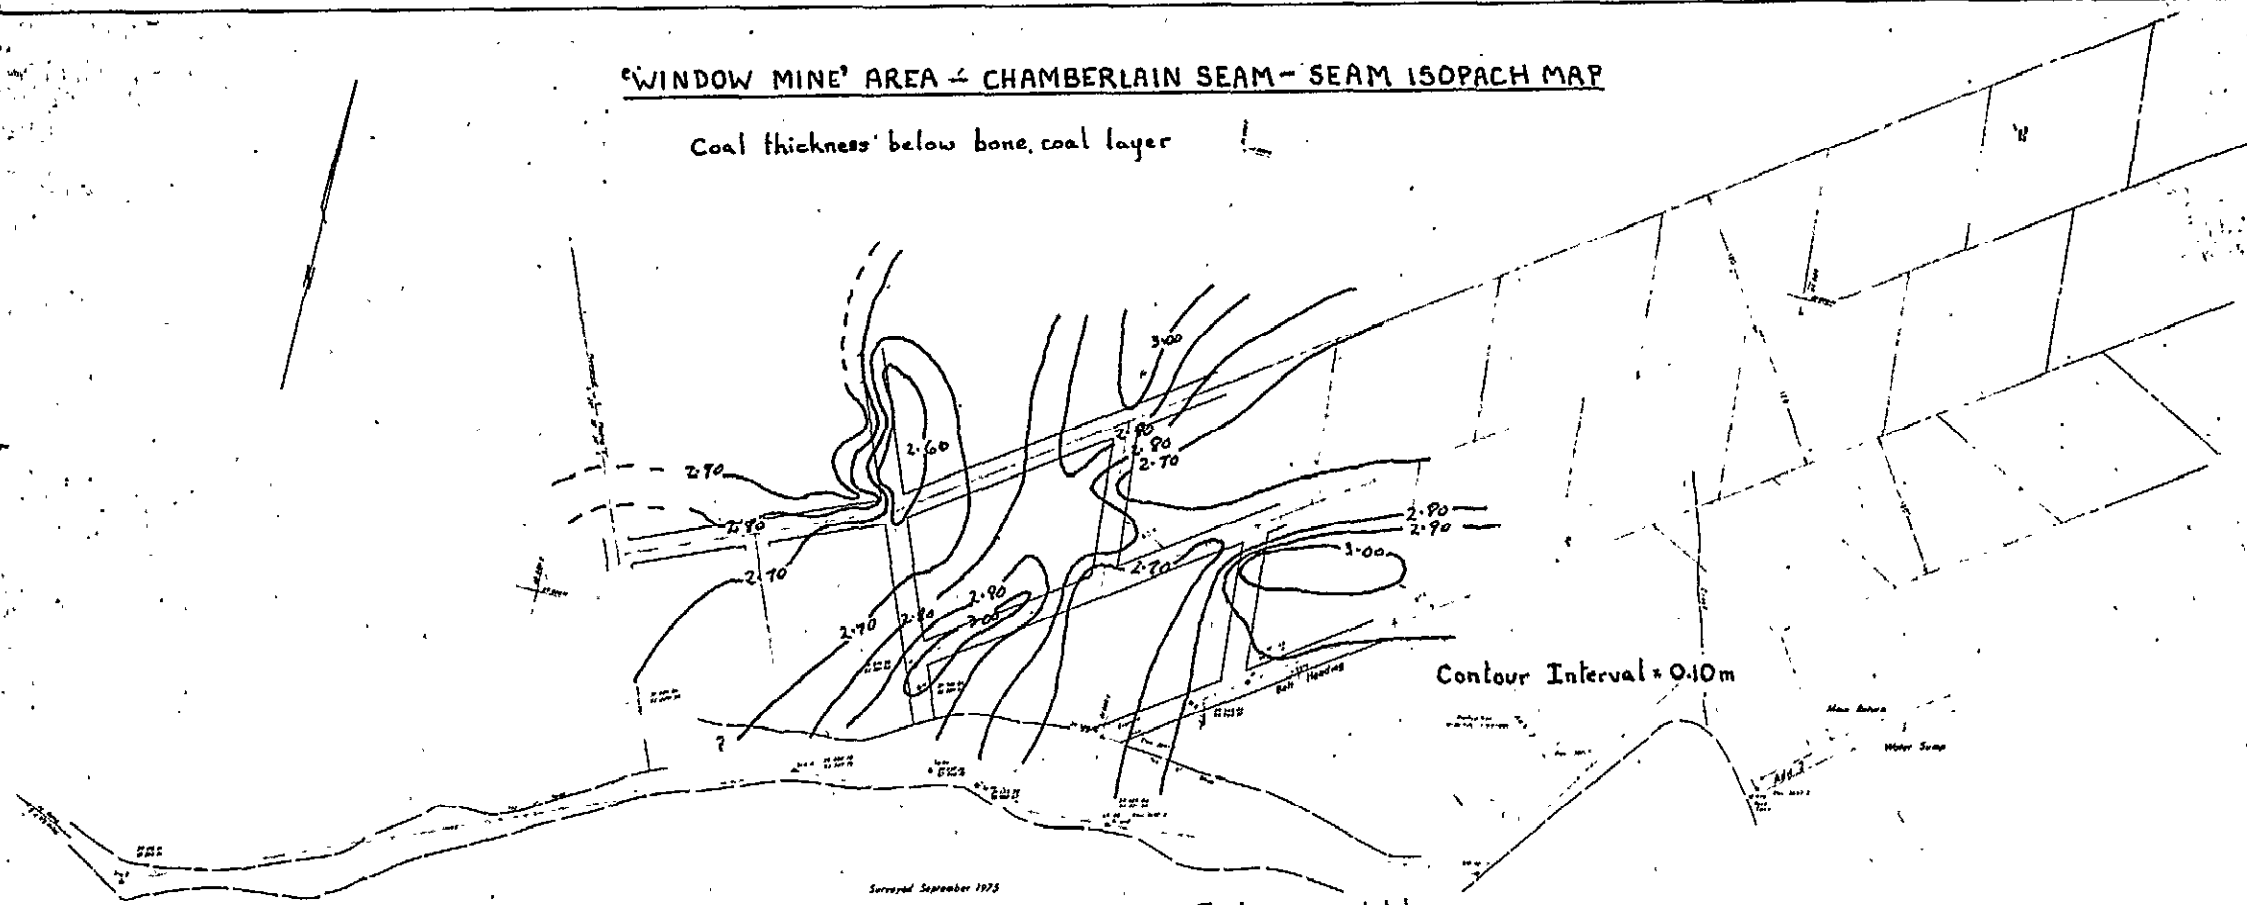
1:2 500
MAP NO. 12

The principal coal horizon consists of generally dull and bright banded coal with some consistent beds having either a reduction or an increase in the percentage of bright bands. The base of the seam is usually sheared and in places appears to contain some sheared claystone material. Map No. 12 is an isopach map of the principal coal horizon and it shows that the seam thickness is uniform throughout the mine workings.

'WINDOW MINE' AREA - CHAMBERLAIN SEAM - SEAM ISOPACH MAP
