HISTORIC MINE SITES IN BRITISH COLUMBIA

By Lisa N. Barazzuol and
Gregg G. Stewart, PGeo

FEBRUARY 2003

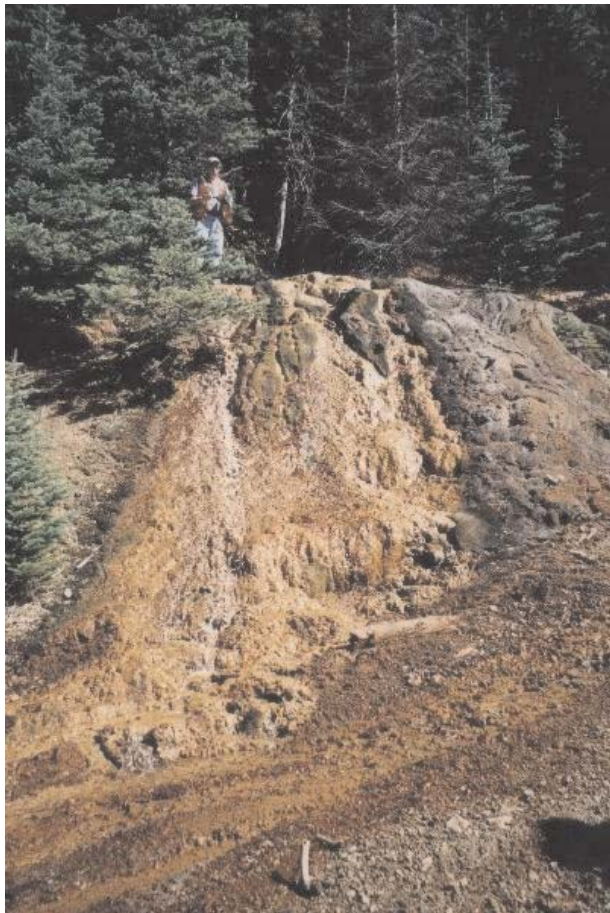
Photo 2. Drainage flowing from the Big Onion adits, located behind Bruce.

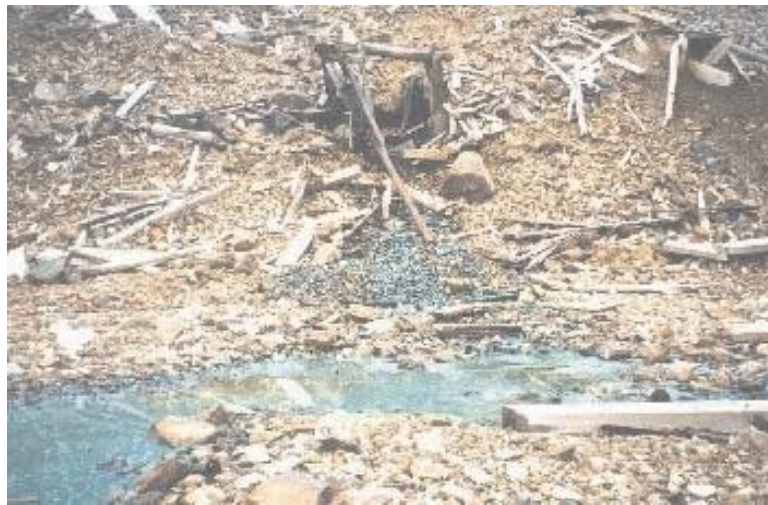
Photo 8. Drainage with malachite precipitate flowing from the 800 level portal, Red Rose mine.

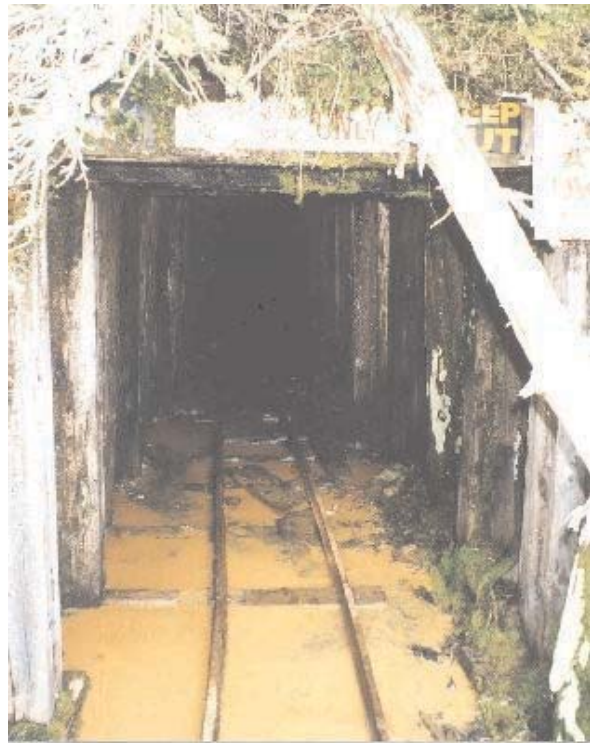
The drainage from the 1200' portal was turbid from the heavy iron precipitation. Sedimentation of the precipitates was up to 10 cm in places. The flow from the adit was about 20 L/min. Zinc precipitates were

Photo 14. Dunwell 1200' portal. The drainage was sampled.

also present but were less prolific than the iron precipitates. The water was sampled at the foot of the waste rock dump. The pH = 5.0 and conductivity = 380 μ S. The water was organic smelling. No vegetation was present proximal to the adit. At the foot of the waste rock dump shrubs and lichen were present.

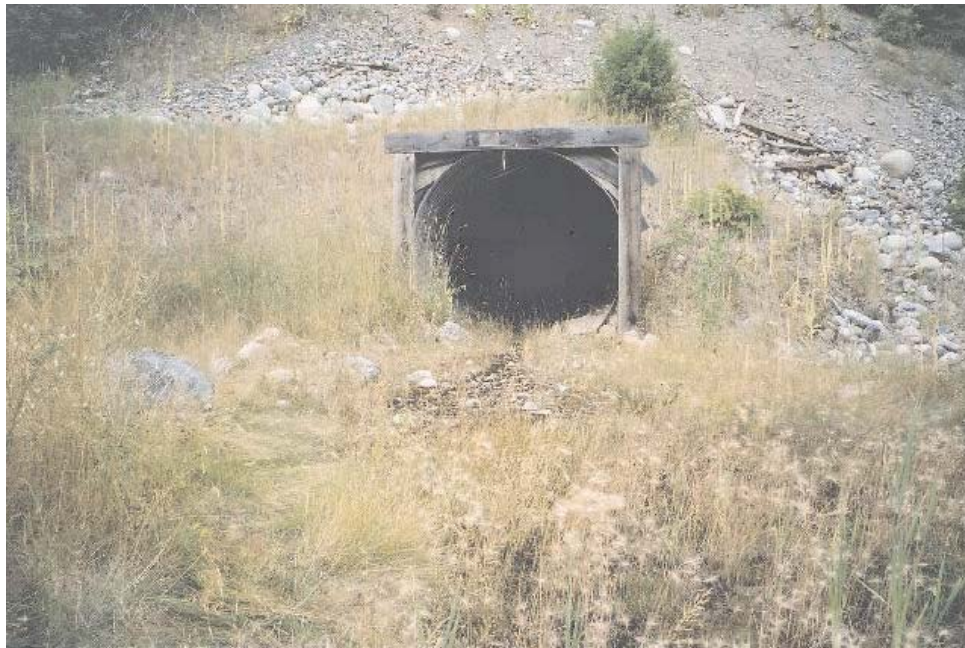
Photo 15. Wayside adit.

lower waste rock dump ranges from fines to boulders. The fines were sampled. Oxidation of the dump is pervasive and a red-brown colour. Lithologies within the dump include quartz, diorite, argillite and greenstone. A few immature trees growing from the dump and grasses are present around the base. The southern end of the dump toes into the river. The volume of the dump is in the order of $\sim 2500 \text{ m}^3$.

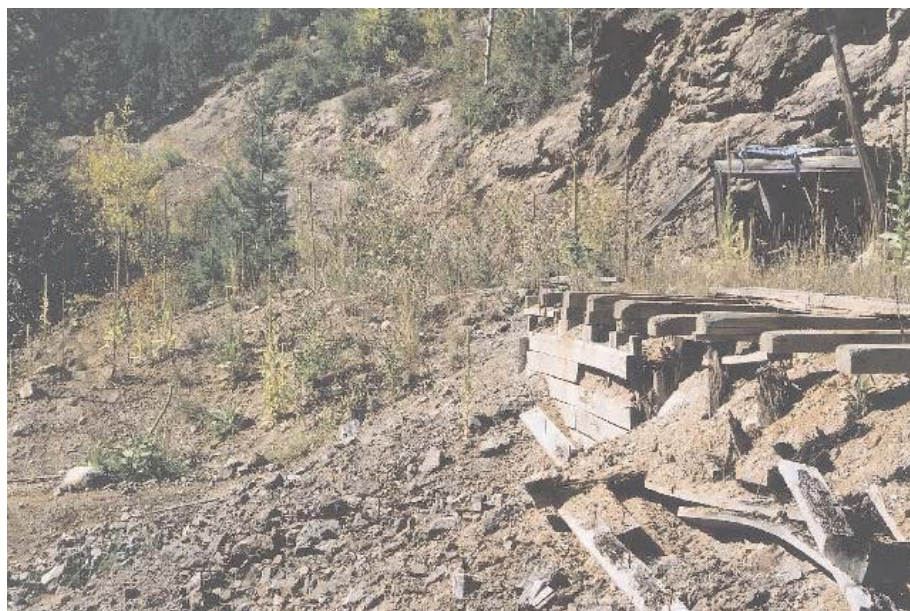
Alkaline mine drainage and metal leaching appears to be occurring at Congress.

Photo 16. Congress adit (background). The drainage from the adit is draining from a small pipe, located below the tracks.

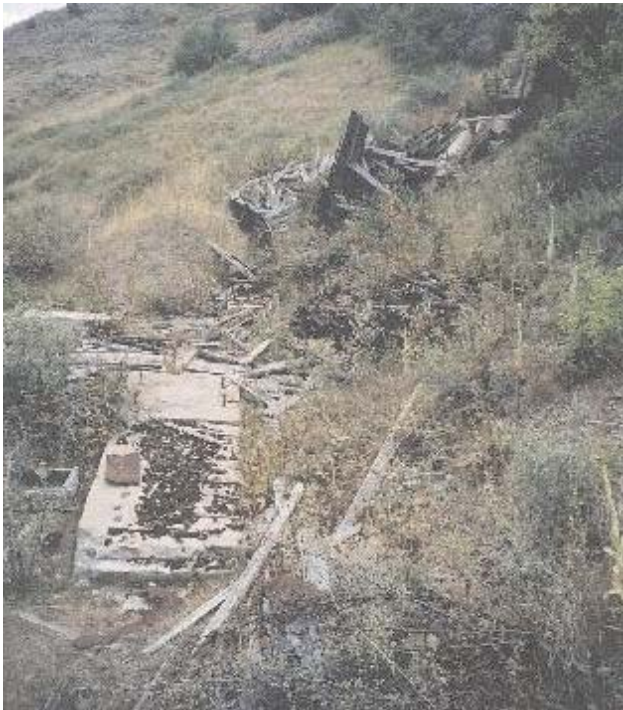
Photo 20. Twin Lakes mill.

Above the mill to the north is an uncollared adit located in an open cut. The open cut faces are vegetated with grasses but appeared unstable. The portal is fenced off but accessible. Stagnant water was present but not sampled.

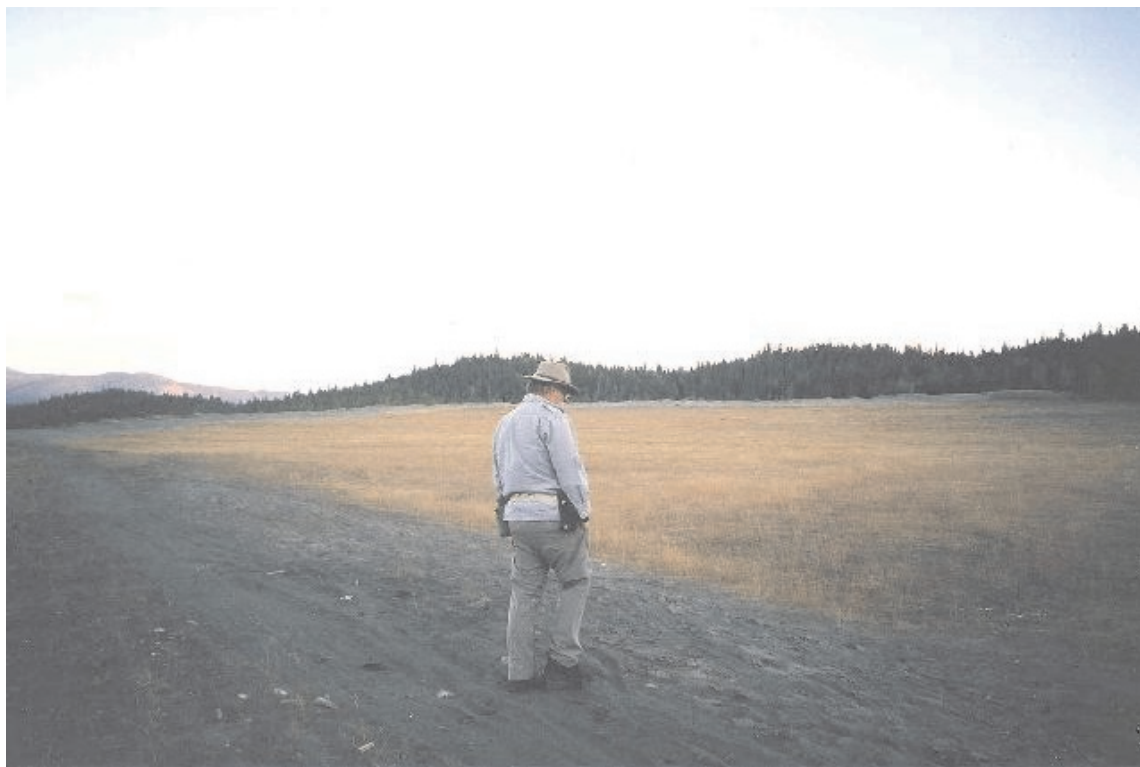
Photo 28. Tremblay tailings facility.

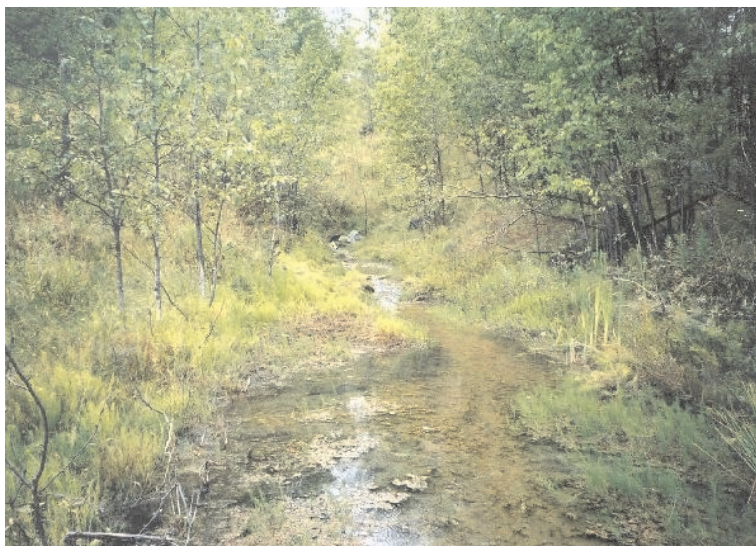
Photo 33. Drainage from Spitzee adit.

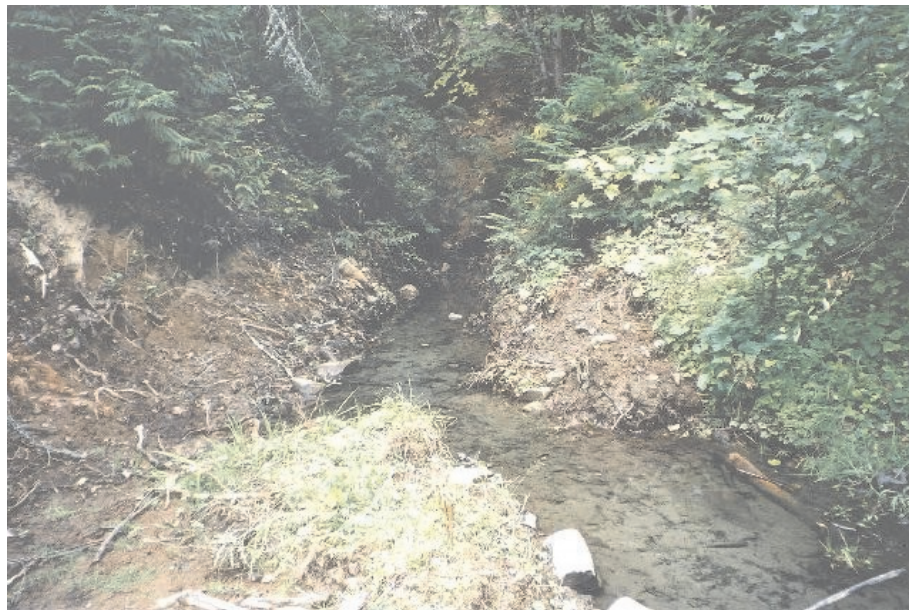
Not a reclamation priority: drainage in compliance (although Zn is elevated) and the one portal has been backfilled.

Photo 34. Portal backfilled with a culvert in place at the Gopher mine site. The drainage was sampled.

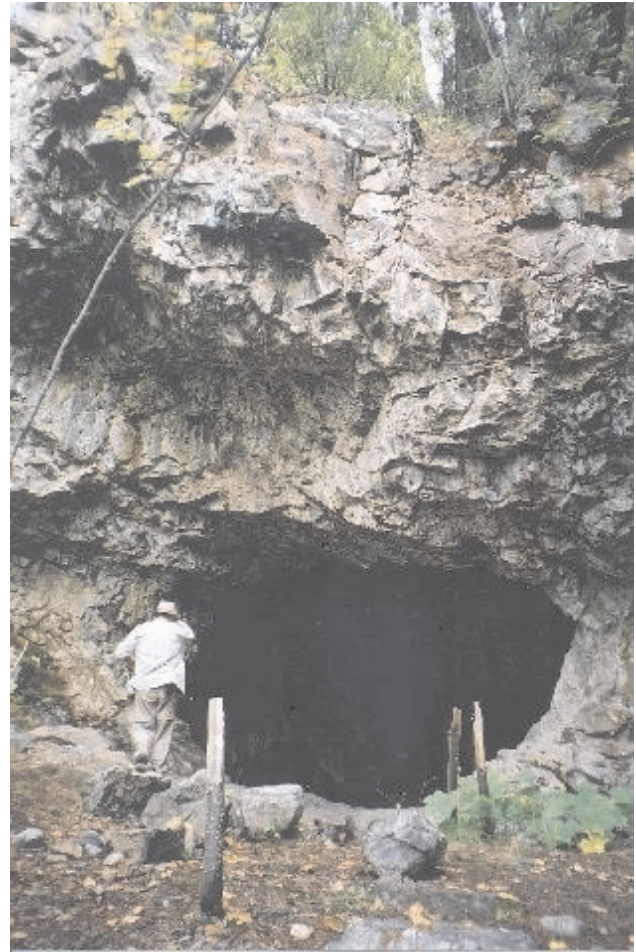
Photo 38. Queen Victoria stope.

The waste rock dumps are located near the surface workings. The cumulative volume of the dumps is relatively small (on the order of 10,000 m³) given the extent of the workings. Mineralization includes disseminated and clusters of pyrite and chalcopyrite. Malachite and iron oxides are visible weathering products. The lithologies of the waste rock are garnetite and quartzite.

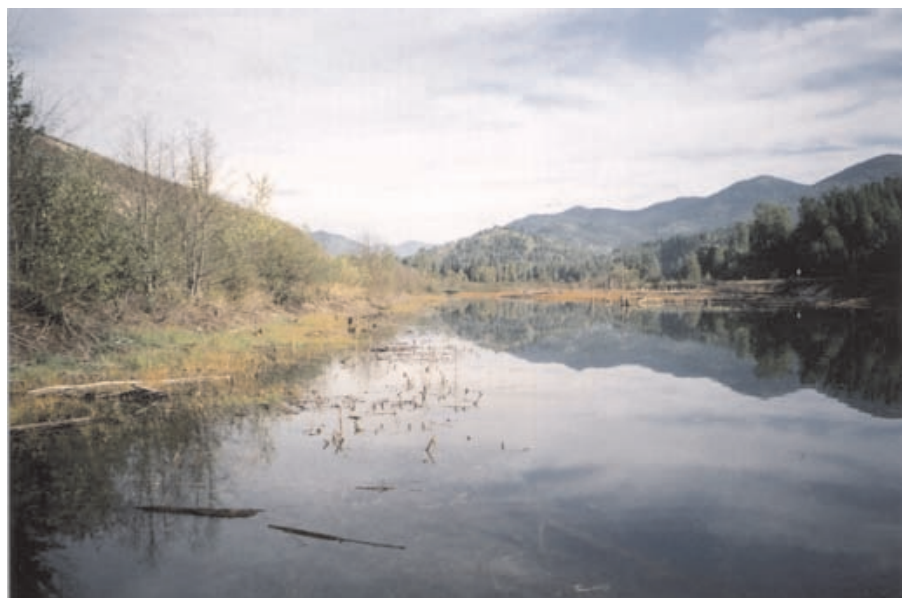
Photo 41. Pond at toe of the Canex tailings.

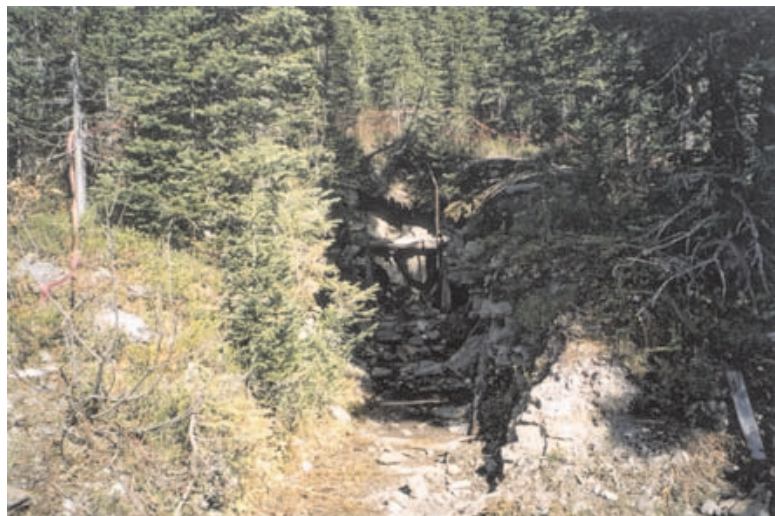
Photo 65. Open cut leading to an adit at the Jim property.

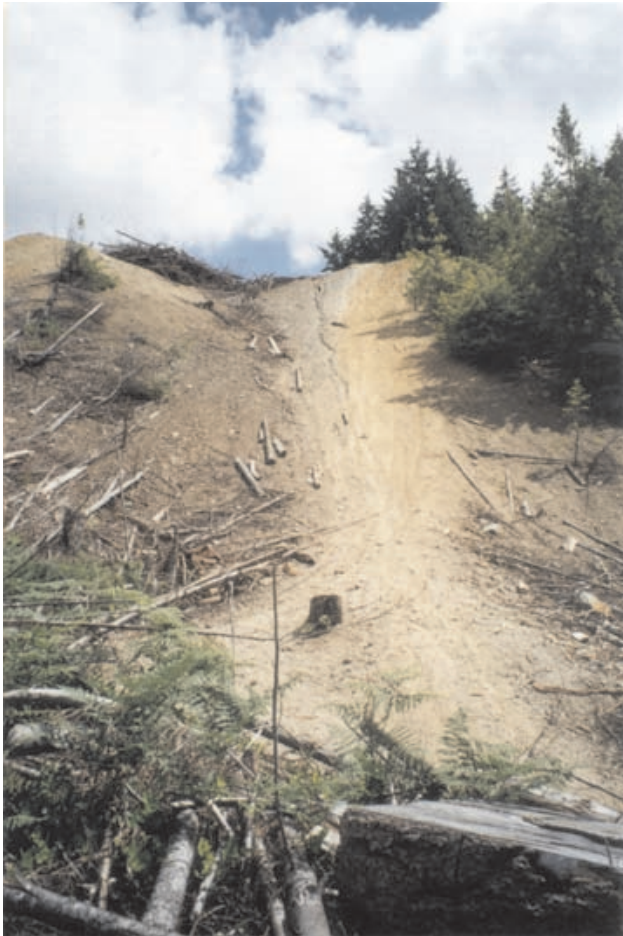
Photo 76. Tyee waste rock dump.

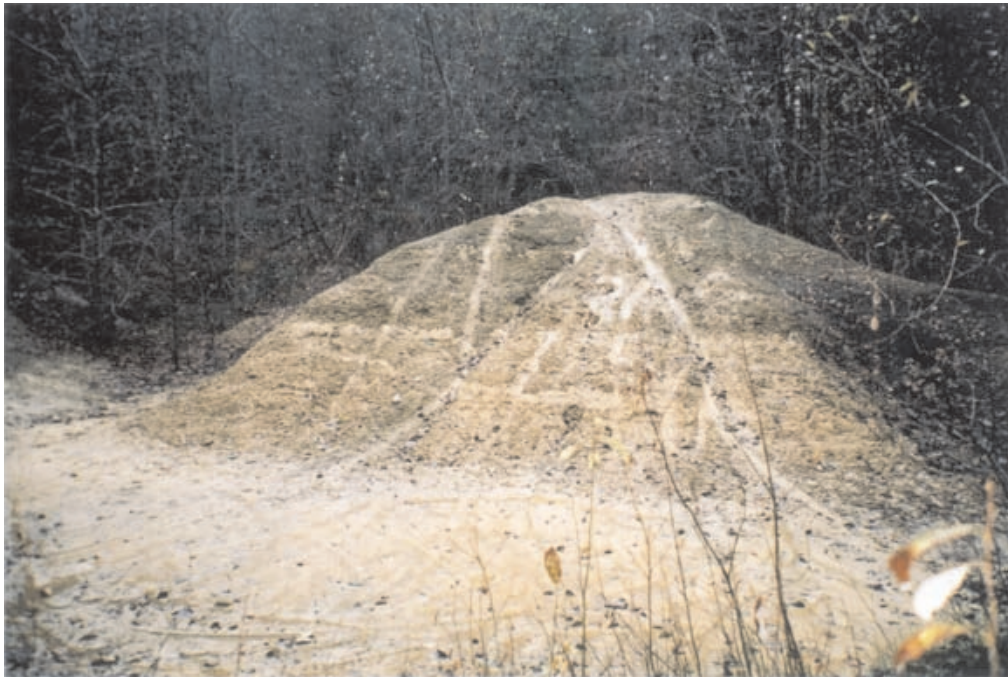
In the upper pond, preferential layering of the tailings causes drainage to flow toward the centre, the location of erosion and the source area for the lower ponds. The eroded gulley is approximately 1.5 m deep and is supporting juvenile trees in the vicinity. The tailings are pervasively oxidized to a red-brown colour containing minor malachite. Where water is pooling on the tailings, it is red. The area is used as a BMX bike course, particularly on the outside edges and in the eroded gulley. A sample of the tailings was taken. UTM coordinates of the upper tailings are: 410972, 5410778, elev'n: 349 m. The area of the tailings is approximately 100 m by 300 m.

Photo 78. Blue Grouse upper tailings facility.

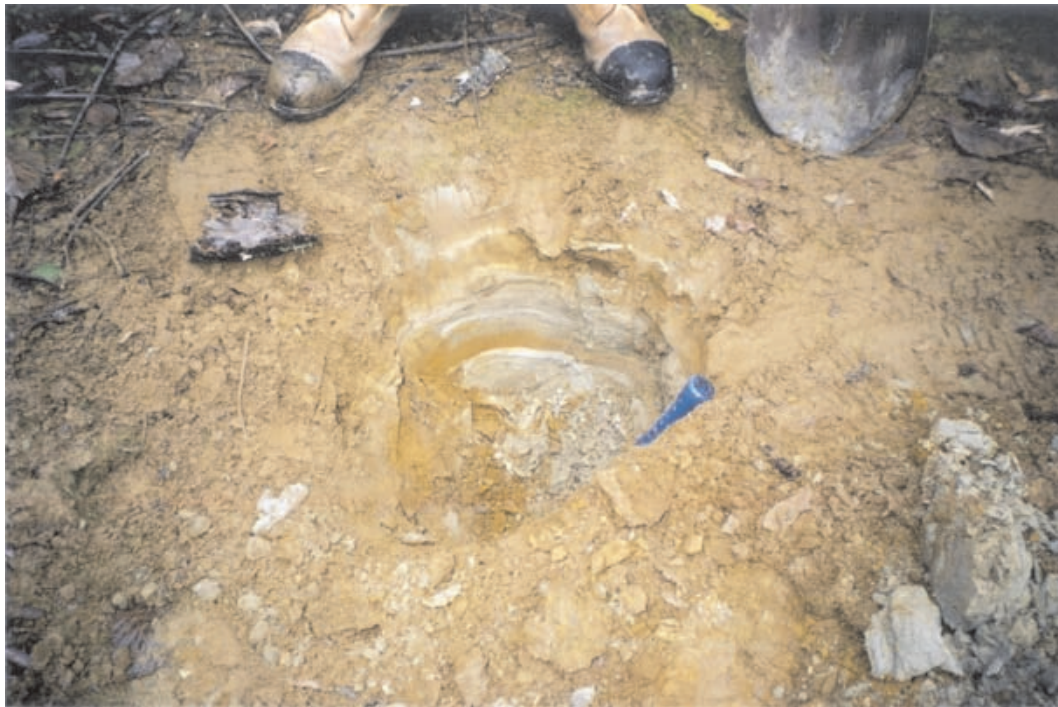
Photo 79. Blue Grouse upper tailings test pit.

The middle tailings are sand sized and are slightly oxidized in a localized area (2 m²) at the upper end, proximal to the upper pond. The depth profile of oxidation was: 0-15 cm oxidized, 15-25 cm unoxidized, 25-32 cm oxidized, >32 cm unoxidized. Overall, the tailings appear unoxidized, likely due to the washing and rinsing during transport. The middle pond has also undergone erosion, leaving a series of mound shaped structures. The area and volume of the tailings is approximately 200 m² and 300 m³ respectively.
