BC Geological Survey Coal Assessment Report 941

COAL ASSESSMENT REPORT WATERFALL PROPERTY

Peace River Coal Inc. - Anglo American Coal Pty Ltd

Author: David Lortie P.Geo. August 1, 2014 Attachments 7, 8, and 9, and Appendix 4 of this report remain confidential under the terms of the Coal Act Regulation, and have been removed from the public version.

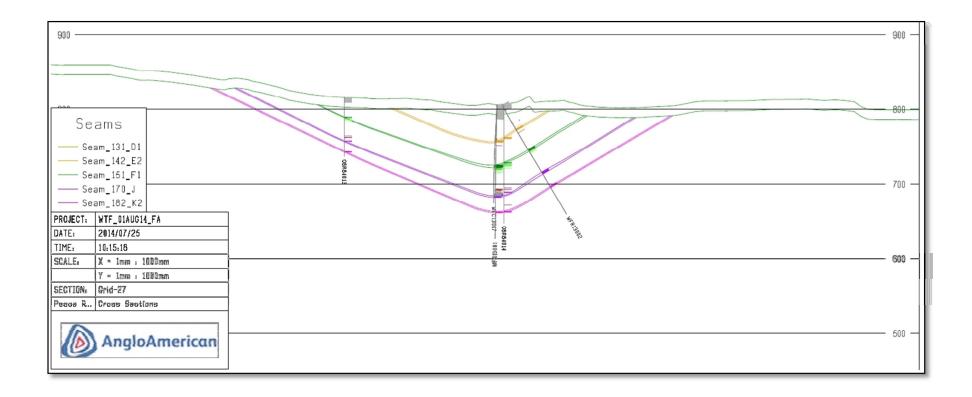
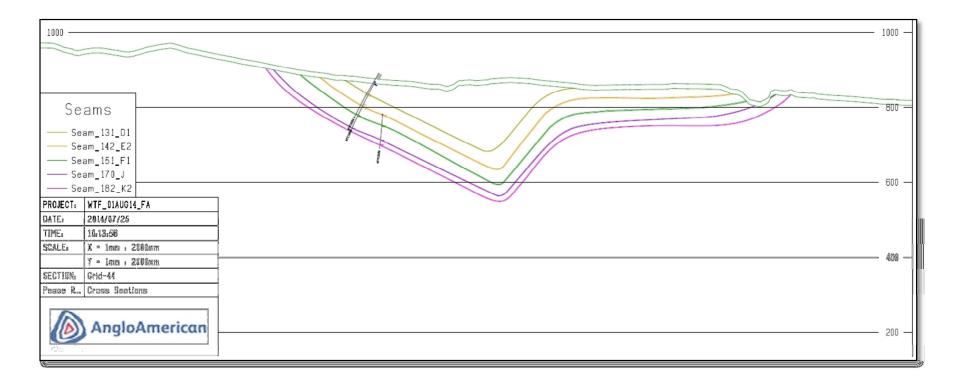
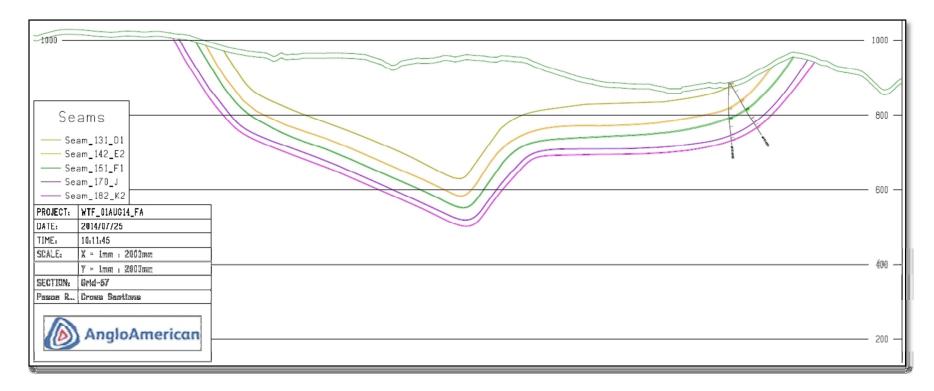
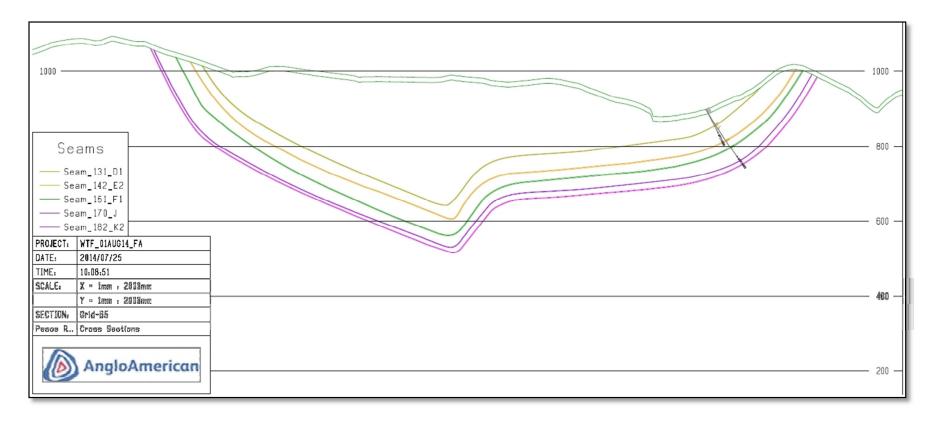
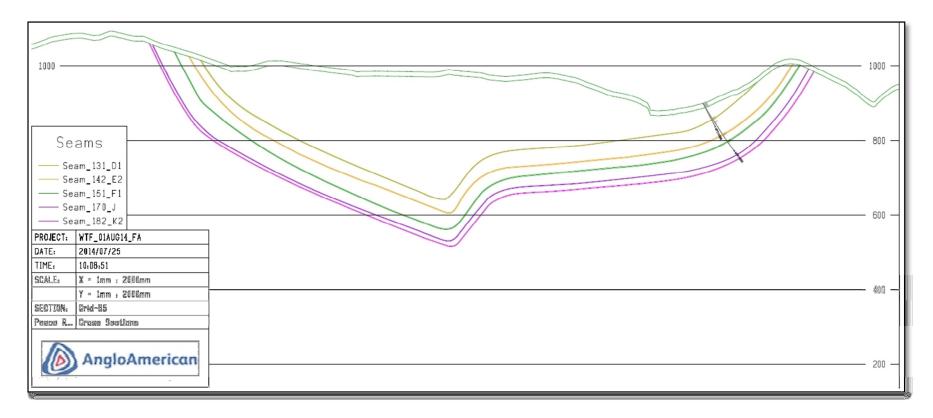
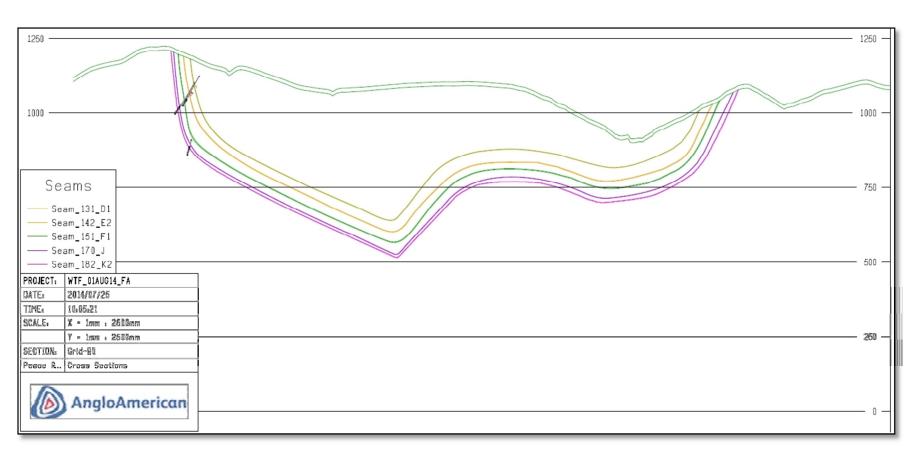
Attachment 12

Representative Cross Section Grid 27

The development of the structure can be seen in the sections found in Attachment 12.
