# HAT CREEK PROJECT

Sandwell and Company Ltd. - Hat Creek Project - <u>Cooling Water</u> <u>Supply Preliminary Design Study</u> - Volume 3 - March 1978

COOLING WATER SUPPLY

PRELIMINARY DESIGN STUDY

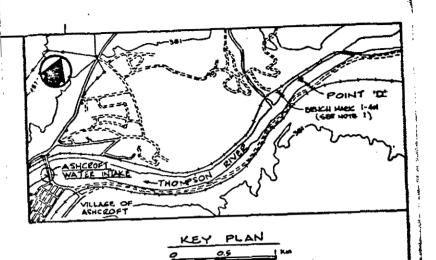
SANDWELL & CO. LTD. HAT CREEK PROJECT SUNDINGS & CONTOUR PLAN MENGINEERING CO. LTO A1-9214-1 | REV.

- 2. CONTOURS ABOVE WATER LINE ARE FROM SANDWELL DWG. D4191-7
- 3. SOUNDINGS WERE PERFORMED BY SWAN WOOSTER ENGINEERING ON FEB. 4, 1978
- 4. WATER LEVEL AT POINT 'D' ON FEB.4, 1978 WAS 289,53

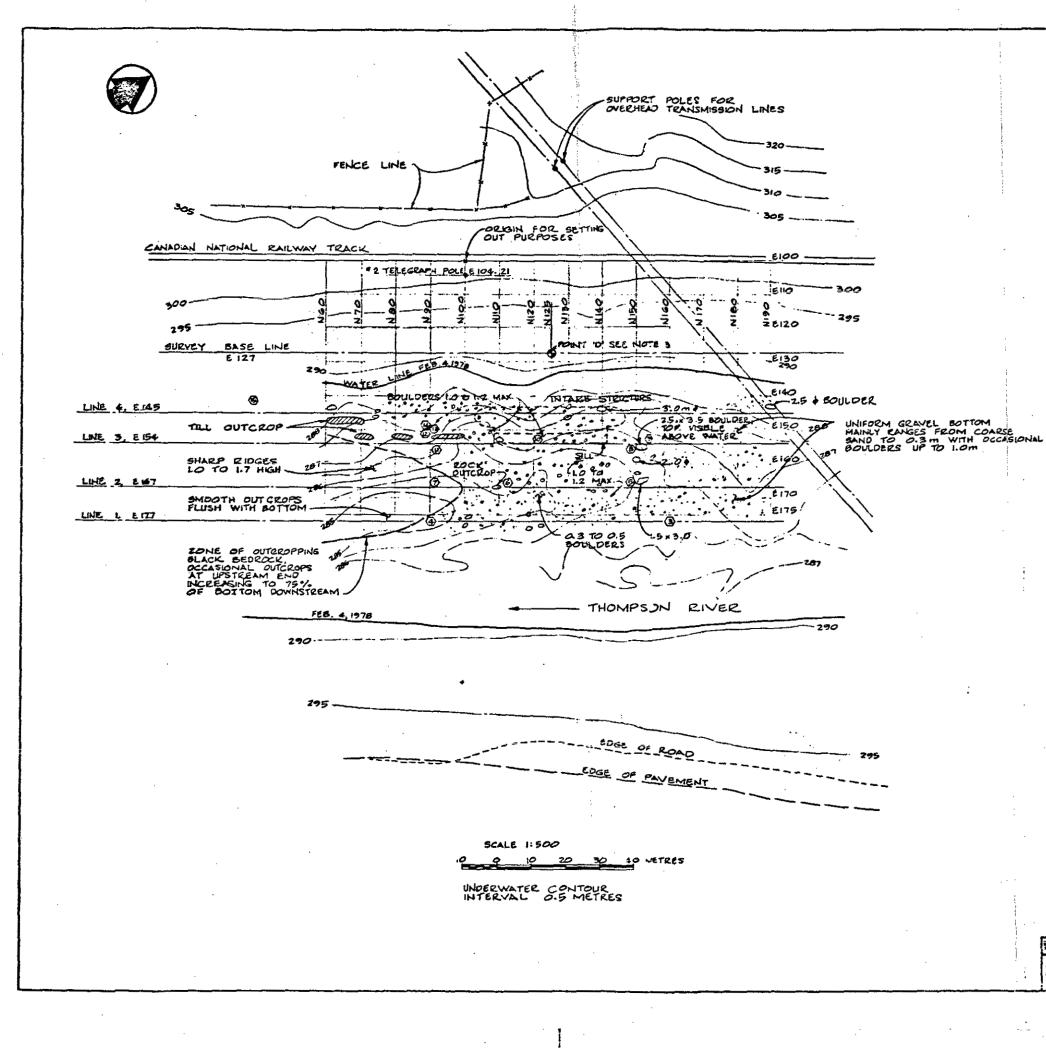
NOTES: I. CONTOUR LEVELS REFERENCED TO MCELHANNEY BENCH MARK 1-401, ELEV. • 301.88 2. CONTOURS ABOVE WATER LINE ARE FROM SANDWELL OWG. P4191-7. 3. WATER LEVEL AT POINT 'D' ON F60.4, 1978 WAS 289.53 LEGEND : (PHOTOS I 12 TAKEN ABOVE WATER) Ð 2220 TILL (GRAVEL, HARD SANDY CLAY) SCRAVEL: COARSE SAND TO 0.3 m WITH 0-20 INDIVIDUAL LARGE BOULDER. (LOCATION 13+) SANDWELL & CO. LTD. HAT CREEK PROJECT COOLING WATER INTAKE SITE IOD SEWAN WOOSTER RIVER BOTTOM DESCRIPTO

Line 1: N190 E177 to N60 E177 (Dwg.Al-9214-2) Visibility was good, in the range of 6 to 8 m. The divers initially crossed the river from south to north upstream from the survey area. The bottom was uniform coarse gravel and cobbles with most material being in the range from coarse sand to 0.3 m diameter. The first 60 m from N190 to N130 showed a similar gravel bottom with some medium sized rounded boulders of about 0.3 m in diameter (photograph 3). There were a few larger boulders in the 1 m diameter range randomly located in this area.

Line 2: N190 E167 to N60 E167 (Dwg. Al-9214-2) For the first 50 m, the bottom is sand and gravel with some 0.3 m boulders. At approximately N150 there is a 1.5 m x 3 m boulder with a slightly smaller one beside it (photograph 5).

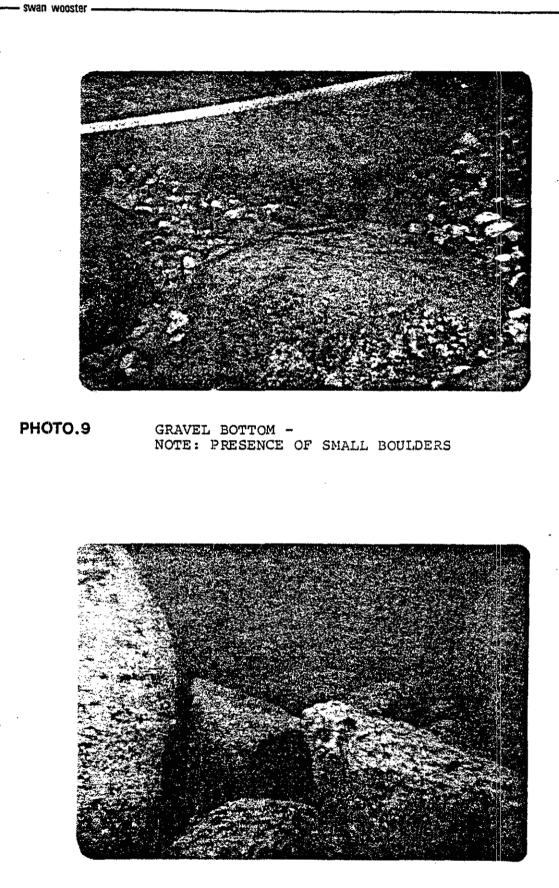
PHOTO, 10

BOULDERS -NOTE VARYING SIZES

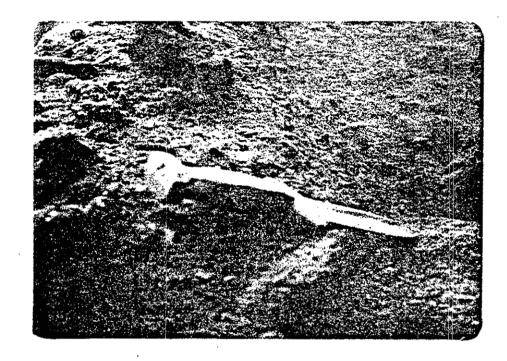
PHOTO, 15

TILL

From N100 to N60, till was encountered generally on the shoreward side of the line (photographs 12, 13, 14 and 15). This till was quite hard insitu, but became crumbly when brought to the surface. The till consists of mainly 6 inch minus gravel set in a matrix of hard sandy clay. Bedrock outcrops were observed on the river side of the line, downstream from N90 (photograph 11).

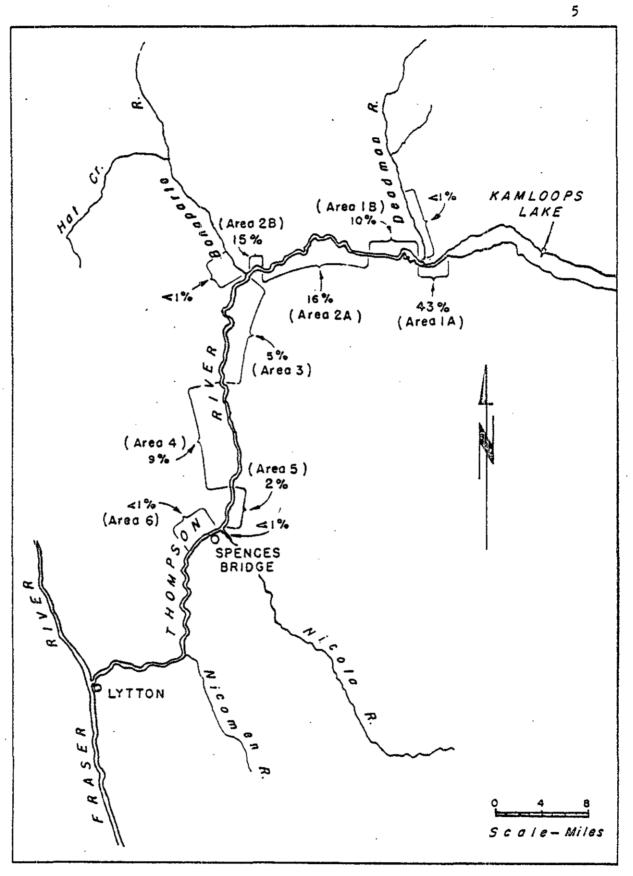
FIGURE 1. - The Thompson River system showing the distribution of spawning pink salmon, estimated on the basis of live counts.

The distribution of spawners was also determined on the basis of the numbers of live fish seen in each of the areas shown in FIGURE 1. The live count method of determining spawner distribution may have been more accurate than the dead recovery method since the water was clear enough to see fish spawning throughout the length of the river, and therefore the error introduced by downstream drift of spawned-out fish was avoided. The proportion of the total number of spawners utilizing each of the designated areas and the tributary streams is shown in FIGURE 1 and the numbers of spawners seen in each of the areas in Thompson River are given in TABLE 3.

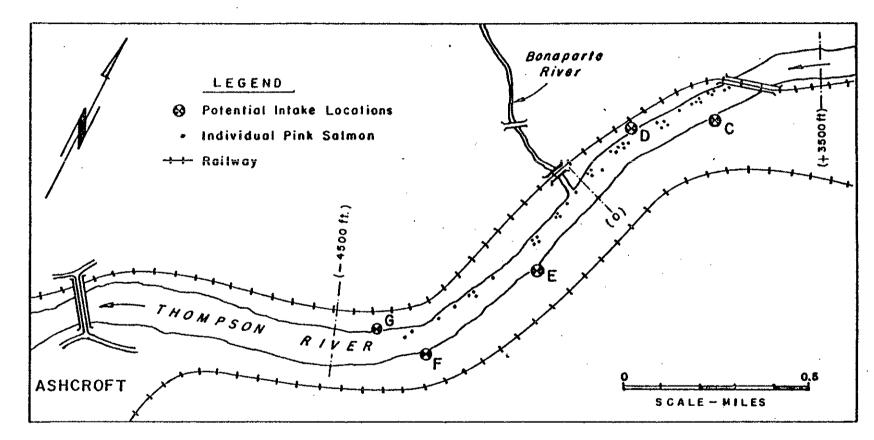
FIGURE 3 - The distribution of pink salmon observed from October 3 - 26 near the proposed Hat Creek water supply intake. Each dot represents a single pink salmon observed.

Five alternate sites for the water intake structure were being considered by B. C. Hydro at the time of this study and these are shown in FIGURE 3, in the locations given in B. C. Hydro drawings D4191-SK54 and SK55. Each pink salmon observed in the 8000-ft reach of the Thompson River that might be affected by the water intake facilities is shown as a dot on FIGURE 3.

Only 41 pink salmon were recorded in this 8000-ft reach, including those seen by the divers. Of these 41 fish, 34 were spawned males, 4 were spawned females and 3 were migrating fish. There was no evidence that pink salmon spawned in this reach of the river or that migrating fish accumulated in schools or rested in the region of the water intake sites under consideration.

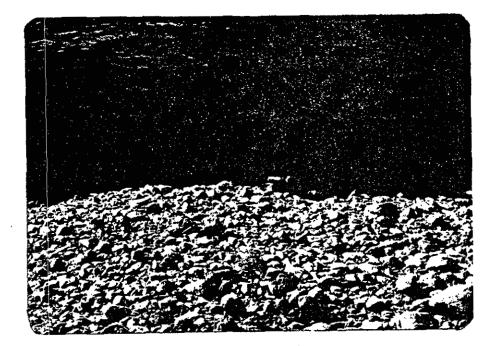
FIGURE 4. River conditions at proposed water intake Site D.

Spawning conditions in the study area were poor. As indicated in FIGURES 4 and 5, the water was deep and slow flowing and in many areas the river bottom was covered with boulders 1-2 ft in diameter.

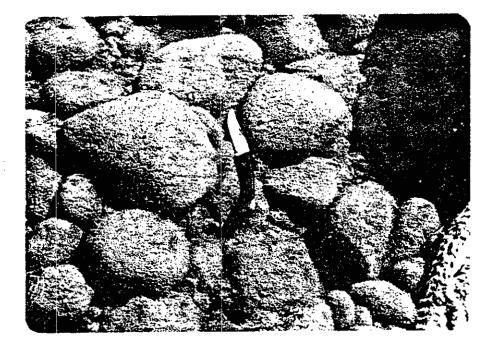
FIGURE 5. Riverbed material at proposed water intake Site D.

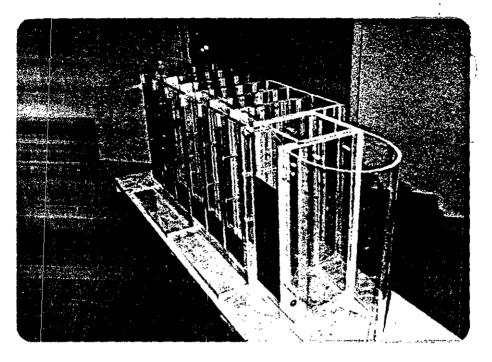
Photo 3.2.1. Geometry A before installation in flume,

features of the intake were reproduced using clear acrylic sheets as shown in Photo 3.2.1. The model intake was built in sections to facilitate testing of the different arrangements. These sections included the streamlined head-form, the block containing the full depth bypass entrance, the upstream three pumping bays, the downstream three pumping bays, and the streamlined tailform. The pumping bays were constructed extra long in case this length was needed to obtain proper approach flow to the pumps. However, the tests showed that lengths indicated in Dwg. 2.3.2 were adequate. Therefore, bulkhead walls were used for all tests to simulate the proper size of bay.

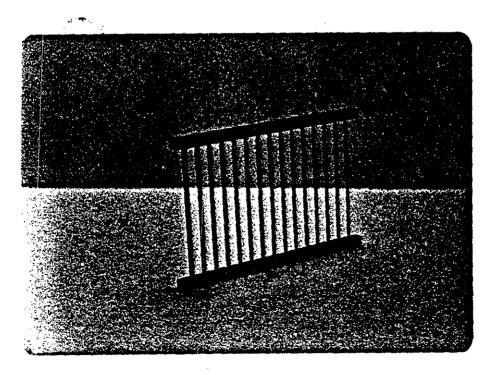
Photo 3.2.3. Model trashrack with 45° bar orientation.

The four arrangements of the model trashracks are shown in Dwg. 3.2.3 and they differ mainly in the orientation of the trashrack bars. Trashracks were constructed with the rectangular bars orientated 90°, 75°, 60° and 45° to the front face of the trashrack. One of the 45° trashracks is shown in Photo 3.2.3. The bars measured 32 mm (1.25 inches) by 160 mm (6.5 inches) and their centre-to-centre spacing varied from 160 mm (6.5 inches) for 90° orientation to 230 mm (9 inches) for 45° orientation. A fifth arrangement consisted of round bars rather than rectangular ones. These were 32 mm (1.25 inches) in diameter and spaced 160 mm (6.5 inches) apart. In the model, the lower level entrances were protected by single trashracks and the full depth entrance was protected by 5 trashracks stacked on top of each other. Geometry A, the initial geometry tested, had a full depth entrance aligned

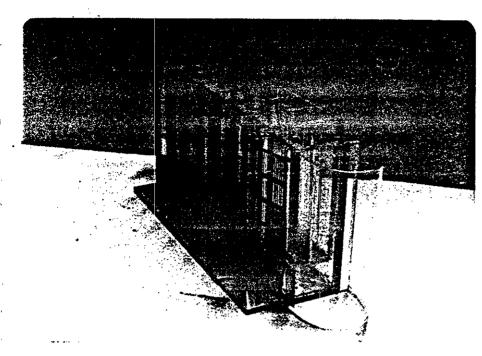
Photo 3.2.2. Geometry B before installation in the flume.

with the lower entrances. Difficulties with this arrangement which will be detailed in the section on model results, led to Geometry B which aligns the full depth entrance obliquely to the flow and to the lower entrances (see Photo Photo 3.2.2).

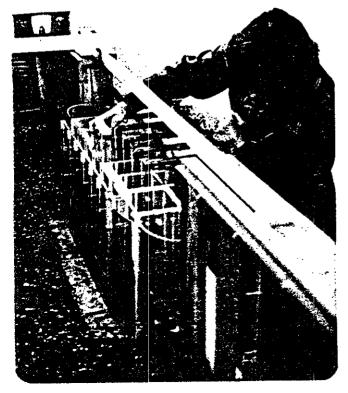
Photo 3.2.4.

Geometry B installed in the laboratory flume.

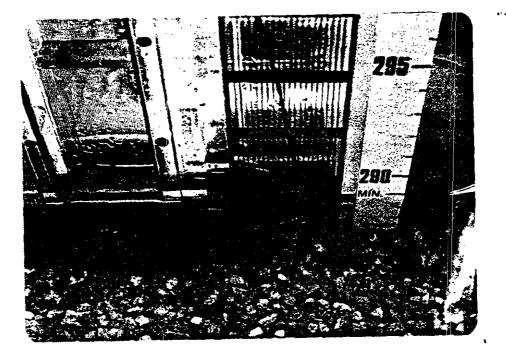
Photo 4.1.1. Dye being released at the entrance for the bypass flow.

Geometry A with prototype discharge of 115 m<sup>3</sup>/s (4000 cfs).

level entrance would flow upstream and exit through the full depth bypass entrance. Photo 4.1.1 shows dye being injected in the river flow adjacent to the full depth bypass entrance. The dye stained water was carried by the river to the first low level entrance where it entered the bypass and flowed back upstream. Dye injected in front of Bay 3 also moved back up the bypass channel as shown in Photo 4.1.3.

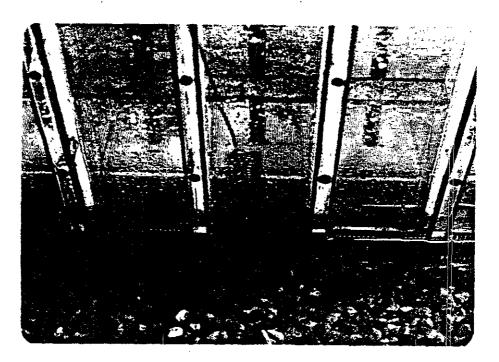
Photo 4.1.3. Dye released in the bypass channel in front of Bay 3 flows upstream.

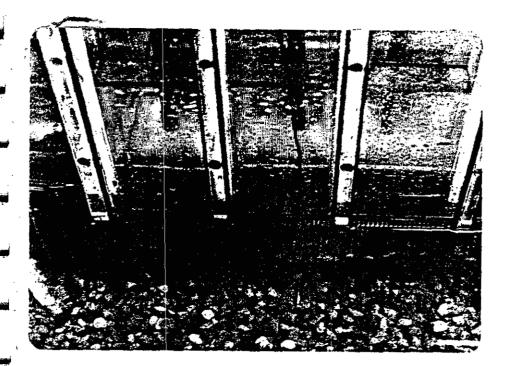
Photo 4.1.2. Dye released outside of bypass channel in front of Bay 5 flows downstream through the trashracks.

Even though there was no flow down the bypass at the upstream end, the original geometry showed promising features. There was a flow out of the bypass at the downstream exit indicating a favorable pressure gradient at the tail. Photos 4.1.2 and 4.1.4 depict the downstream movement of dye introduced in the river at Bay 5. The flow through the travelling screens into the pump bays was also observed to be uniform in its overall distribution.

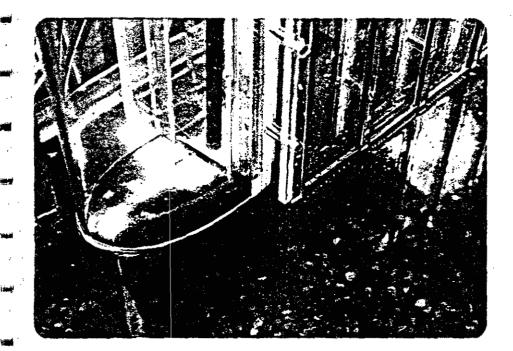
Photo 4.1.4. Dye released in the bypass channel in front of Bay 5 flows downstream.

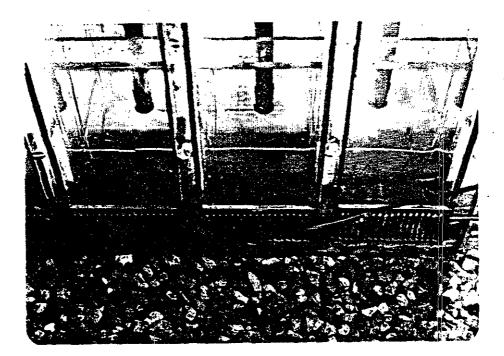
Photo 4.2.3. Dye released outside the bypass channel flows through the trashracks.

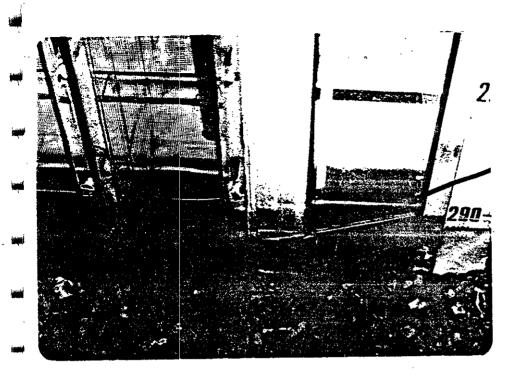
Photo 4.2.2. The dye wand is inside the bypass entrance.

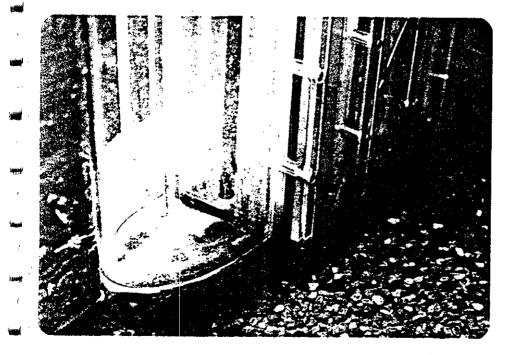
Photo 4.2.4. Dye released in the bypass channel flows out the exit.

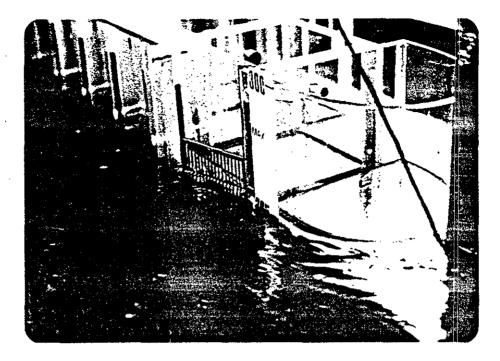
Photo 4.2.5. The dye is released upstream of the pier. The prototype discharge is 1980  $m^3/s$  (70,000).

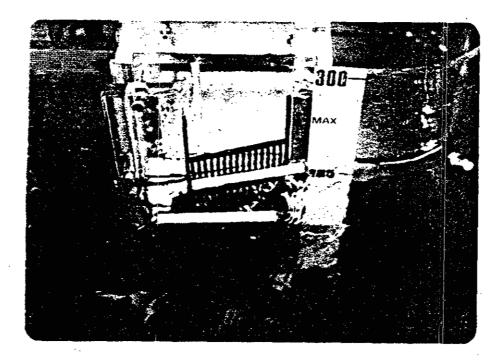
Photo 4.6.1. Model logs floating past the bypass entrance.

The first type of tests involved floating and submerged logs approaching the intake (submerged logs may be dislodged from the bed and shore area of Kamloops Lake upstream). Logs 4 m (13 ft) long and 0.5 m (20 inches) in diameter were individually released immediately upstream of and in direct line with the pier and a count was made of those that hit the head form, the full depth bypass trashracks or any portion of the curtain wall downstream. Table 4.6.1 contains the percentage of both floating and submerged logs that impacted at three different discharges. Photo 4.6.1 shows logs passing the structure when the flow was 1980 m<sup>3</sup>/s (70,000 cfs).

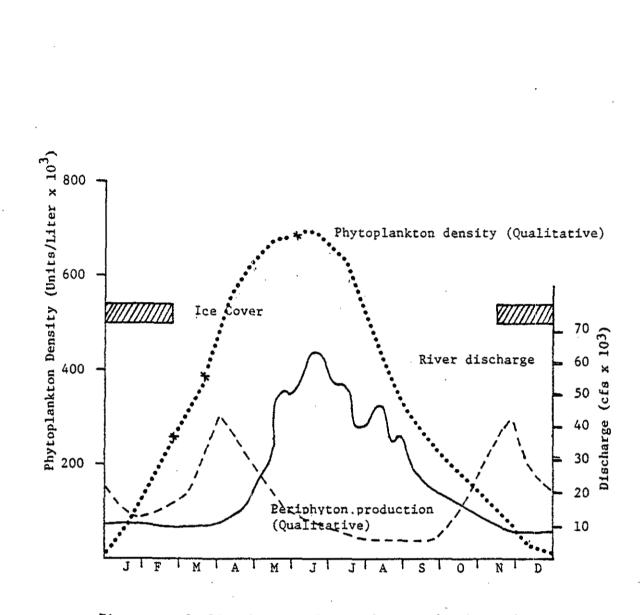
Figure 2 Qualitative periphytic algae production and a typical hydrologic regime in the Thompson River near Walhachin, B.C. based on Langer and Nassichuk (1975), and Sandwell, Vancouver, B.C. drawing No. D4191-SK47. Phytoplankton densities from data in Appendix 2 of this report (\*) and from Northcote, Ennis and Anderson (1975). Entrapped air may enable pieces to drift near the surface of the river. The total amount of periphyton material sloughed off during the highest growth period may be considerable. The size of the fragments which would be present in the river cannot be determined from previous work, however, from our experience clumps less than 5 to 8 cm in diameter and mat-like sections  $24 \times 1$  cm may be expected. The composition of these materials (small cells attached by gelatinous material) allows rapid disassociation in turbulent water.

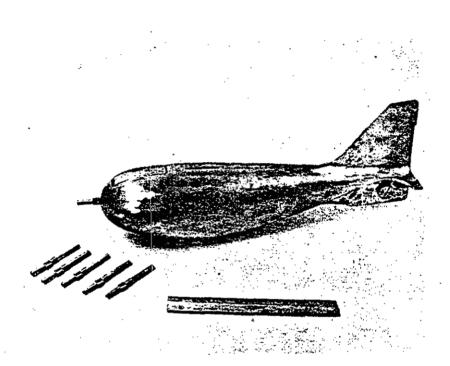
# D-49 SUSPENDED SEDIMENT SAMPLER CAE MODEL 314 c/w CASE

This 62 pound bronze sampler is intended for use in streams up to 18 feet in depth. It is raised or lowered by means of a steel cable attached to a hand reel. A glass pint bottle is used to collect the sample.

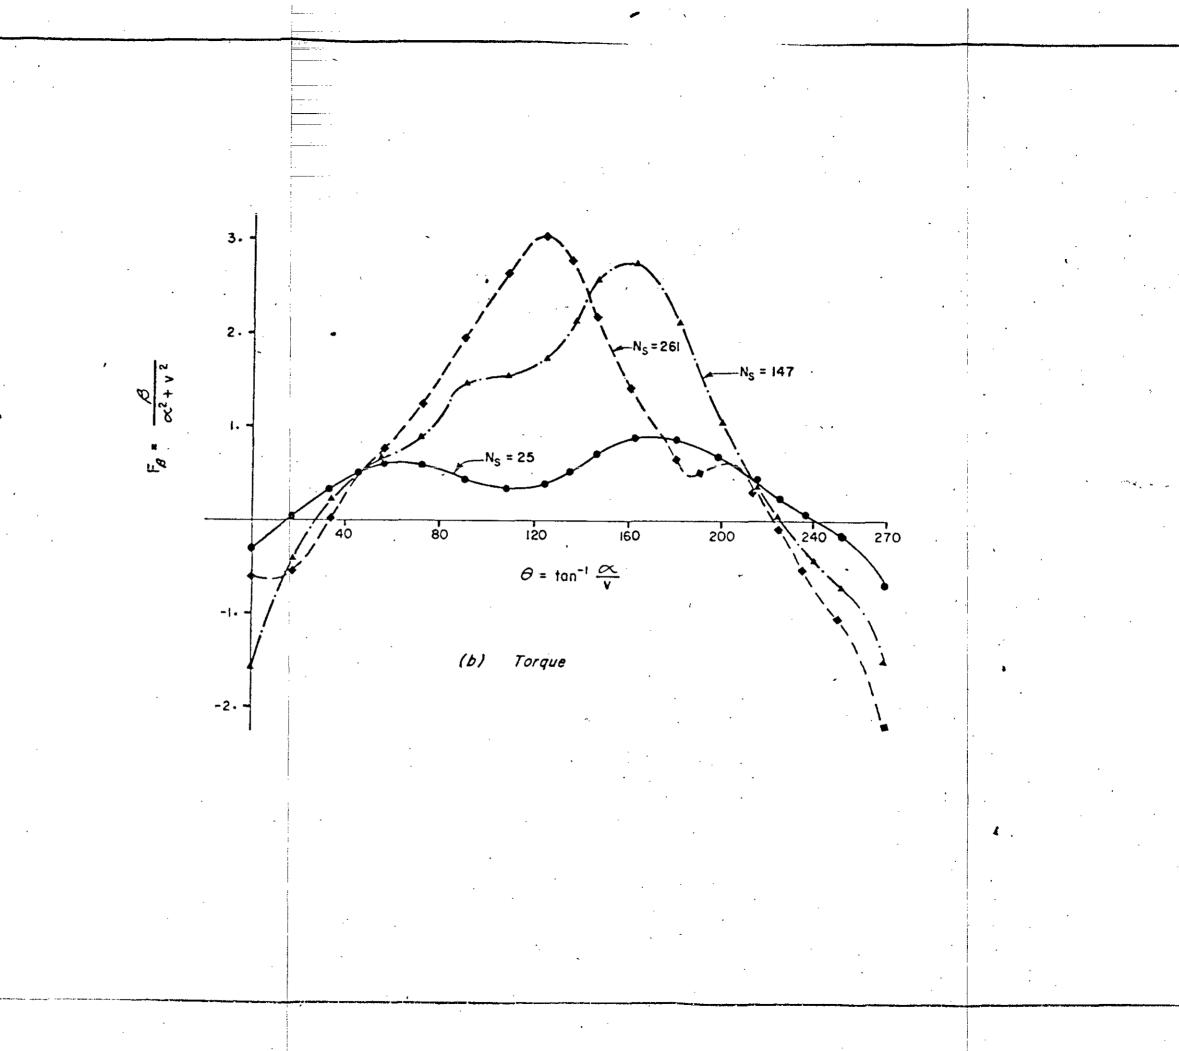
NOTE	<u>.S:</u>
 1.	This figure is taken from Applied Hydraulic Transients by M. H. Chaudhry, Ref. 2.
2.	$\alpha = N/N_R$ ; $v = Q/Q_R$
	$\mathcal{L} = T/T_R$ ; $h = H/H_R$
	$N_{s} = \frac{N_{R}\sqrt{Q_{R}}}{H_{R}^{3/4}}$
	In these expressions, N = speed, T = torque, Q = flow, H = pumping head and subscript "R" refers to rated conditions.
BR	ITISH COLUMBIA HYDRO AND POWER AUTHORITY
CO CH V	AT CREEK PROJECT OLING VATER SUPPLY MARACTERISTICS OF PUMPS OF MARIOUS SPECIFIC SPEEDS
	DEC 1977 FIG. 5
DWN	DBG 0485 No 6048-C14-D35
	· · · ·
