Province of
British Columbia
Ministry of
Mines and
Petroleum Resources

Mining
in British Columbia

1974

This volume replaces the report on Inspection of Mines by the Chief Inspector. It is primarily an account of the accidents, dangerous occurrences, safety, and operating experience of the mining industry for the year but it also includes the work of the Inspection and Engineering Division which is the office of the Chief Inspector. To preserve continuity, the report follows the format of the previous reports of the Chief Inspector which were published in the Annual Report of the Minister.

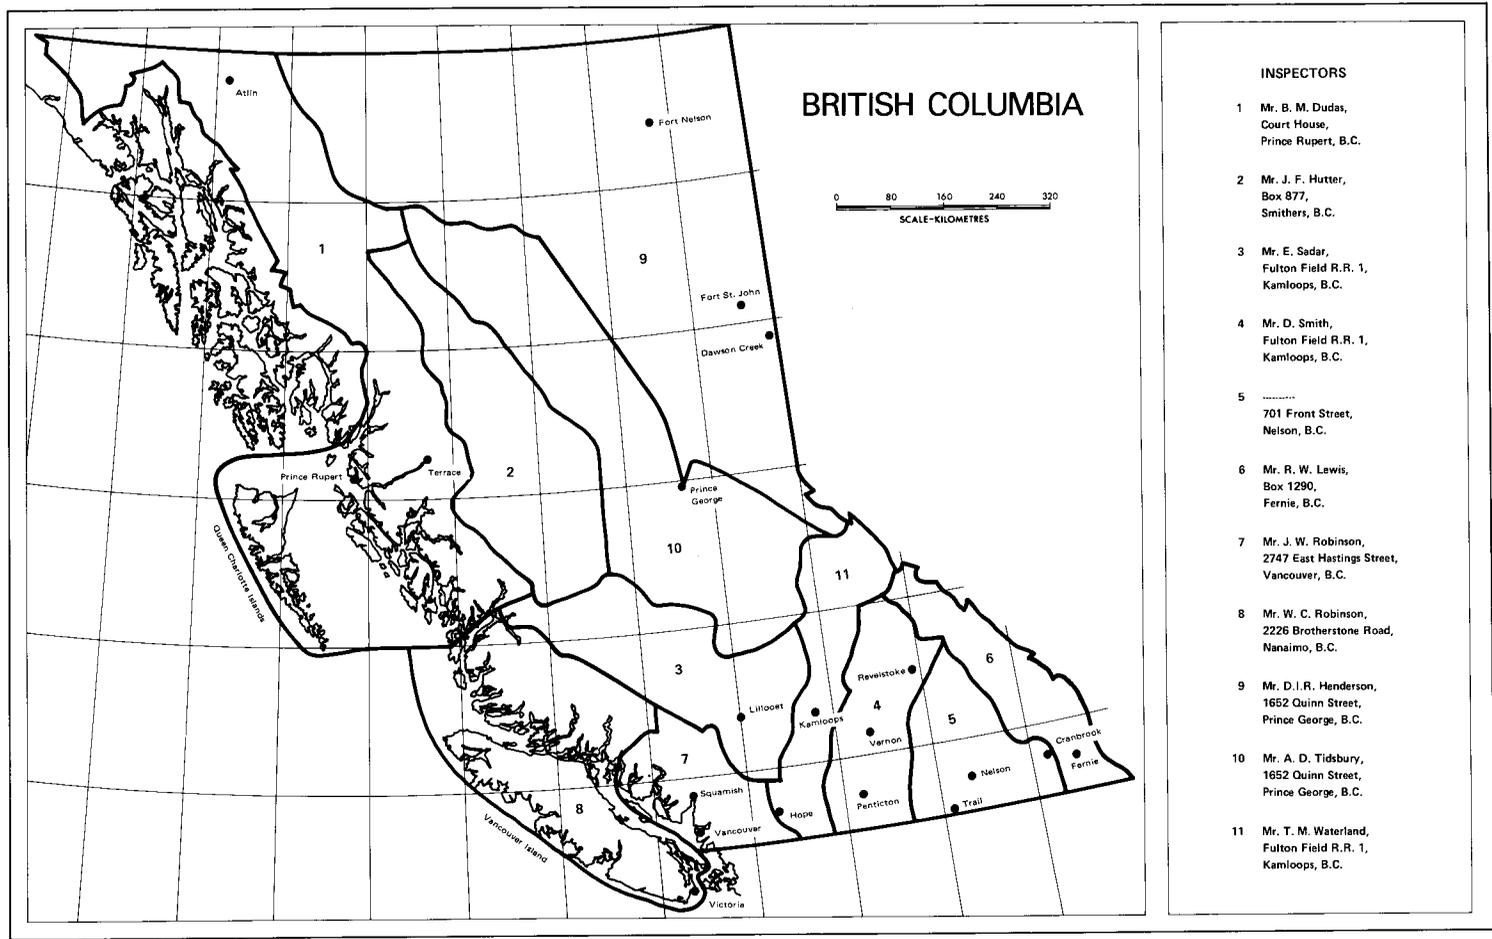
Figure 1. Index map showing inspectoral districts.

The following lists indicate the location and duties of the staff of this Division on December 31, 1974. Except for the senior staff in Victoria, the Inspectors examine coal mines, metal mines, and quarries in the districts as indicated on Figure 1. They also may examine prospects, mining properties, road and trails, and carry out special investigations under the *Mineral Act*. The Environmental Control Inspectors conduct dust, ventilation, and noise surveys at all mines and quarries and, where necessary, make recommendations to improve environmental conditions. The Senior Inspector, Mining Roads, supervises the roads and trails, and the prospectors' assistance programs. The Senior Inspector, Reclamation, administers the reclamation sections of the *Coal Mines Regulation Act* and the *Mines Regulation Act*. The Senior Inspector, Coal, has additional duties as mining advisor to the Securities Commission. Mine-rescue training is completed under the direction of the Co-ordinators, Rescue Training, for the areas in which their stations are located.

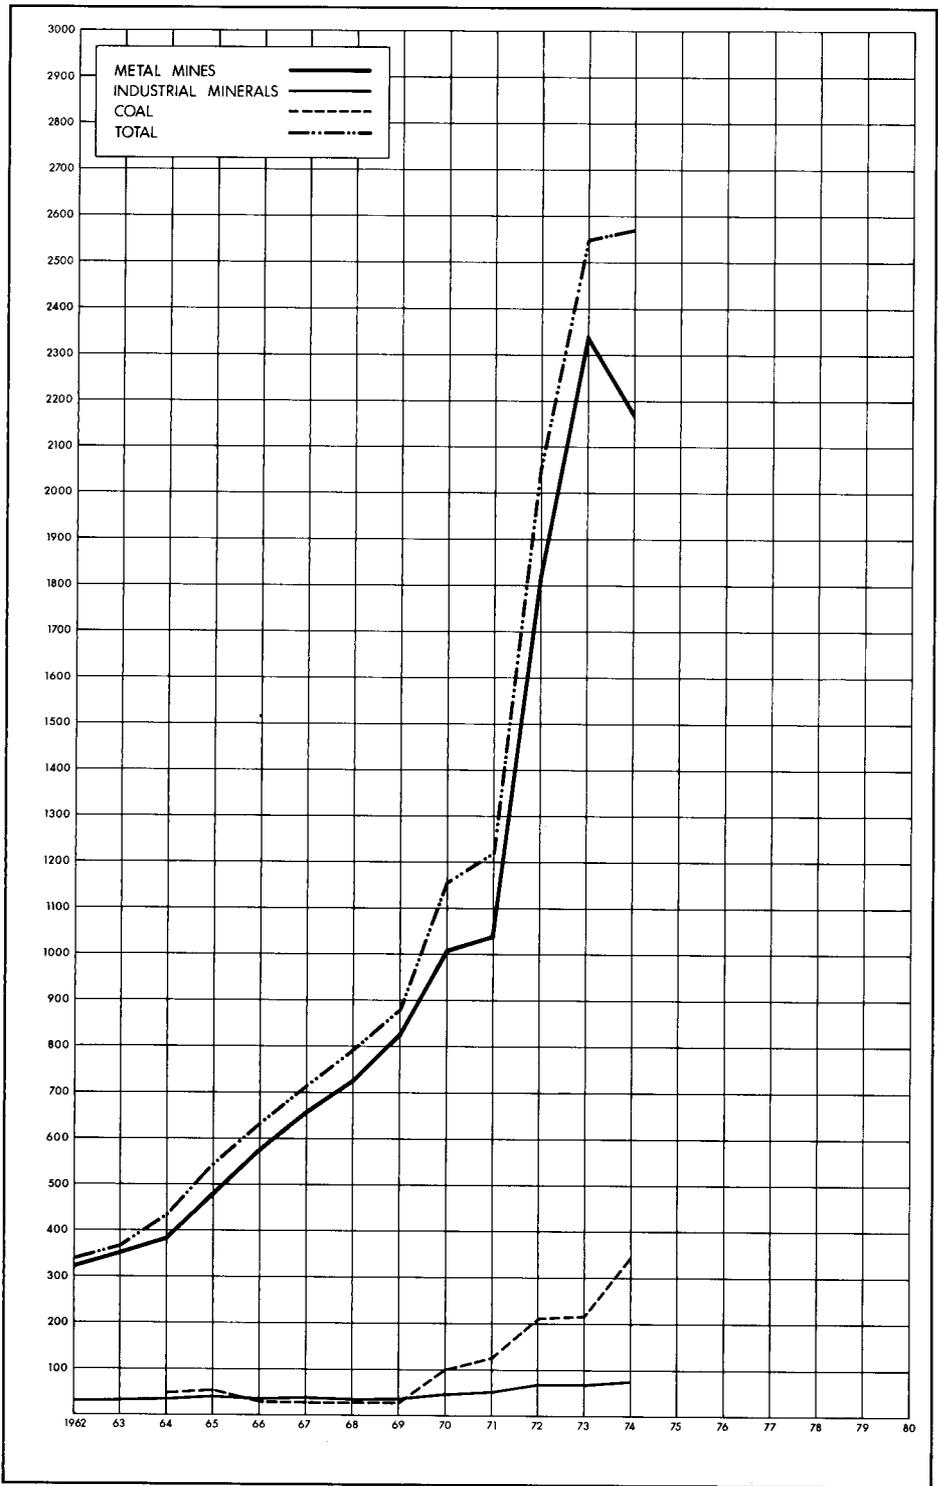
Figure 2. Power consumption in kilowatt-hours in mining operations since 1962.

ANNUAL CONSUMPTION OF POWER (IN KILOWATT HOURS)

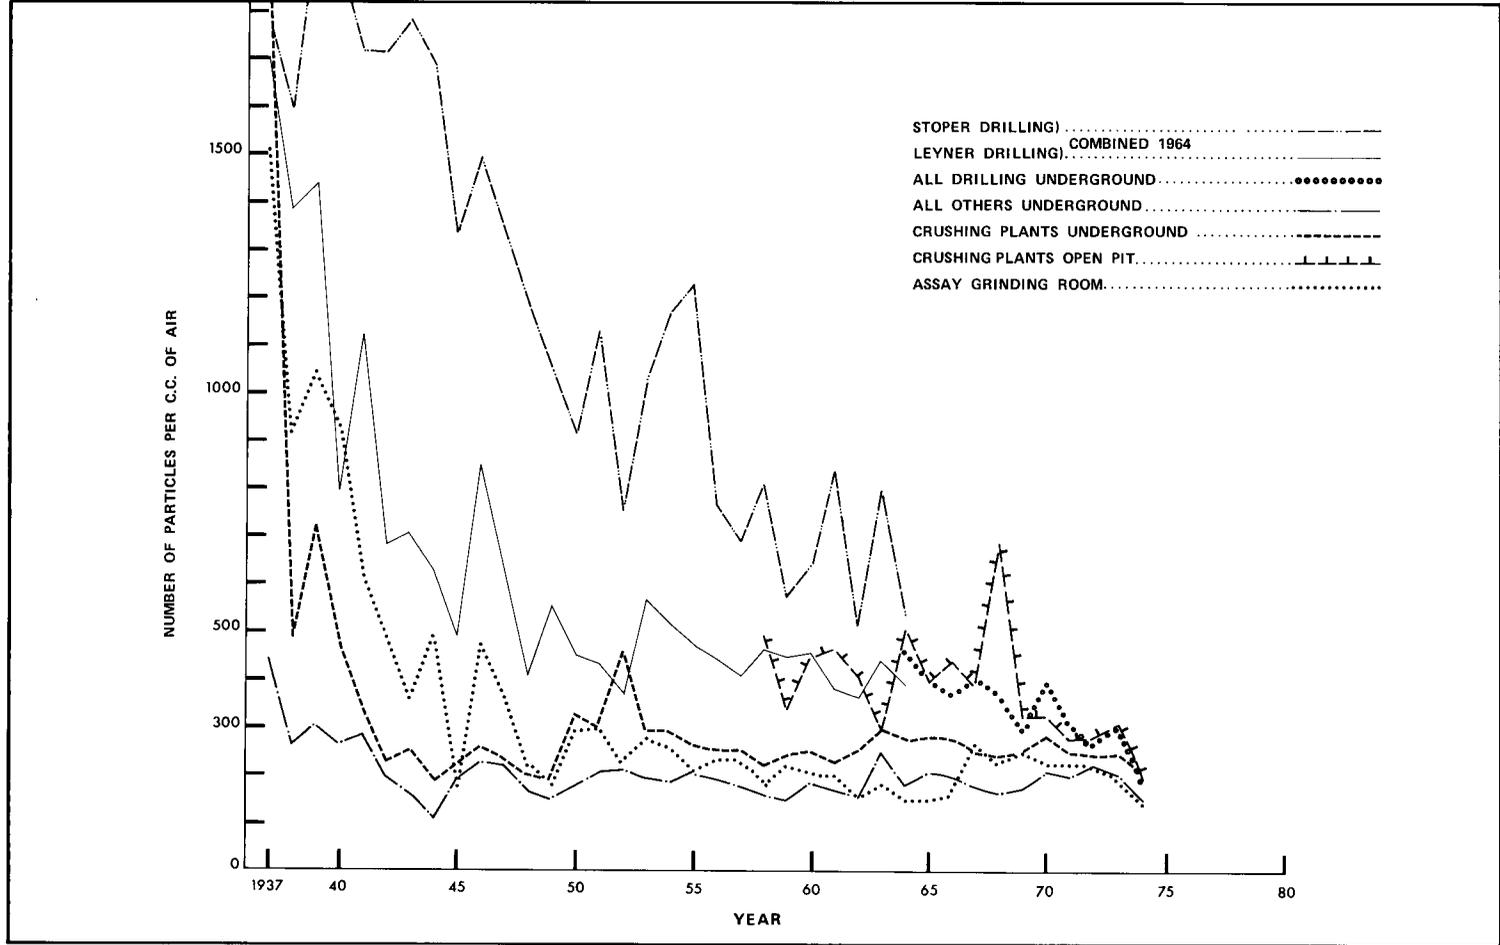
Figure 3. Graph of median average dust concentrations in the metalliferous mining industry.

When examined in comparison with the crushing plants at open-pit mining operations, the latter has shown an improvement from 41 per cent below 300 particles of dust per cubic centimetre of air in 1973 to 74 per cent of operations below 300 particles in 1974.

A great improvement was registered in dust control in the assay grinding rooms at both underground and open-pit mines as the percentage of surveys showing less than 300

particles per cubic centimetre increased from 63 in 1973 to 95 per cent in 1974. The improvement is attributed to the operating companies having modified their dust control systems following recommendations made by the Inspector. Dust control at drilling sites in open-pit operations showed some improvement with 73 per cent of the surveys taken showing less than 300 dust particles per cubic centimetre of air but this is still below the 100 per cent achieved in 1972.

Figure 3 is a graph of the median average dust concentrations in the metalliferous mining industry and indicates for all types of operations a consistent converging trend to dust concentrations below the threshold limit value of 300 particles per cubic centimetre of air.
