Geology of the Parliament Buildings 6. Geology of the British Columbia Parliament Buildings, Victoria

Zdenek D. Hora¹ and Kirk D. Hancock² '3657 Doncaster Dr. Victoria, BC, Canada, V8P 3W8 E-mail: zdhora@telus.net

SUMMARY

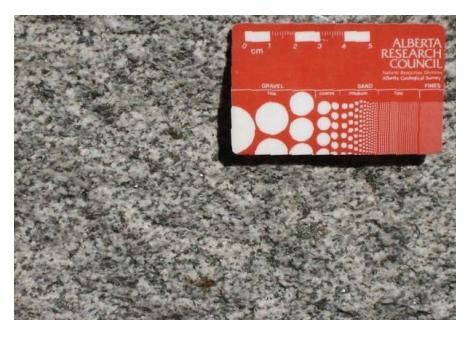
Figure 7. Detail photograph of Nelson Island Granite.

The stone is fairly uniform in appearance, having only occasional small (a few centimetres) dark knots (from xenoliths and autoliths to inclusions of black mineral aggregates; Fig. 7). It is a medium-grained, light grey, salt-and-pepper granodiorite, and is composed essentially of quartz, orthoclase and plagioclase feldspar, minor biotite and hornblende, and accessory magnetite. The stone polishes easily and contains very few microfractures.

Nelson Island granite typically has a specific gravity of 2.657, absorption of 0.175%, and a compressive strength of 240 MPa (approximately 35 000 psi). The superior quality of this stone is well known; it has been used widely in western Canada, Washington, and Oregon, and some has been shipped to Hawaii and Australia (Parks 1917).

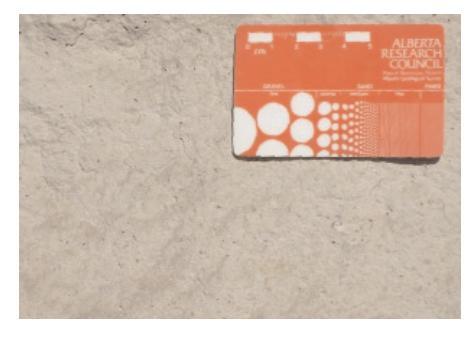
Figure 8. Detail photograph of Haddington Island Andesite.

Haddington Island andesite has a very uniform, minutely crystalline (0.1 millimetre and less), light grevish vellow or bluish grey groundmass. It is composed of about 80-85% plagioclase and minor quartz, biotite and magnetite (Fig. 8), and is dotted with about 1% light green to brown, 1 to 2 mm crystals of twinned plagioclase. This dacite is a part of the Miocene Alert Bay volcanics, and is unique to the area (Muller et al. 1974). The typical properties of the stone are a specific gravity of 2.67, absorption of 3.79% and compressive strength of 127 MPa (approximately 18 500 psi; Parks 1917). Compared to most British Columbia sandstones, the Haddington Island andesite is slightly harder, but well suited to fine carving and all types of dressing. In the masonry for the parliament buildings, this stone has been used both as smooth surface-cut blocks and as rusticated blocks with roughly chipped exposed surfaces. The obligatory cultural features of the parliament buildings required extensive ornamental carving, sculptures and similar artwork. Of particular note is the sculptural work for the outer walls of the legislative library (Fig. 9). These walls feature 14 statues of persons important in British Columbia history, and six 'medallions' displaying busts of outstanding literary personalities (Fig. 9). They were all carved of Haddington Island stone by sculptor Charles Marga (Segger 1979).

Haddington Island andesite, a dacite in terms of bulk composition, is the primary building stone of the parliament buildings (Fig. 8). The

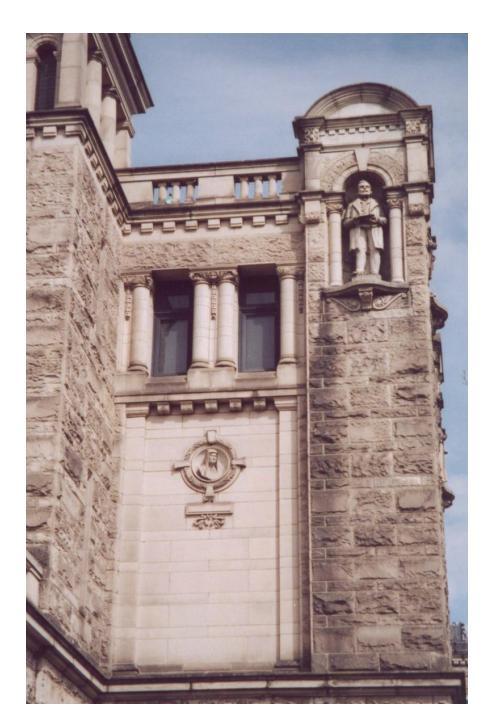
Figure 9. Ornamental statue (above) and medallion (below) carved from Haddington Island Andesite.

After more than one hundred years of exposure to the coastal climate, with its humid, salty air and many annual freeze-thaw cycles, there is no noticeable deterioration of detail in the highly ornamental work or the statues – proof of the exceptional

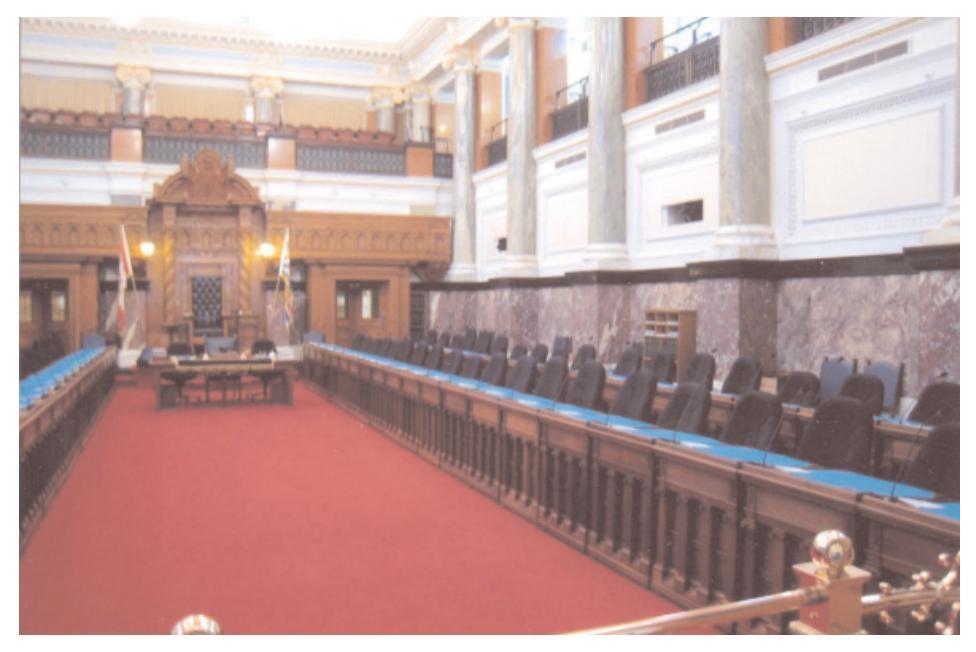
Figure 12. Interior view of the Legislative Chamber.

The best display of contrasting colours from a variety of marbles is in the legislative chamber itself (Fig. 12). The marbles used were approved only after some hesitation because of concern over cost overruns. It took a considerable effort by Rattenbury to obtain approval for the installation of marble in the legislative chamber (Segger 1979). Four types of Italian marble were incorporated in the interior design. A narrow band at the base of the walls and at the bases of the 22 round columns that support the roof of the legislative chamber, are made of fine grained *Pavonazzo white marble* (with occasional black streaks). This stone is Jurassic limestone that was metamorphosed during the Alpine Orogeny in the Tertiary, and is quarried in the north part of the Tuscanian Apennines.

Between the bottom white strip of Pavonazzo marble and the bases of the supporting columns, the walls are faced with sheets of dark red Breccia Pernice marble containing some white veins and patches (Fig. 12). This marble is also Jurassic in age, metamorphosed in the Tertiary, and quarried in Veneto, northern Italy. On top of this wall facing, and between this marble and the bases of the supporting columns, is a narrow projecting band of black marble of unknown provenance (Fig. 12). The 22 supporting columns consist of irregularly banded olive green-grey and white Cipollino Apuano marble, Jurassic in age and quarried in northern Tuscany, Italy (Blakey Smith, no date). In the legislative chamber galleries, additional roof support is provided by square pillars behind each of the rounded columns. These pillars are clad with a meat-red Rosso Verona nodular limestone, Jurassic in age (British Columbia Ministry of Provincial Secretary and Government Services, no date). This building stone, popular since antiquity, is quarried near Sant' Ambrogio di Valpolicella, Veneto, in northern Italy.

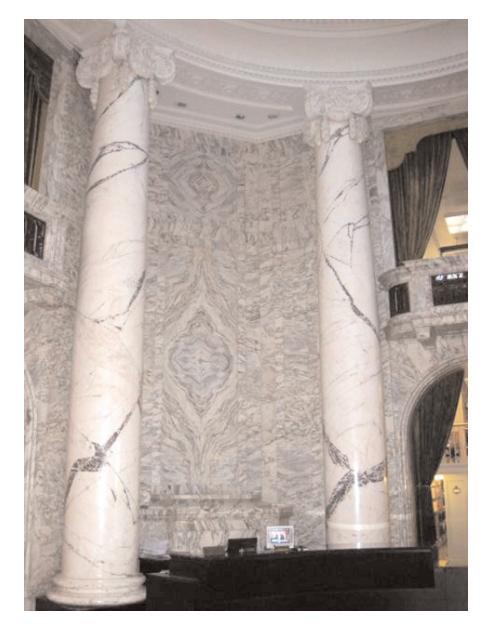
Figure 13. View of the library rotunda.

A collection of several attractive marbles can be seen in the library rotunda (Fig. 13). Government records merely mention 'Italian marble' as the source (Blakey Smith, no date). Based

on their colour and pattern, the walls and entrances are most probably two varieties of Jurassic *Carrara marble*. The *Arabescato*, with irregular black and grey fragments, patches and veins, is seen around the entrances and balconies, whereas *Bianco Venato* or *Venato Fantastico*, with parallel grey and black veining in a white matrix, forms wall panels.

The library rotunda floor is composed of several colours of marble that form circles and triangles in a very interesting ornamental fashion. The floor consists of a *Bianco Carrara*

marble matrix within which two black circles and triangles of banded *Cipollino marble* have been laid. Small circles of thinly banded marble in each corner are either a *Cipollino marble variety* or *Arni Fantastico marble*. Eight columns supporting the dome are not real marble, but a so-called scagliola, a marble imitation consisting of finely ground gypsum and limestone or marble. Figure 14 shows the location of Italian quarry sites used in the British Columbia parliament buildings.

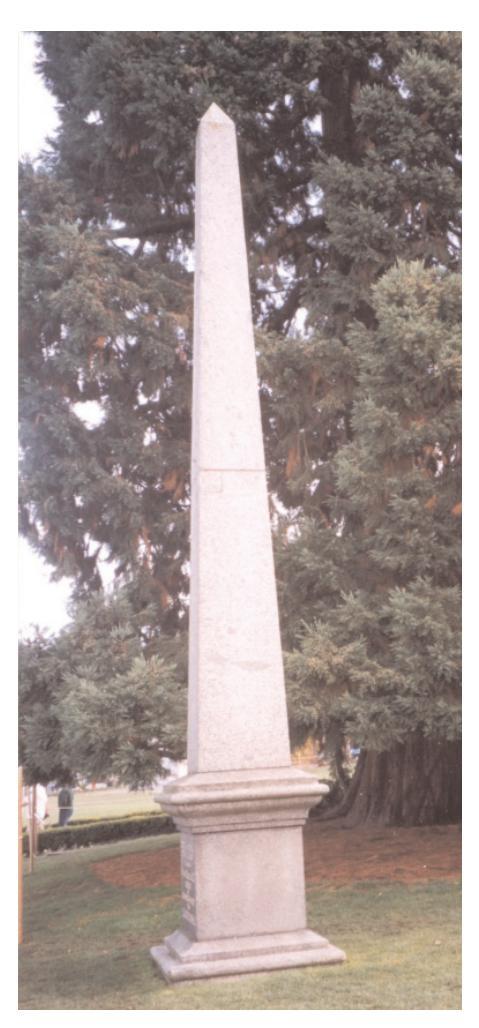
Figure 16. Sir James Douglas Memorial Obelisk of coastal granodiorite.

Four monuments and two fountains have been placed within the precinct grounds of the parliament buildings (Fig. 15); three of these monuments are along Belleville Street in front of the parliament buildings. The oldest is the 1879 obelisk in the memory of former governor, Sir James Douglas (Fig. 16). This simple, 27 ft (7.1 metre)-high needle, has been repeatedly and incorrectly described as Beaver Cove marble (Blakey Smith, no date). While a shipment of marble from Beaver Cove (on the north coast of Vancouver Island) to Victoria is reported to have been made around 1880, it is not the stone of this obelisk. The source of this misinformation is probably a local newspaper report about this monument, dated November 14, 1879. Actually, the stone used is a dark type of granodiorite from an unknown source, displaying large black 'knots' (xenoliths) on its surface. The obelisk was assembled from several smaller pieces of stone. Similar rock can be found in the Victoria area.

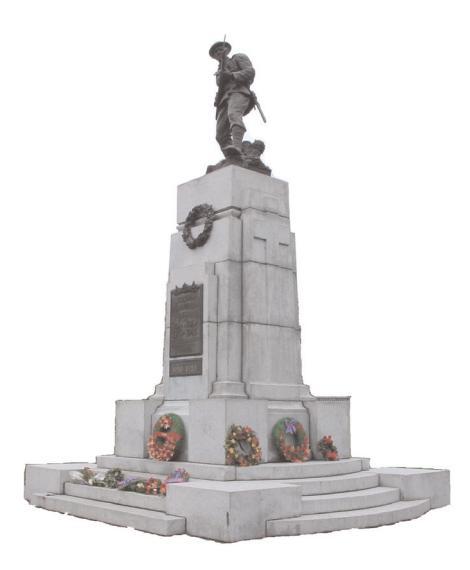
Figure 17. British Columbia War Memorial Monument made of Nelson Island Granite.

Vernon Marsh and his siblings, who also designed and sculpted the National War Memorial in Ottawa (Sutherland Brown, pers. comm. 2007); the stone is all *Nelson Island granite*.

Farther east, on the corner of Belleville and Government Streets, is a World War I memorial, unveiled and dedicated on July 12, 1925 (Blakey Smith, no date). This cenotaph is an important monument and the focus of countless memorial services (Fig. 17). It was designed by the English sculptor

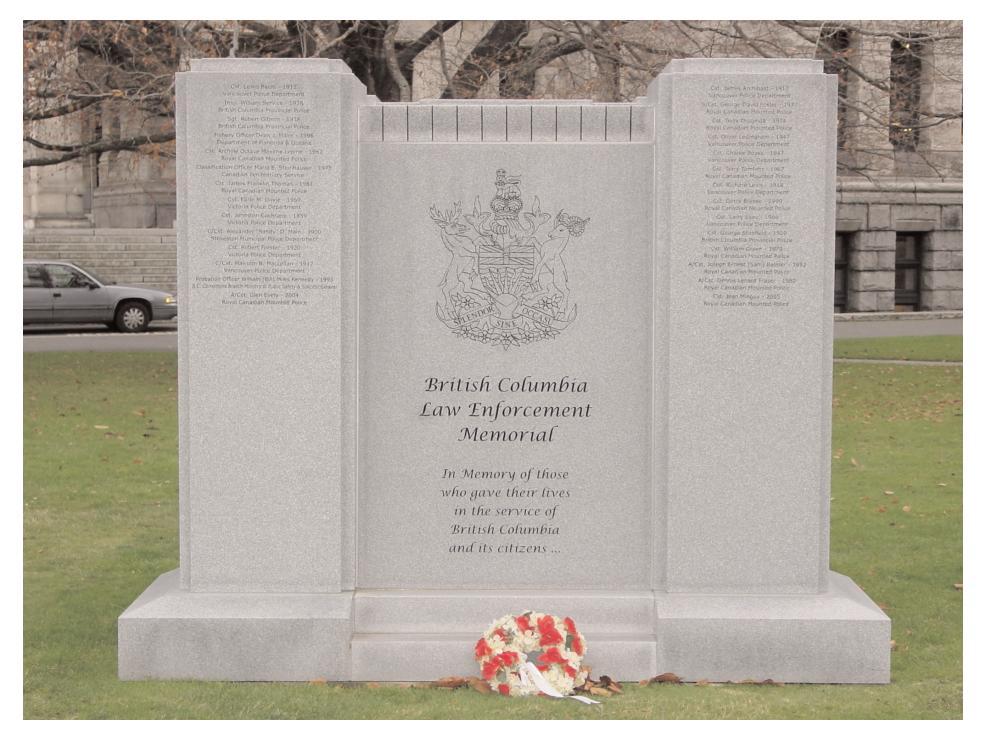
Figure 18. British Columbia Law Enforcement Memorial made of Dark Barre Granite from Vermont.

A recent addition near the southeast corner of the precinct grounds is the 2003 British Columbia Law Enforcement Memorial (Fig. 18). The stone is a very uniform, finegrained, bluish grey *Dark Barre granite* from Barre, Vermont, USA.

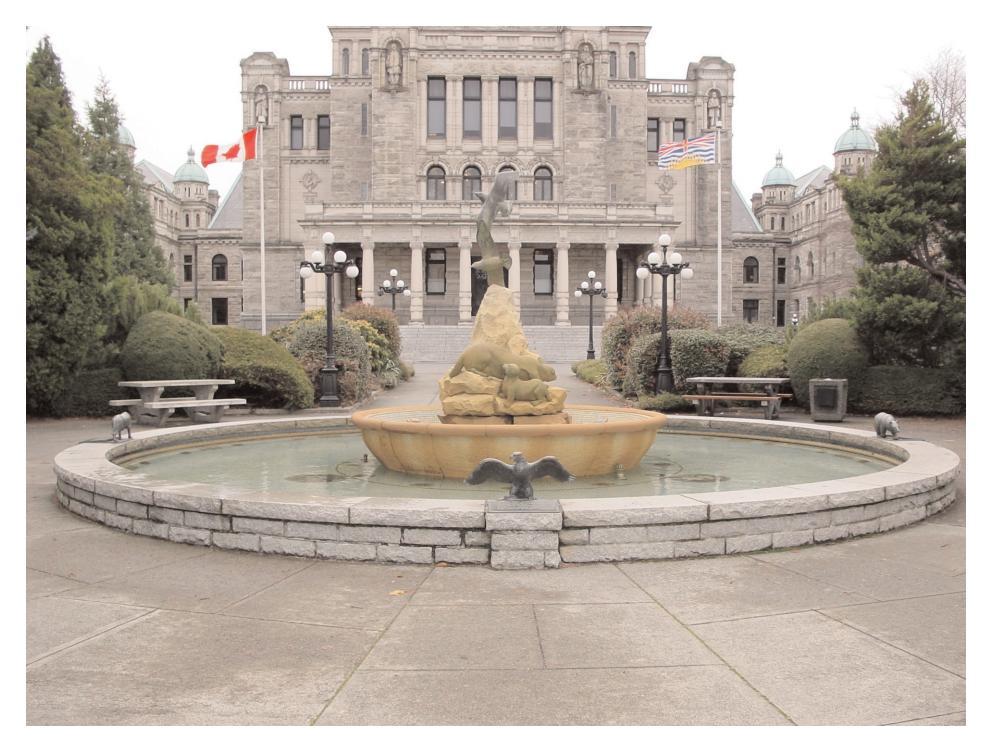
Figure 19. Centennial Fountain made of Nelson Island Granite.

Of the two fountains, only the one on the south side of the parliament buildings has interesting stonework. Called 'Centennial Fountain' (Fig. 19), the central sculpture is made from *Nelson Island granite* and commemorates the union of four territories, which in 1862 were amalgamated into the colony of British Columbia. The four territories involved were Vancouver Island, Queen Charlotte Islands, British Columbia and the Stikine Territory (Segger 1979). The second fountain, located in front of
